Pleasant Lake Shoreline Evaluation

North Oaks Homeowner Association

July 2009

The North Oaks Home Owners Association (NOHOA) owns the entire buffer area surrounding the lake, an approximately 50-feet strip up from the Ordinary High Water Line (OHWL). Funded by NOHOA, this report outlines the findings and recommendations stemming from the shoreline assessment that was performed by Great River Greening in June and July of 2009.

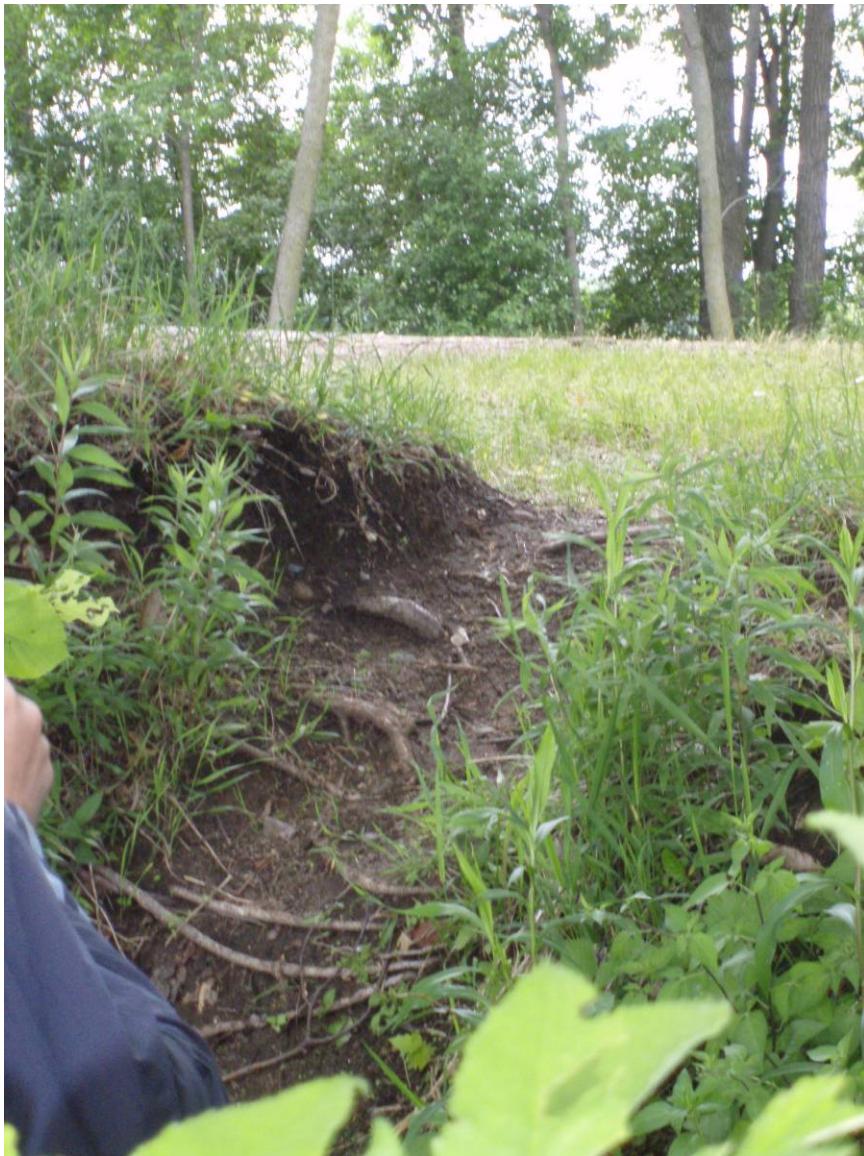
Way-point	Photo #	Description	Priority	Recommendation
1	1:49	Erosion from walking to lake from road. About 10 feet of shoreline.	U	Trees or shrubs; dogwood live stakes/Amorpha planting; black willow tree planting sandwiched between willows and basswood-southwest maybe to west of the area
2	1:49	Yellow gas/bench. 10' wide area of eroding, sloughing bank.	U	Planting trees, shrubs, live stakes.
3	1:49	Lake access; 3' wide buffer to Island Road. High Priority! Not much time before road starts to undermine. Must do something now to head this situation off.	U	Trees or shrubs; dogwood live stakes/Amorpha planting; black willow tree planting sandwiched between willows and basswood-southwest maybe to west of the area. About 50' of shoreline.
4	1:33	Purple loosestrife coming in. 100 ' of shoreline bare with no vegetation.	1	
5	1:42-43, 50-51	Mowing to water's edge; no native vegetation in the buffer zone. ("Tract X"). No trail exists on this section of lakeshore.	U	Replant buffer zone with native shrubs and herbaceous plants. Live stakes at toe. If trail construction project is approved, wait until trail is installed before vegetation is installed.

Figure 12. Erosion caused by un-authorized lake access (waypoint #1).

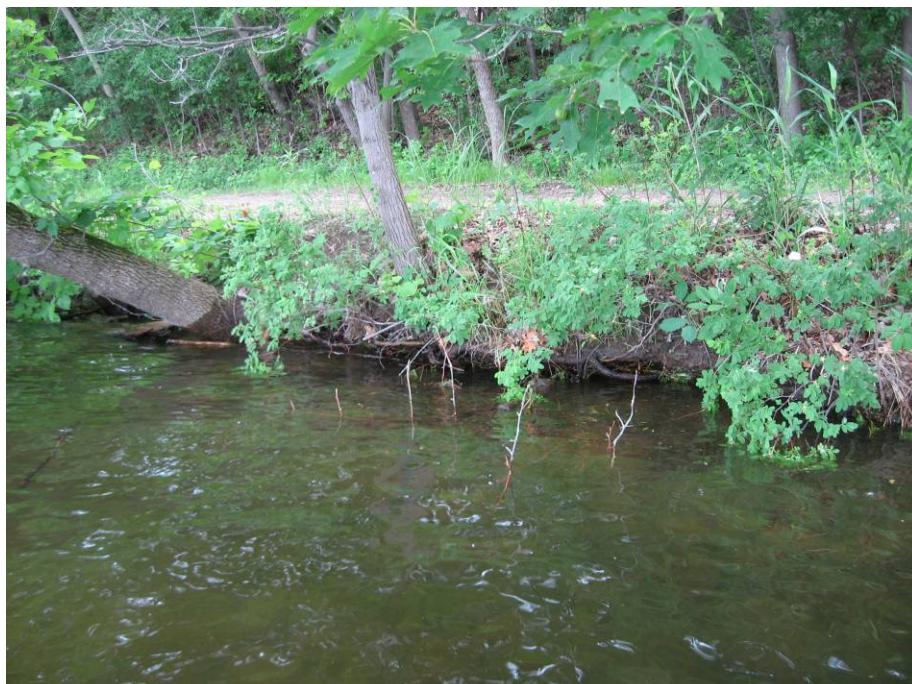
Figure 14. Undercutting at toe and closely encroaching on trail (waypoint 28).

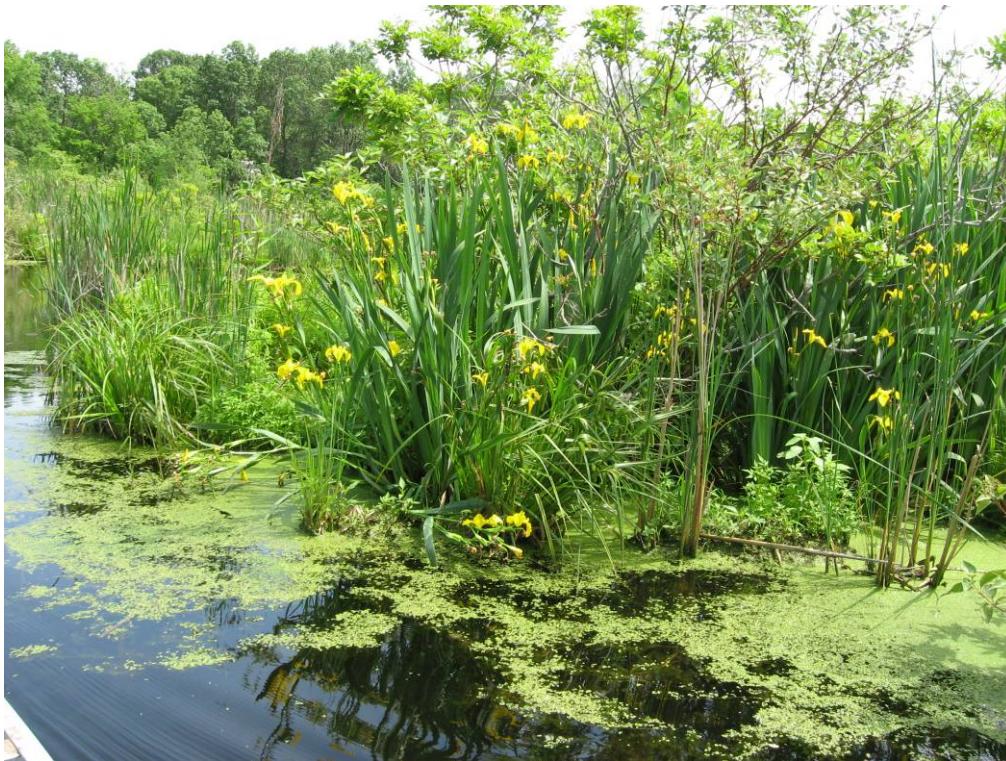
Figure 16. Yellow Iris (*Iris pseudocorus*) in Marsh Bay, an exotic invasive wetland plant.

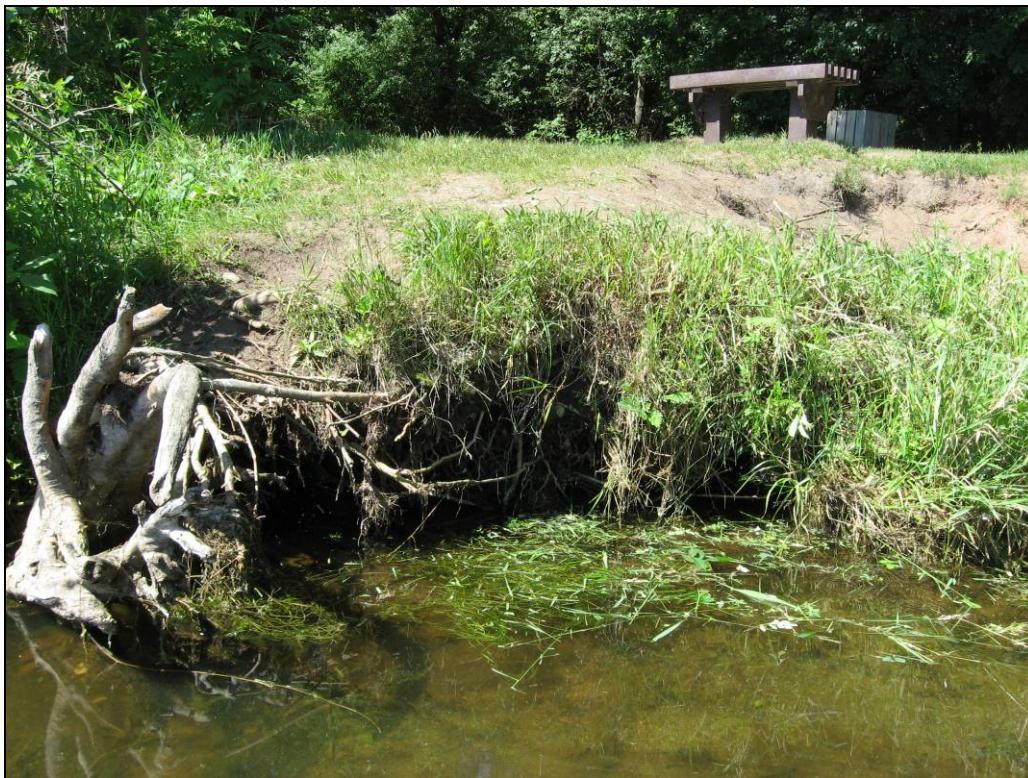
There are several priority areas here; including the large Urgent Priority area associated with the Charlie Lake Inlet canal (Figures 19-20), which is very eroded at the point, and potentially eroding the footings of the bridge. Included are plan and sections drawings of recommended practices for the Charlie Lake Inlet Canal area. A full, vegetated restoration of the point area is recommended, and rock vanes for the canal (see Appendices 5 and 7). Rock vanes are a practice that redirects the channel (the “thalweg”) away from the shoreline and towards the middle of the canal.

Figure 19. Erosion and degraded shoreline by Charlie Lake inlet canal.

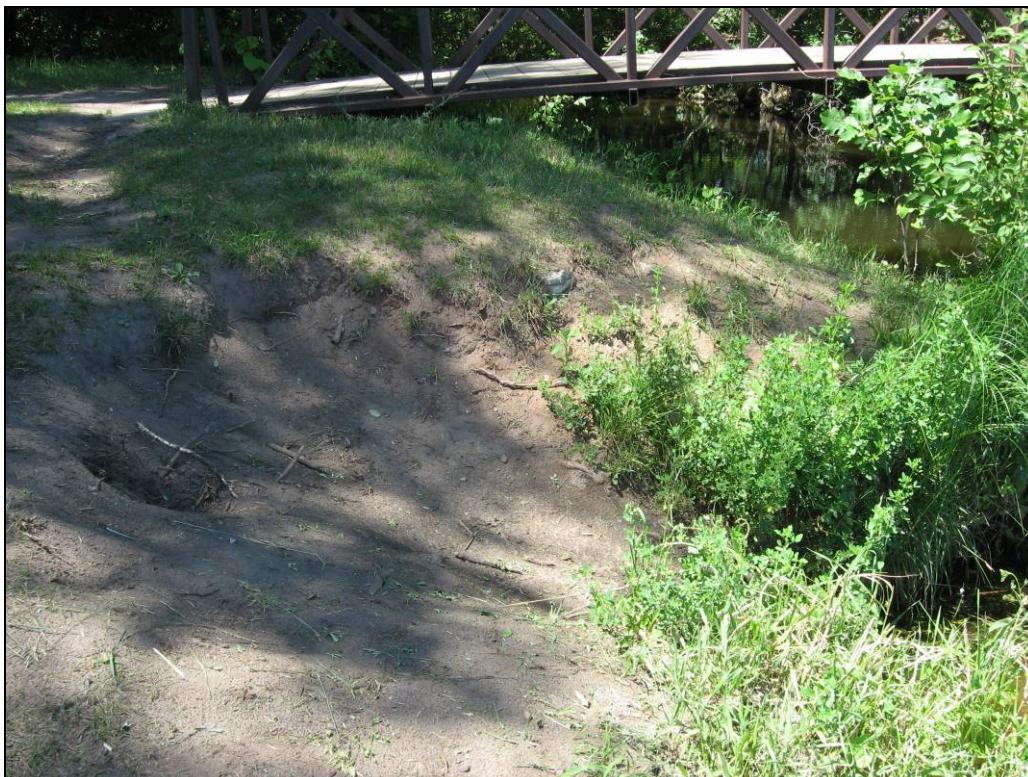
Figure 20. Eroded shoreline by the bridge over the canal at Charlie Lake inlet canal.

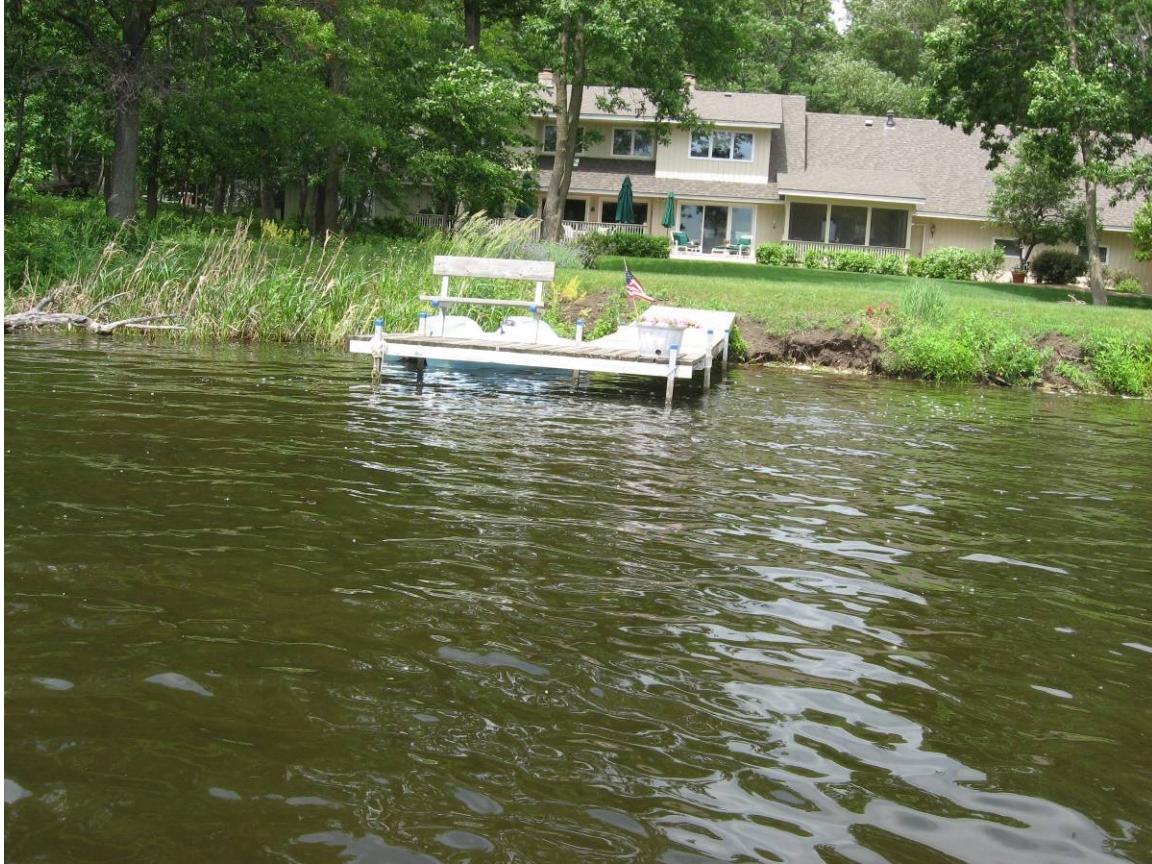
Figure 21. Text book example of shoreline erosion due to the removal of emergent vegetation (waypoint 40 & 40A). Both sides of dock have a lack of *transitional* vegetation, but notice that the right side bank is steep and is actively sloughing off into the water, where the left side bank is gradual and is stable. The reason is that the left side has intact *emergent* vegetation, whereas the right side has no emergent vegetation at all. Nevertheless, mowing of transitional vegetation should be discontinued.

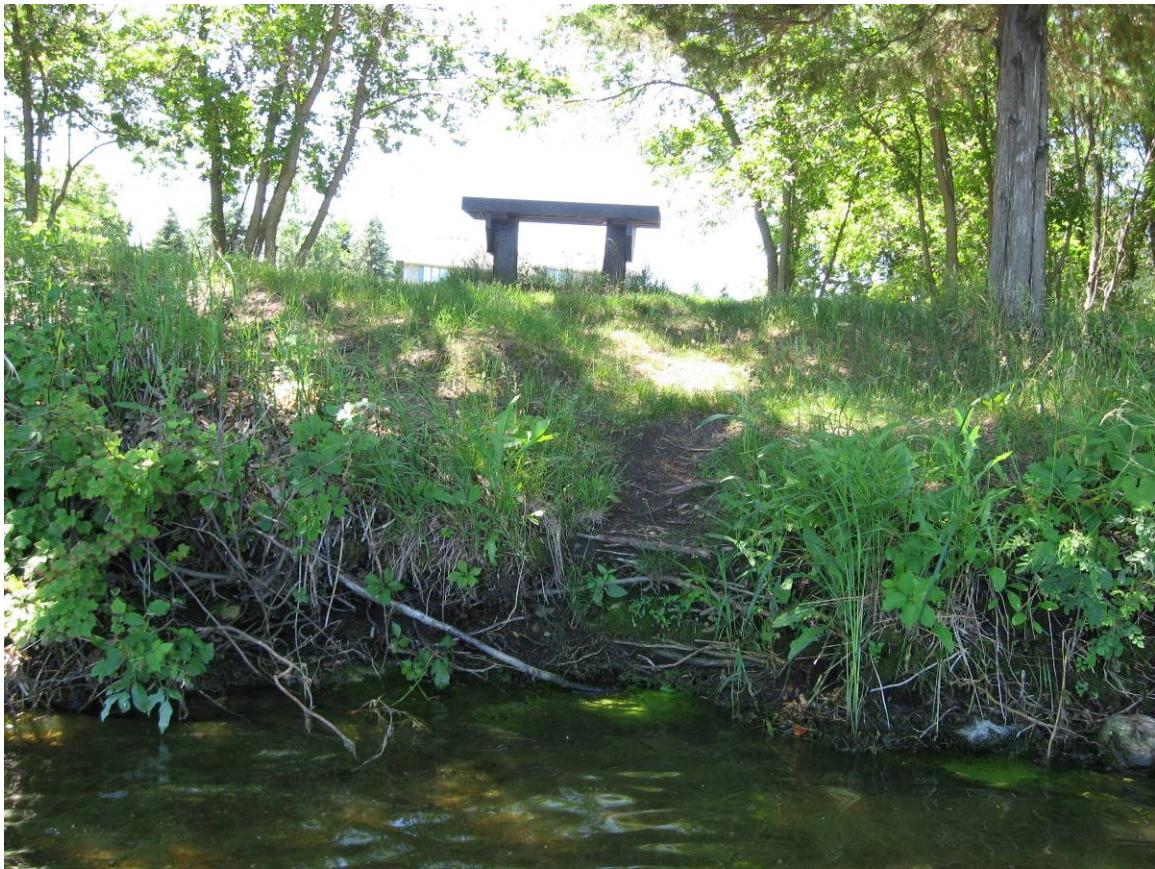
Figure 23. Erosion by sitting bench at Blue Water Lagoon.

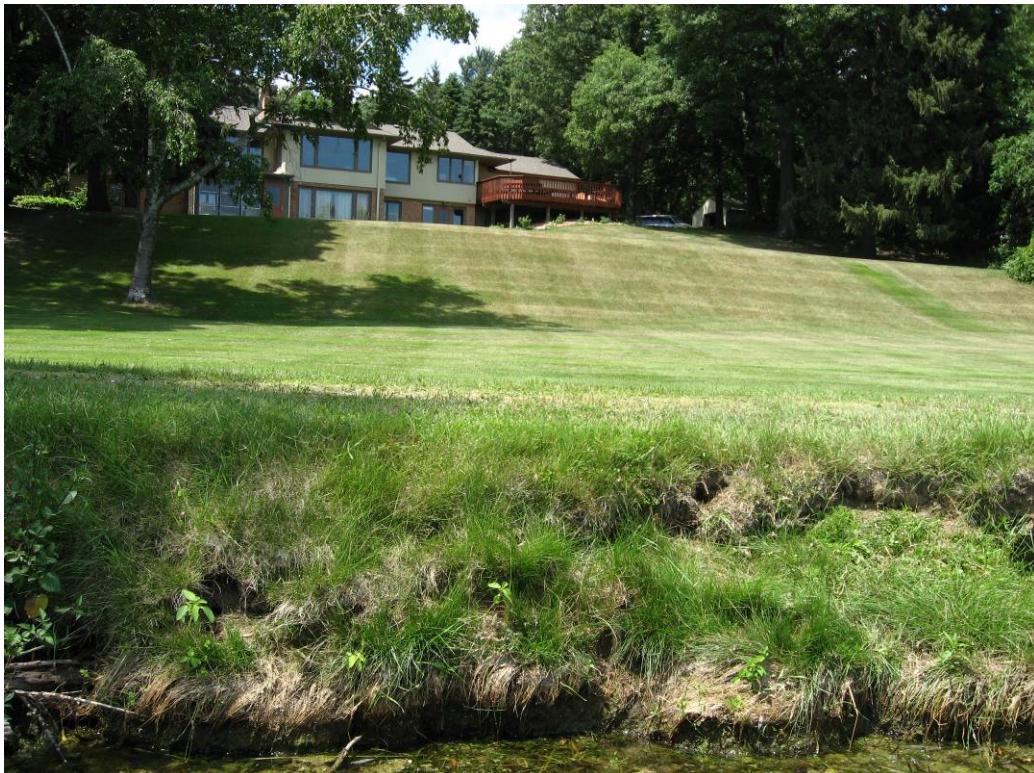
Figure 26. Slumping bank due to complete lack of native buffer.

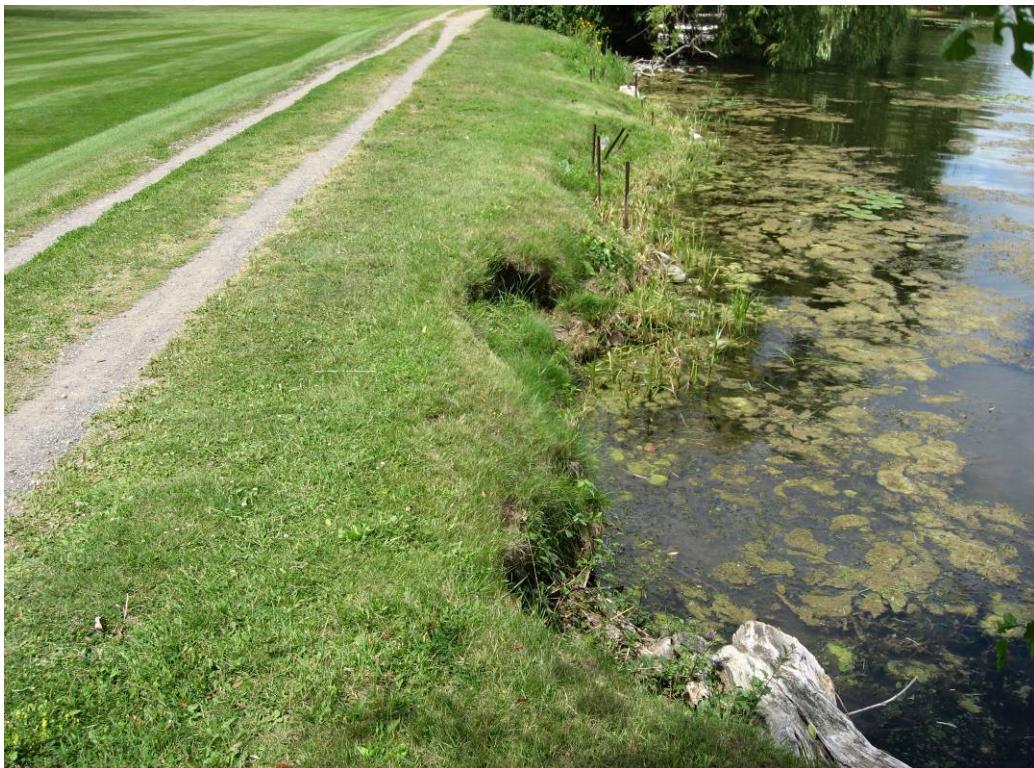
Figure 27. Bank slumping close to trail on southwest shore.

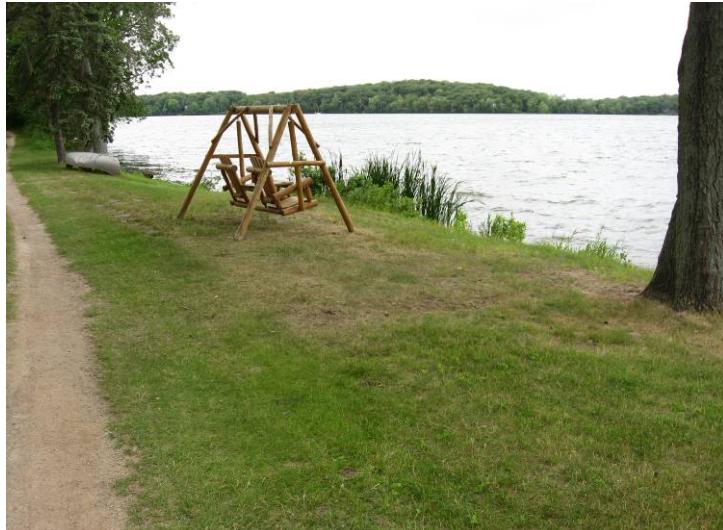
Figure 30. Problem site on southeast shoreline.

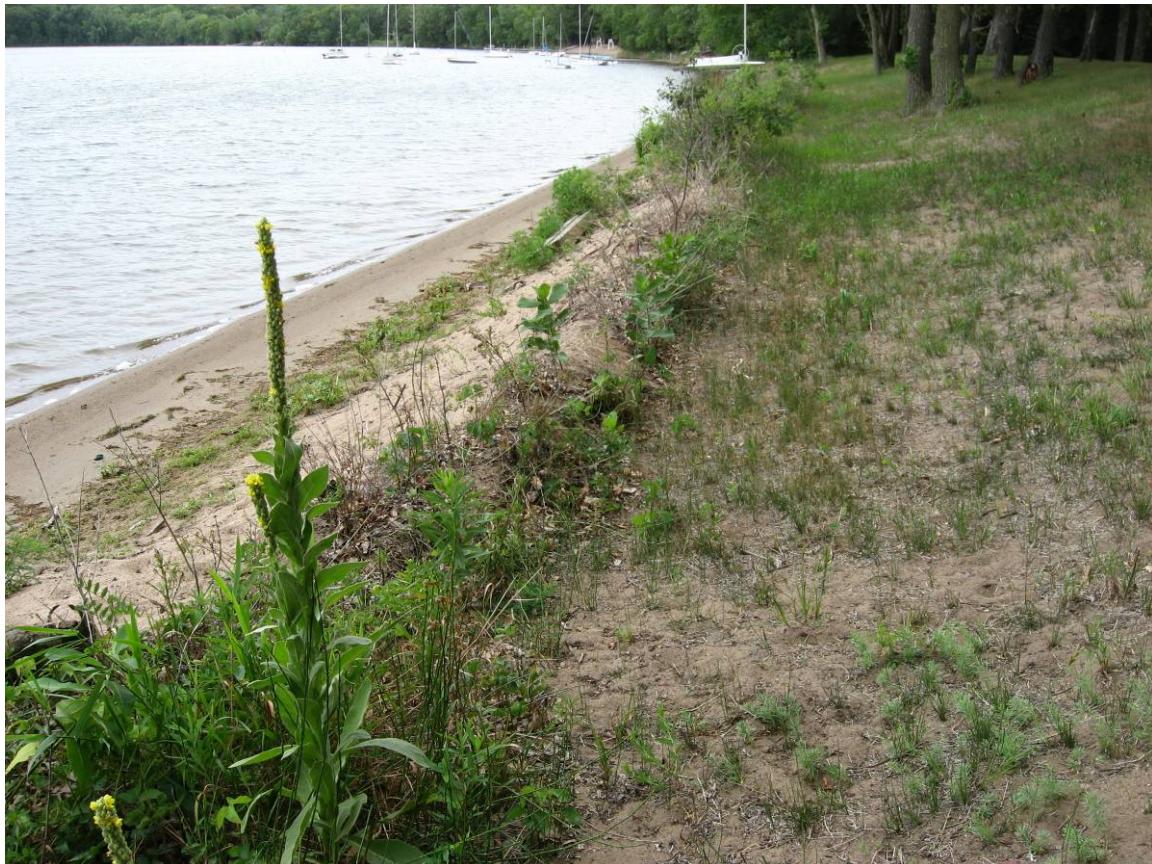
Figure 32. Ice ridge formation on open shoreline area.

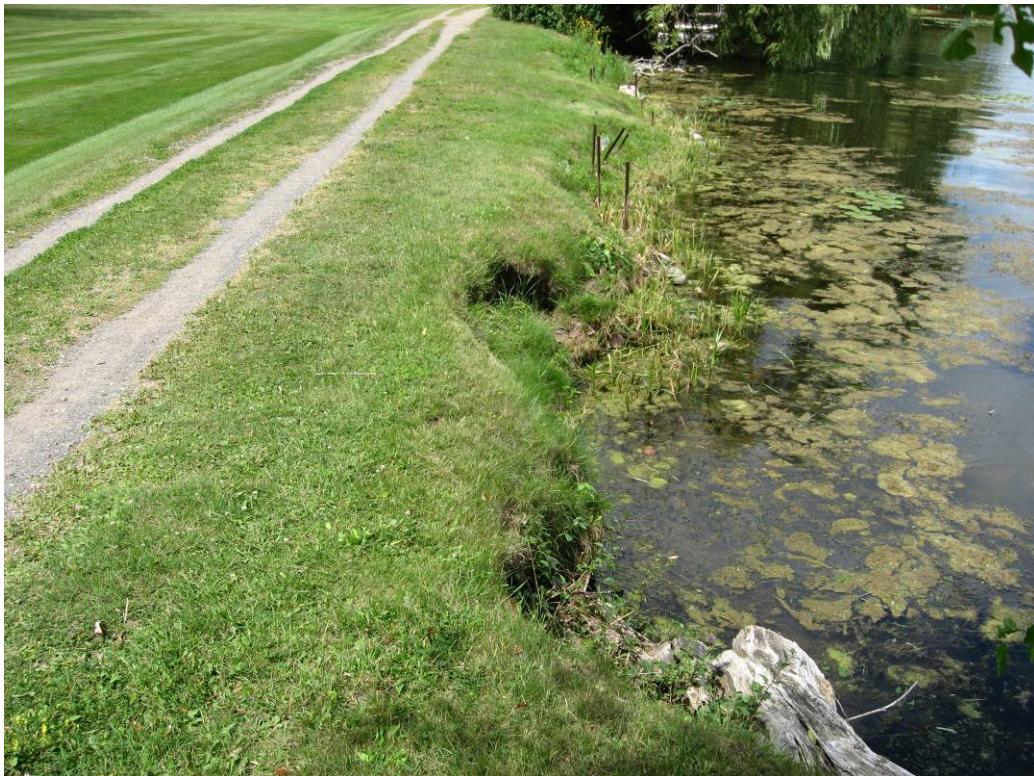
Figure 44. Mowing down to the water's edge: a poor lakeshore practice.

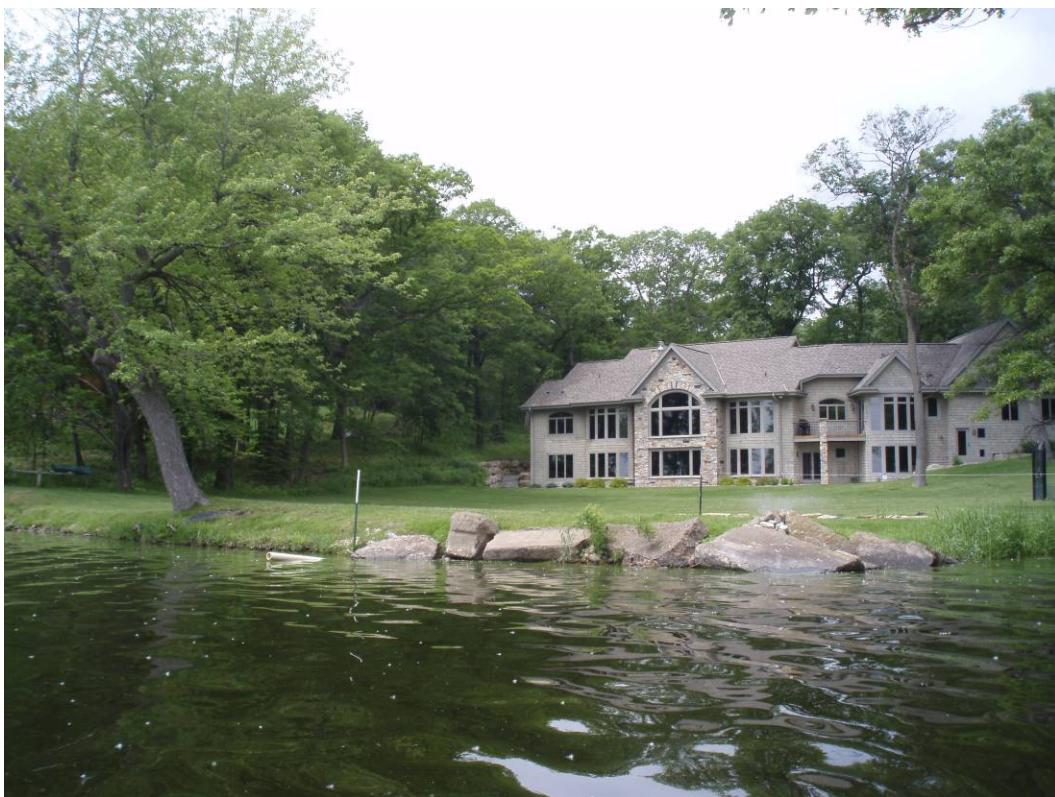
Figure 45. Excessive clearing of buffer vegetation and mowing turf to the water's edge.

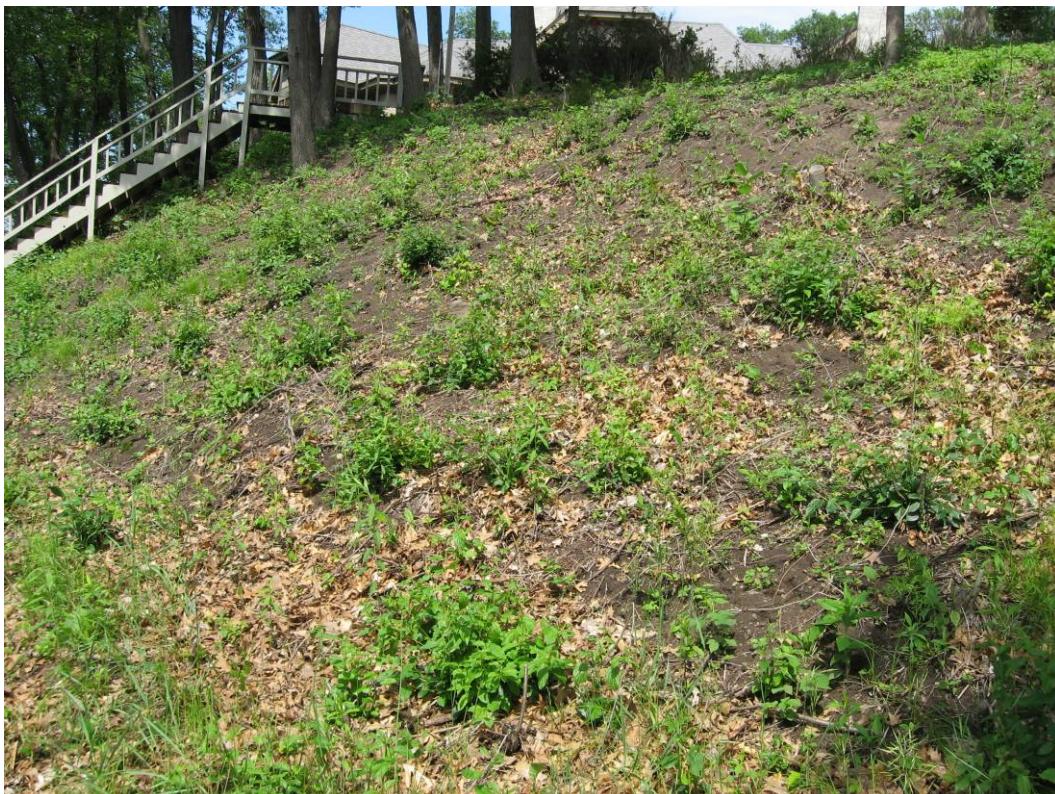
Figure 46. Clearing of a steep slope without treating buckthorn stumps and without adequate re-vegetation.

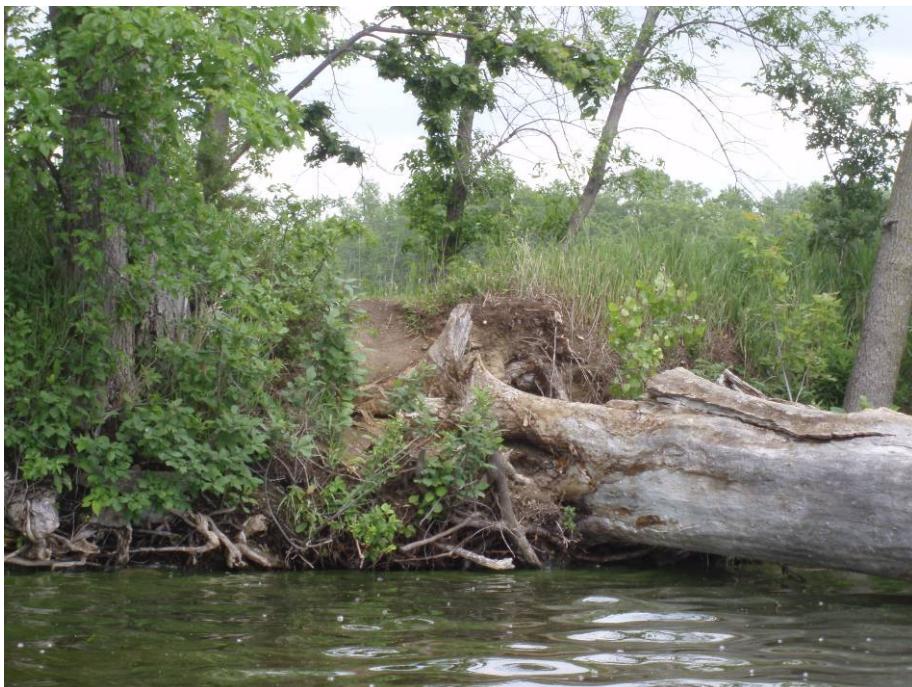
Figure 51. Cottonwood that has fallen causing a “blow out” of the bank.
(near foot-bridge on north shore of lake)

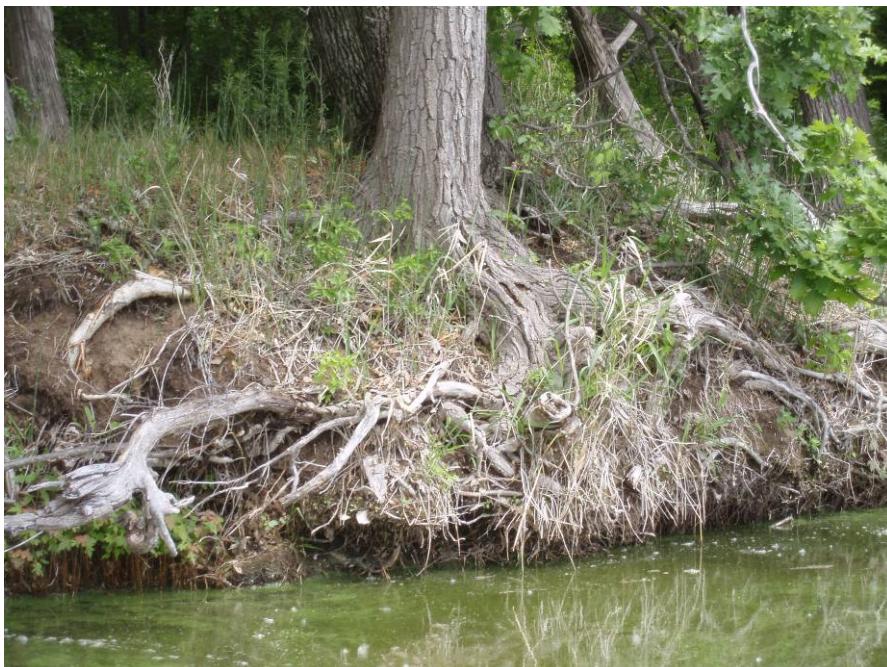
Figure 51b. Cottonwood succumbing to erosion and undercutting on shoreline.
Note that although some upland stabilization is being provided by the root system, little to no stabilization is occurring at the toe of the bank, where erosion is continuing unchecked.

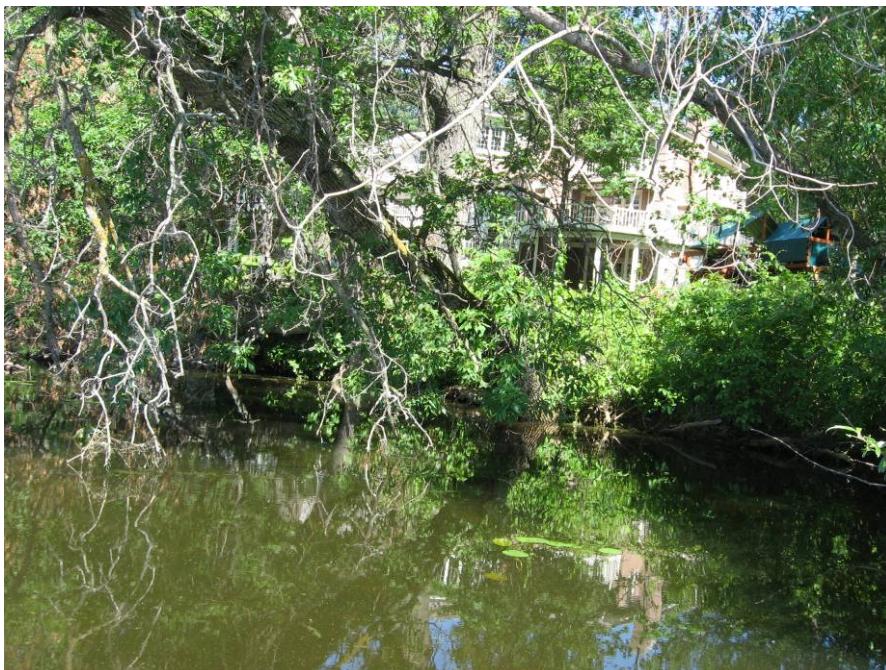
Figure 52. Leaning tree that poses no concern. Leave it for fish habitat value.
