Sustainable Lake Management Plan

Wilkinson Lake

Ramsey County, MN

Prepared by:
Kristine Jenson
Vadnais Lake Area Water Management Organization
November 2011

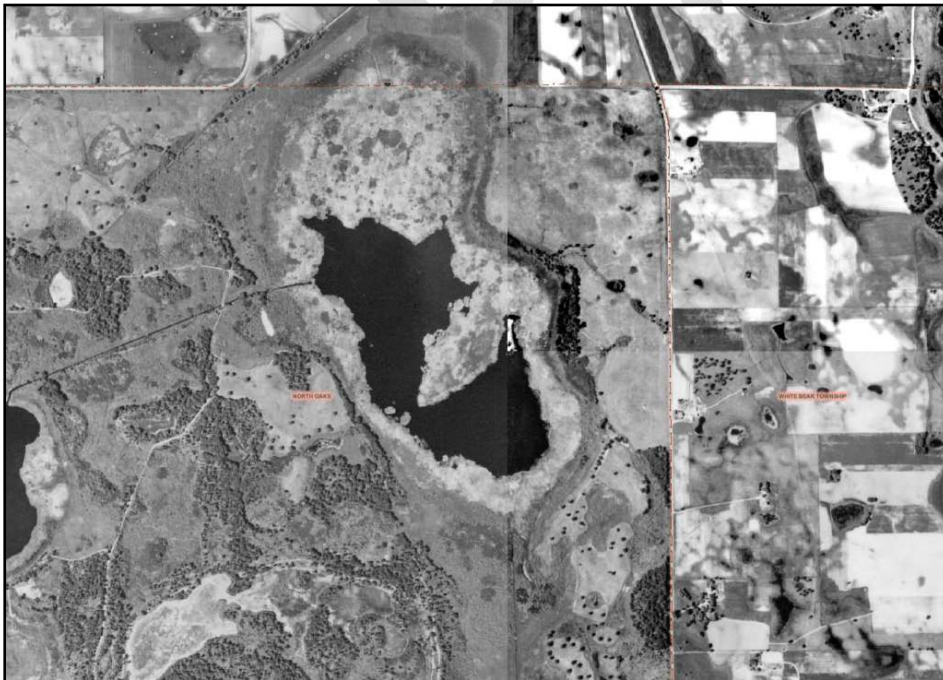
Figure 2: 1940 Aerial photo of Wilkinson Lake

In 1940, the area is largely undeveloped and Interstate 35E has not been constructed yet. The roads now known as County Road J and Centerville Road were constructed. To the east and north of the lake, there is agricultural land. The “island” in Wilkinson Lake is considerably larger in 1940 than it is currently, perhaps due to lower water levels.

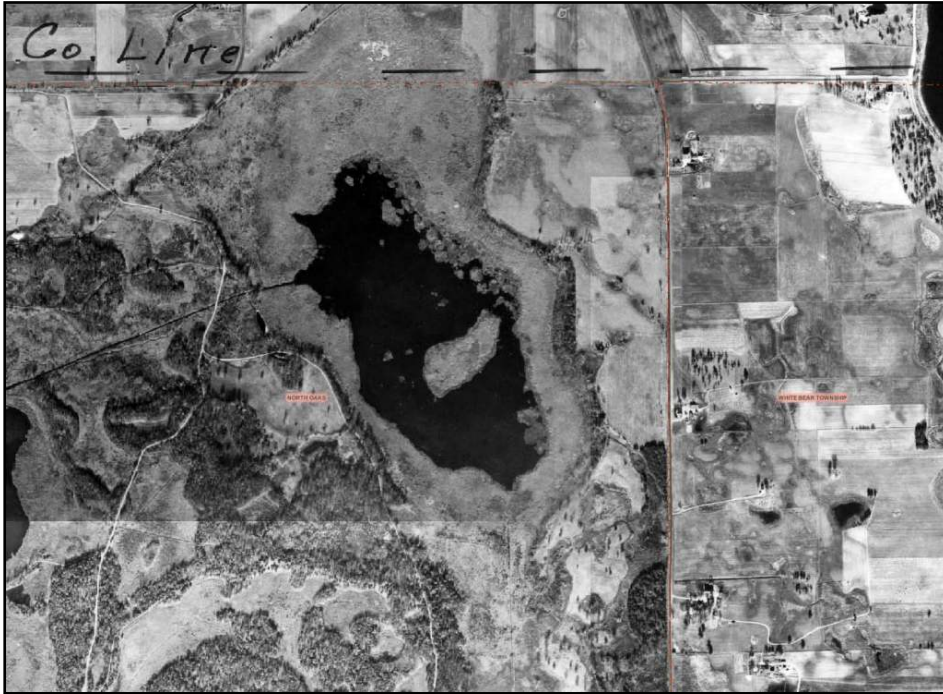
Figure 3: 1953 Aerial photo of Wilkinson Lake

In 1953, there is still no development around the lake. It appears the water levels are higher due to more open water.

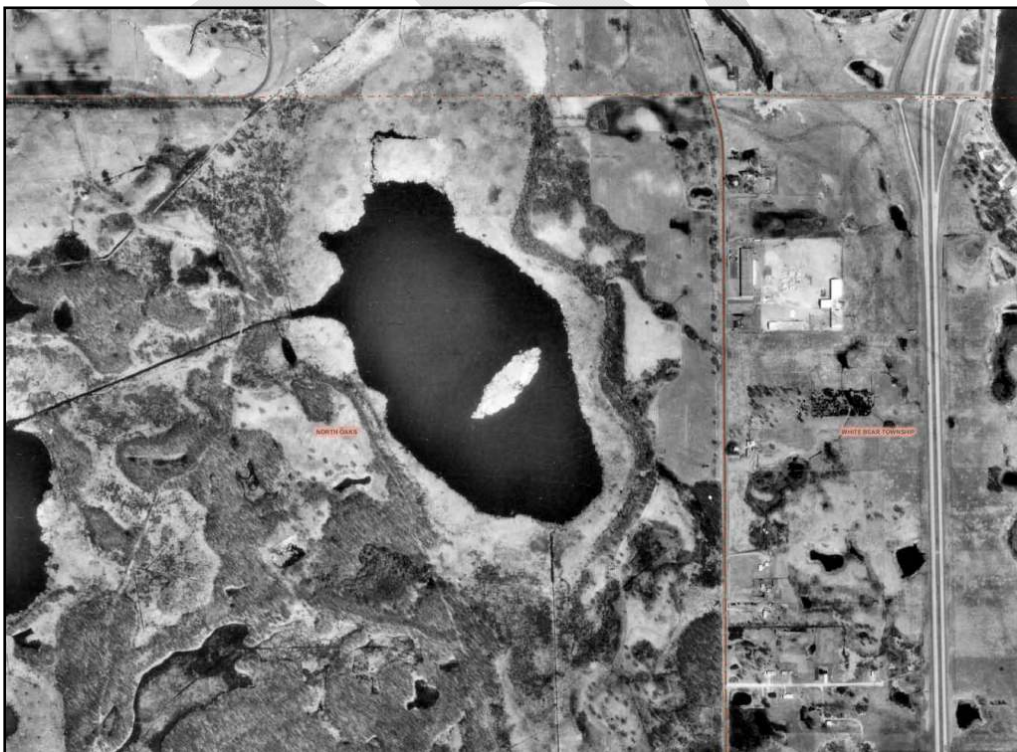
Figure 4: 1974 Aerial photo of Wilkinson Lake

By 1974, Interstate 35E has been constructed and some industrial development has occurred on the east side of the lake. The property is now owned by Schwing America, Inc.

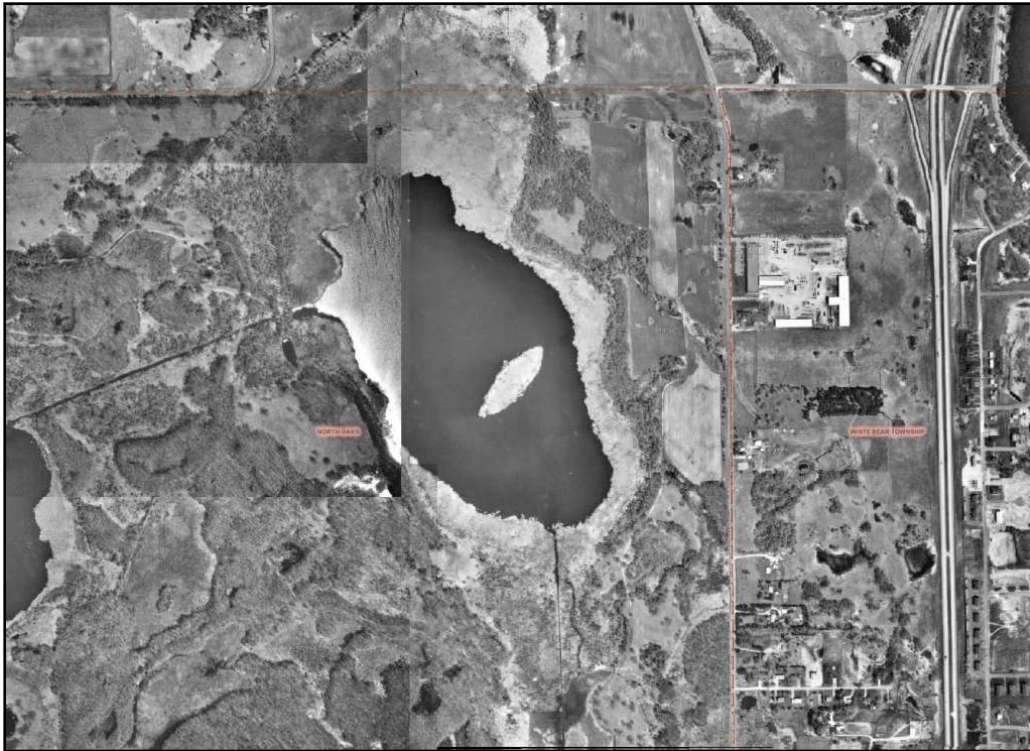
Figure 5: 1985 Aerial photo of Wilkinson Lake

In 1985, more residential development has occurred east of the lake.

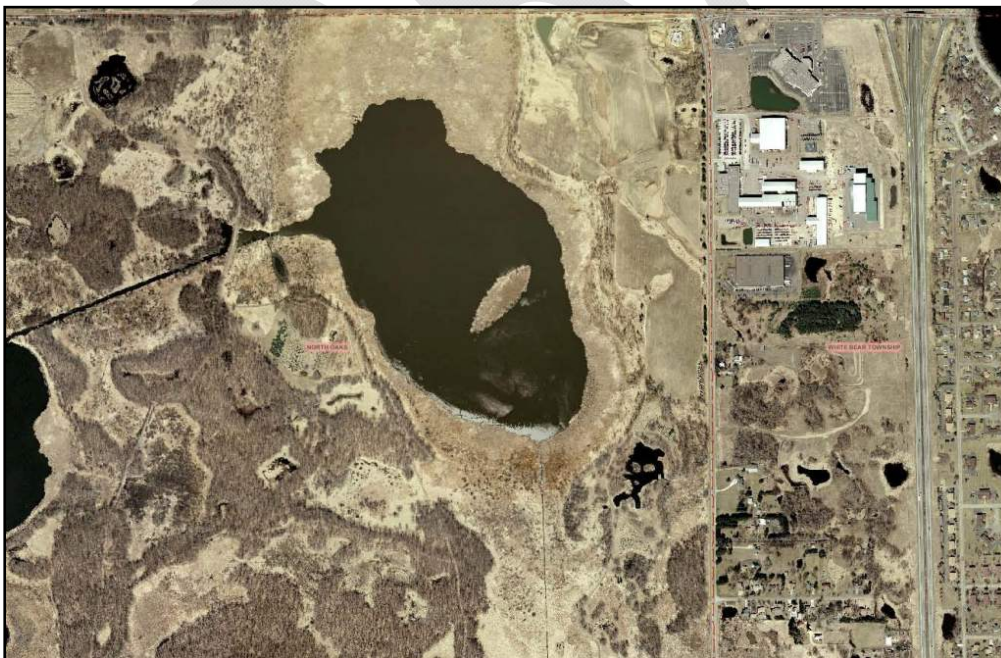
Figure 6: 2003 Aerial photo of Wilkinson Lake

By 2003, more industrial and commercial development has occurred on the east side of the lake. And it appears that grading work has begun for what is now known as Waverly Gardens.

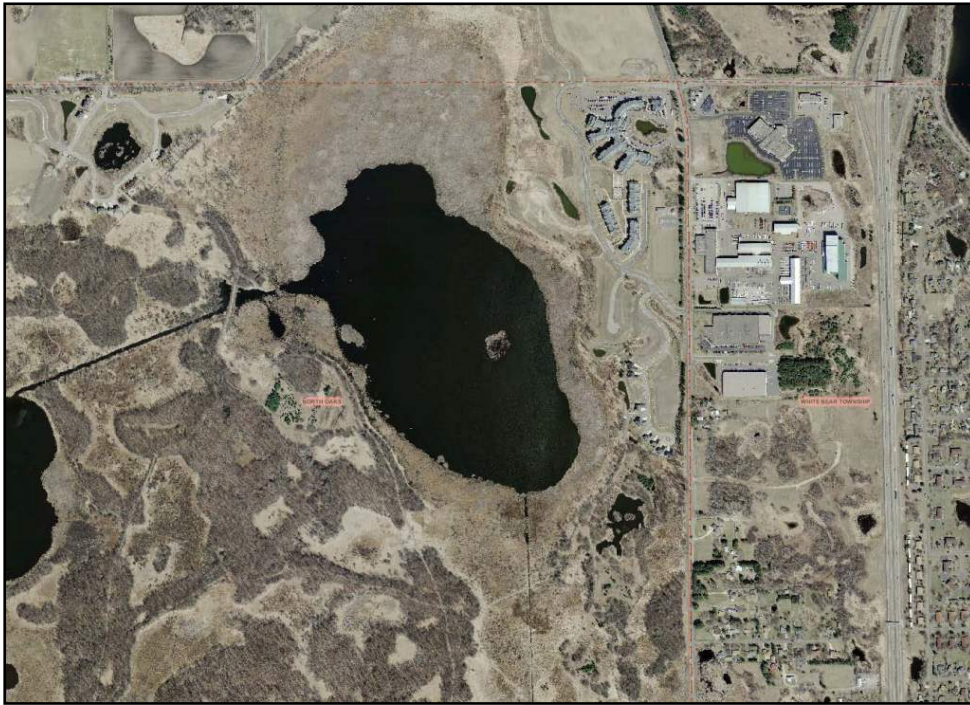
Figure 7: 2009 Aerial photo of Wilkinson Lake

By 2009, Waverly Gardens has been constructed as well as the office area for the North Oaks Company and Tria Restaurant. Residential development is also going in south of Waverly Gardens and beginning on the west side of the lake.
