Sustainable Lake Management Plan Goose Lake

**Prepared by The
Vadnais Lake Area Water Management Organization**

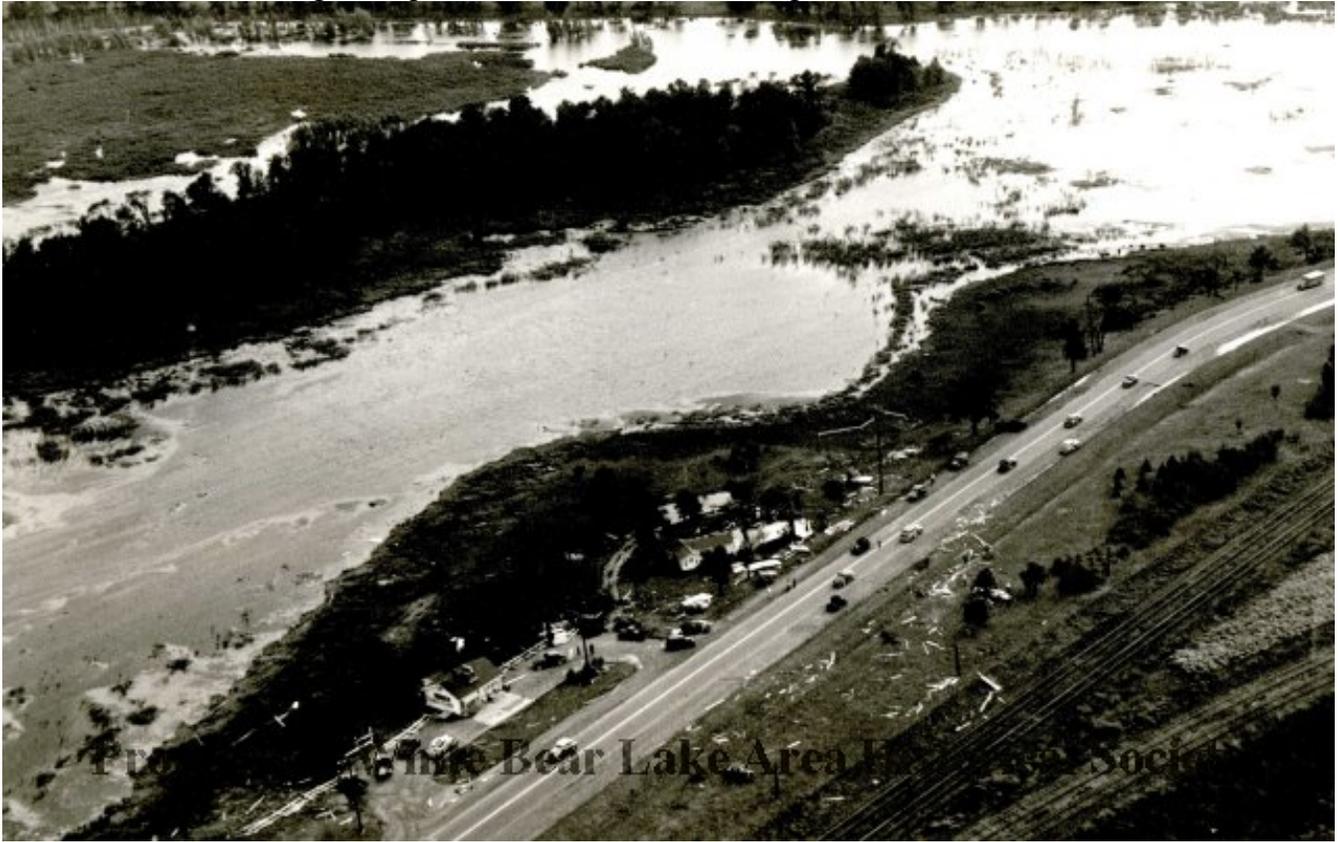
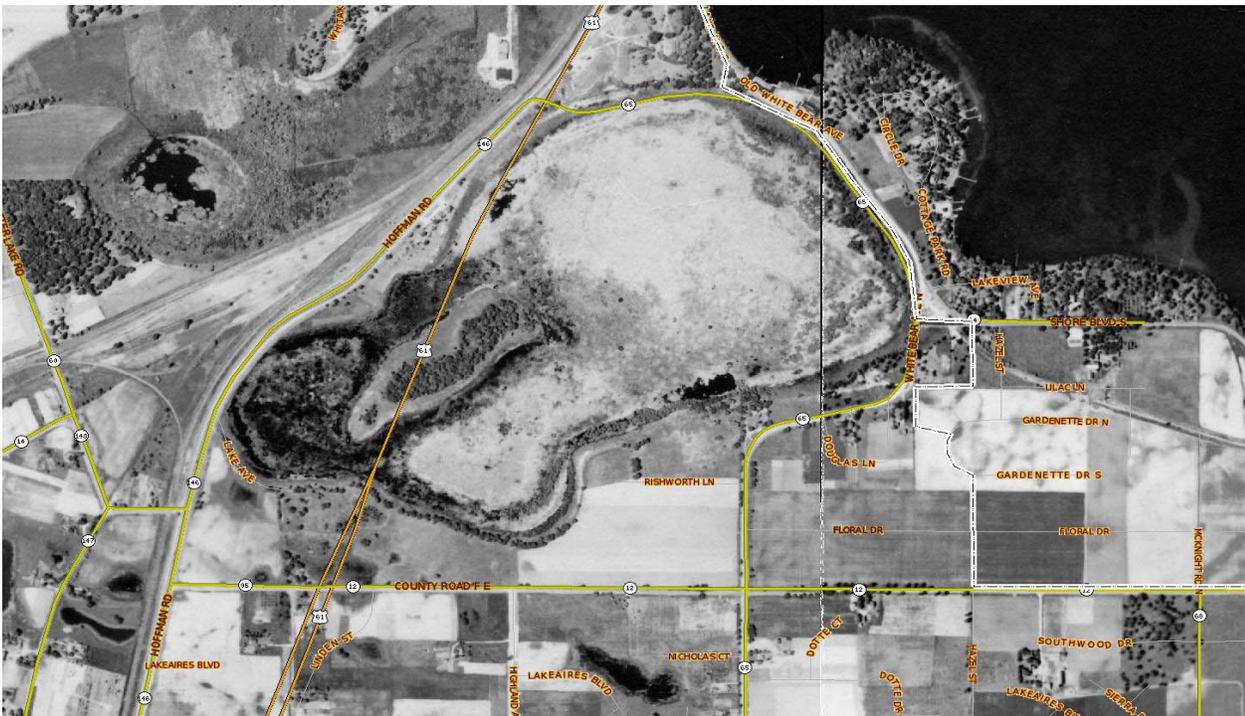
This is a **1940 aerial** photo of Goose Lake. There is little standing water in the photo, the “lake” looks to be more of a wetland/bog. First picture is of West Goose along Hoffman Rd 1941 after tornado.

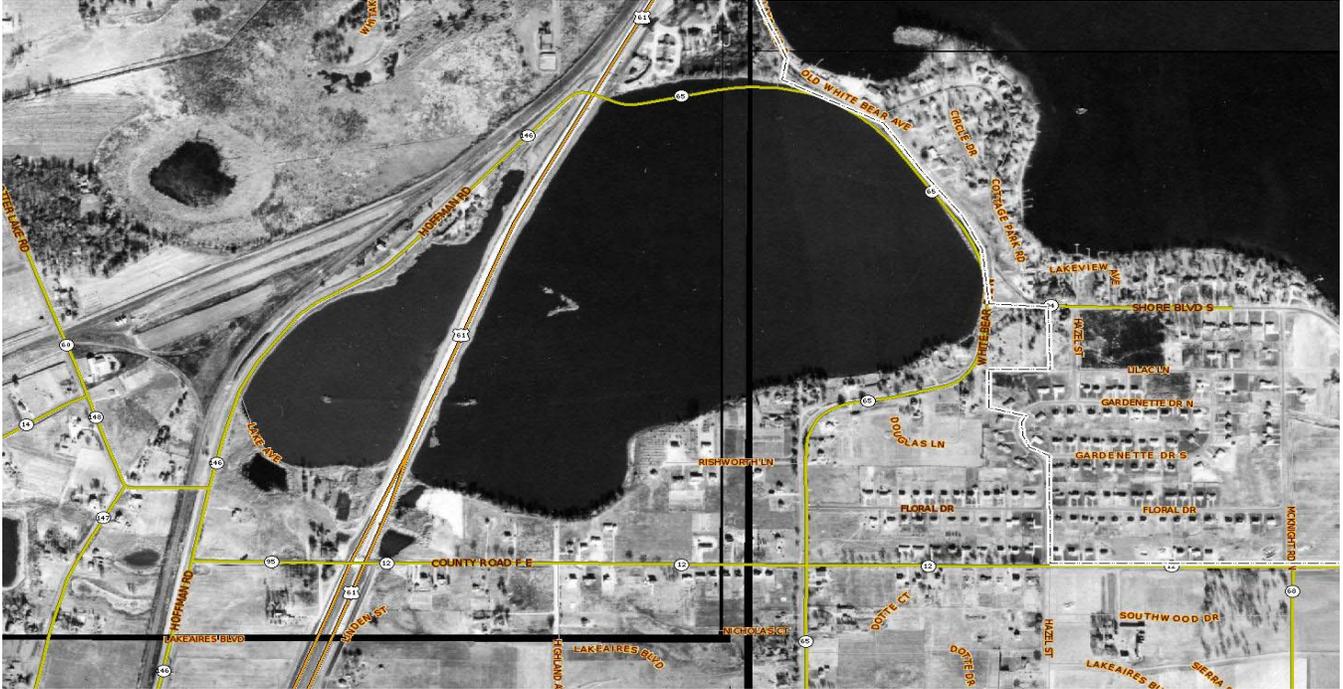
Here is the **1953 aerial** photo. Goose was dredged some time during the 1940's early 1950's. Highway 61 was also built in the early 1950's separating Goose lake into the two basins.

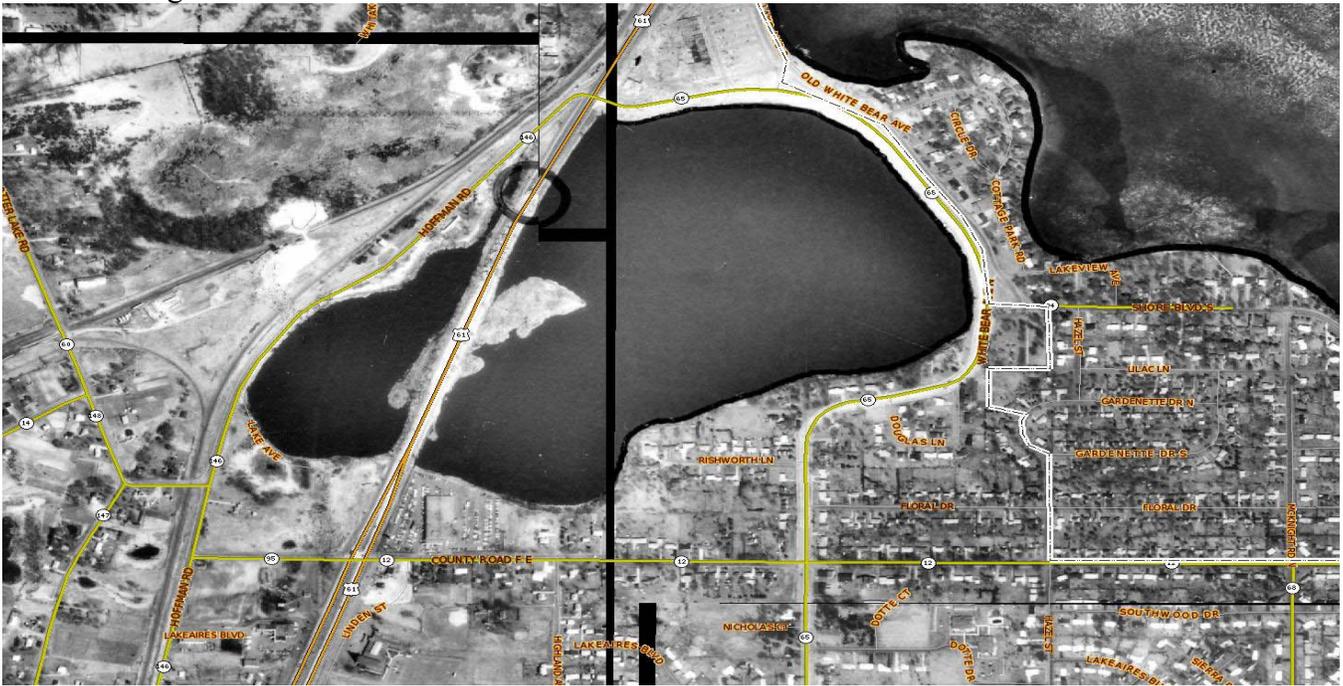
This is the **1974 aerial**. More structures are appearing around Goose lake. White Bear Lake Sewage Plant discharged into the north end of the East basin

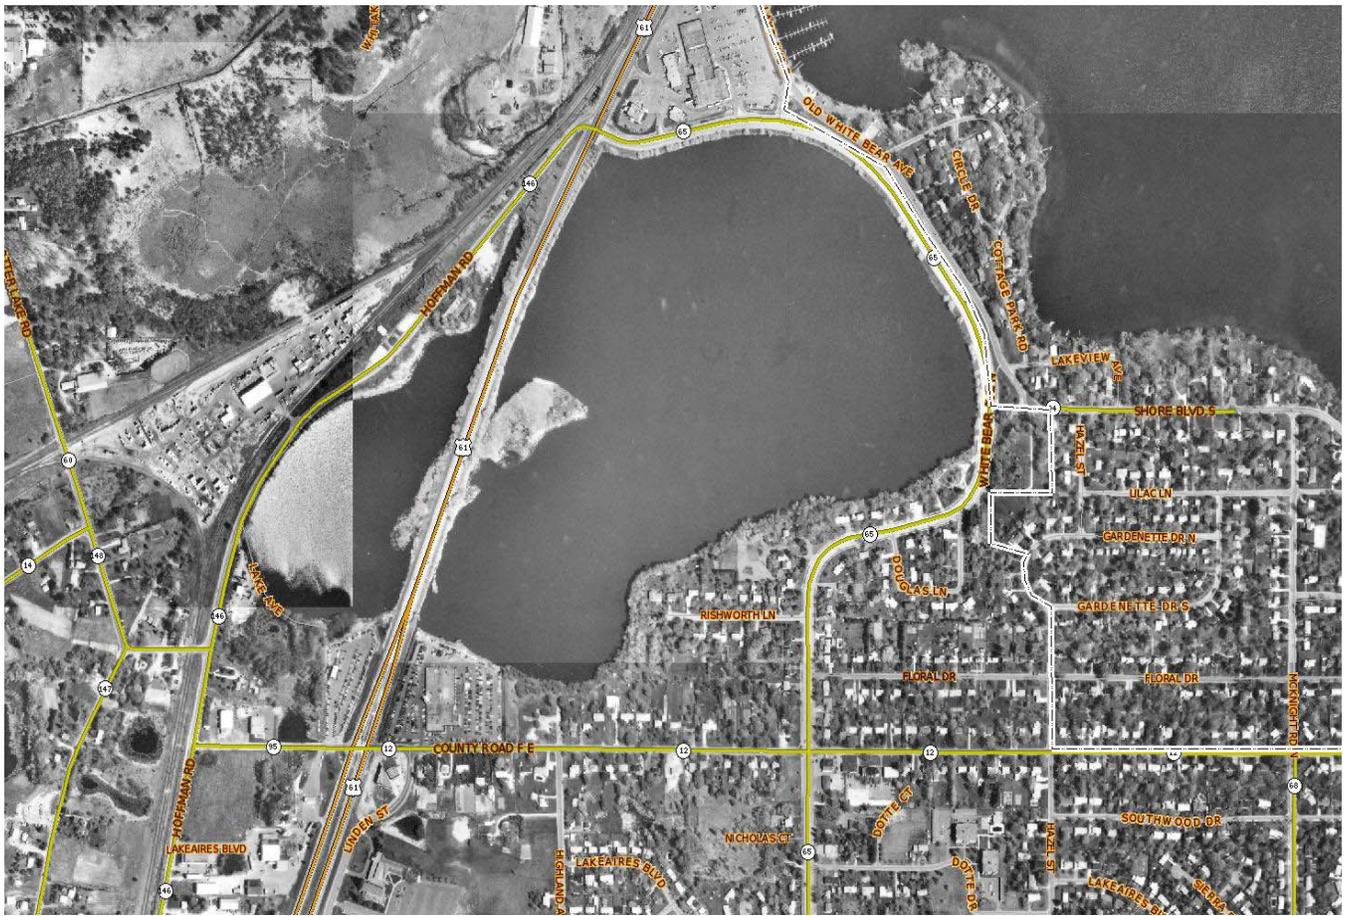
1985 aerial. The Morningstar Plant is now visible on the south end of West Goose Lake. Cooling water is likely being discharged into the basin.

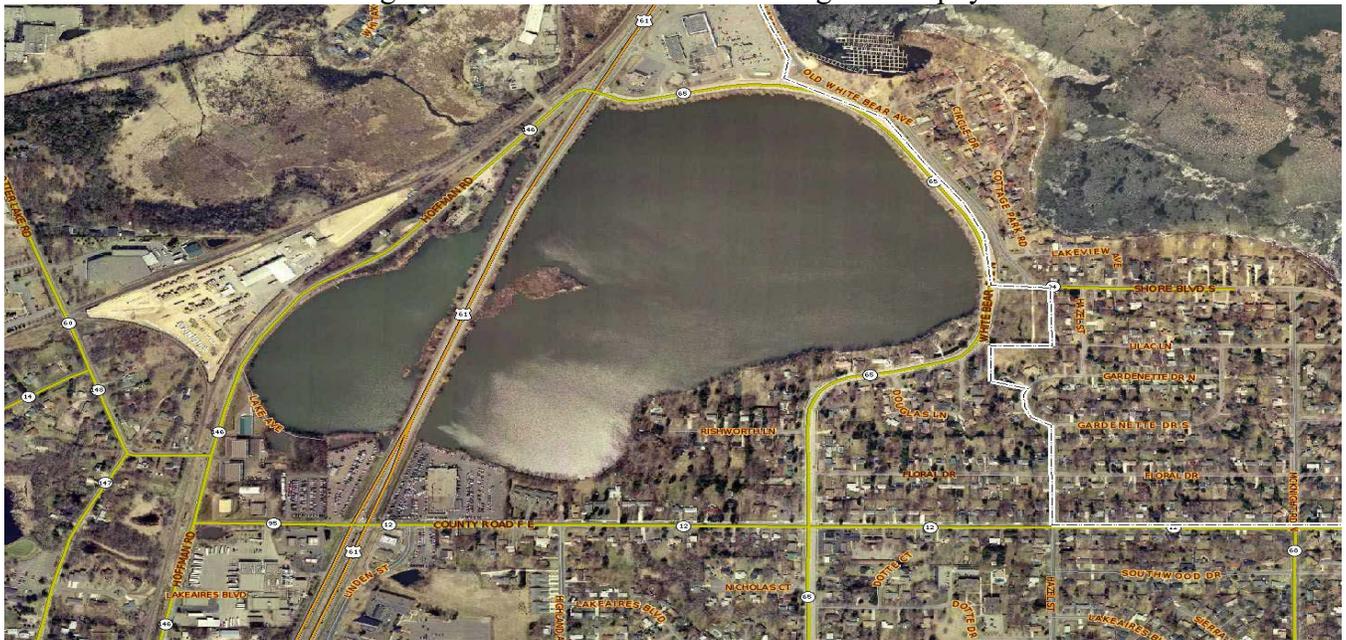
2006 aerial. You can see the green color of the lake from the high chlorophyll levels.

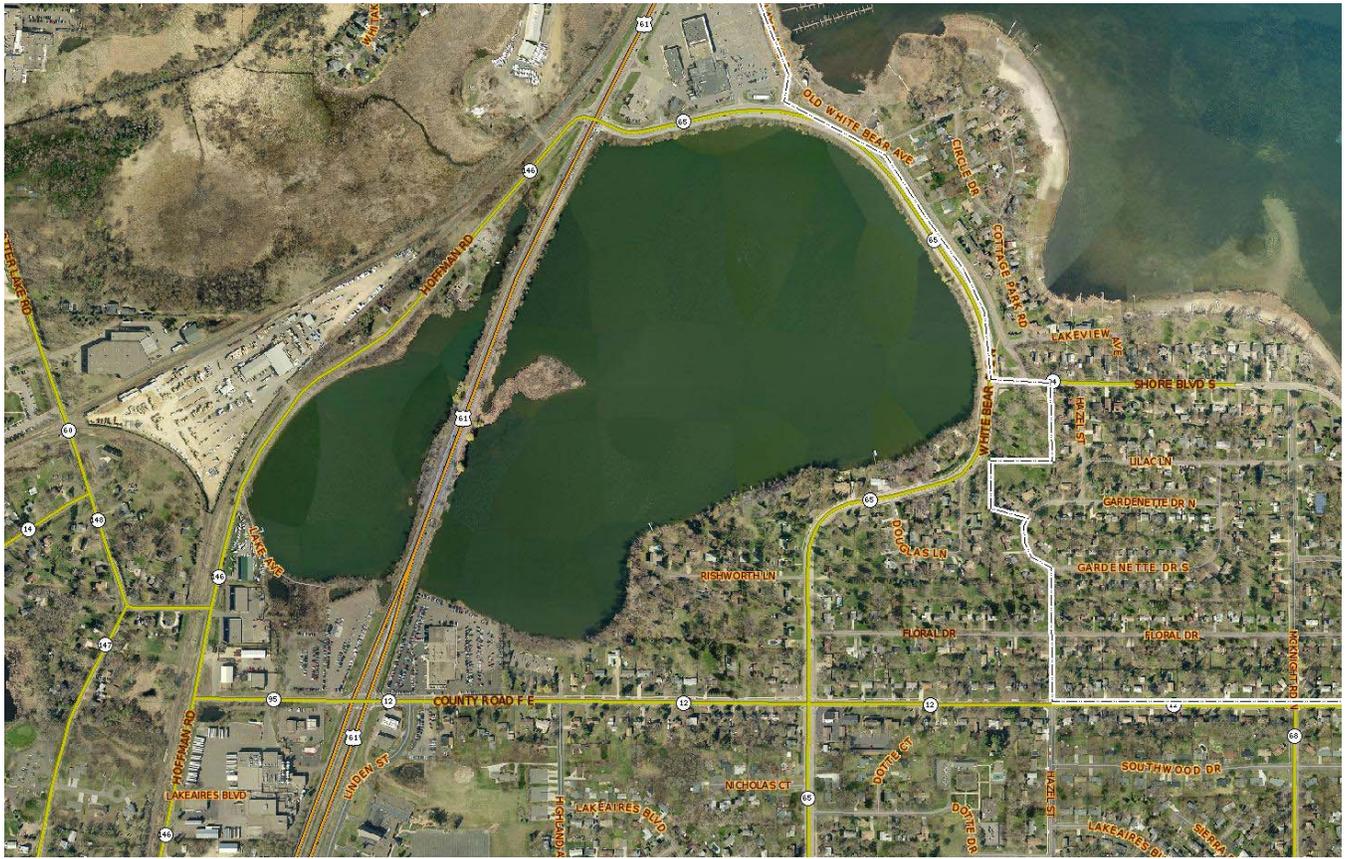
2012 aerial. Aerial color is brighter than the one above, but still shows the high chlorophyll level indicated by the green water color compared to that of White Bear Lake to the north east. .

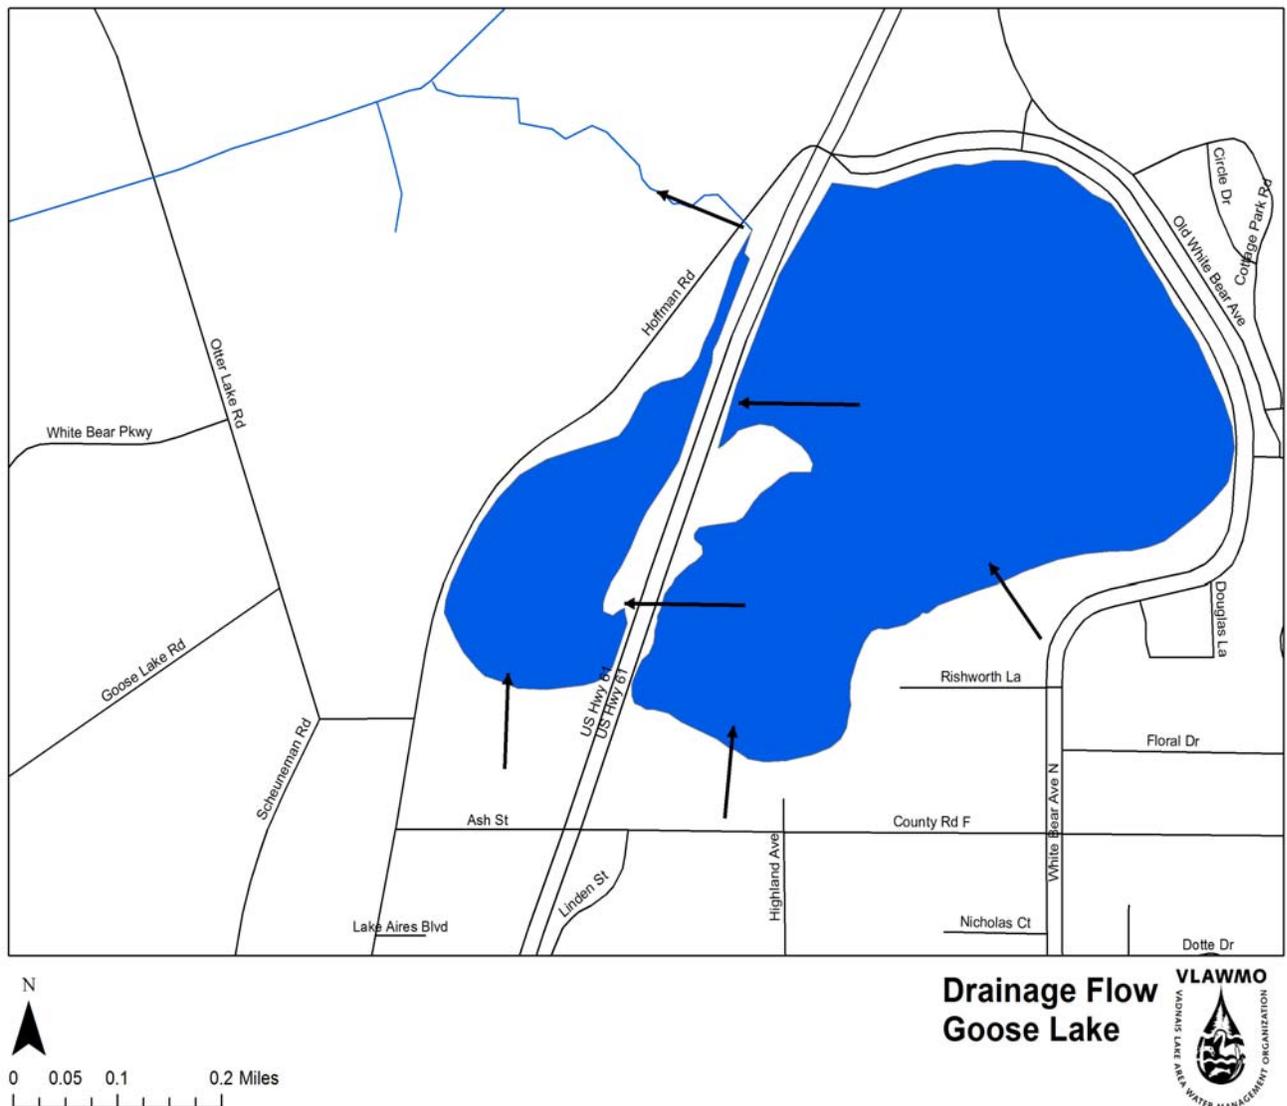
Drainage area

It is important to understand where water flows into and out of a waterbody in order to ascertain the potential inputs of pollutants. The drainage area into Goose Lake is approximately 1124 acres and is about 8 times larger than the surface area of Goose Lake which is 140 acres. This is a large drainage area to Goose Lake which can be a negative aspect for the lake. Large drainage areas are more likely to wash pollutants into the lake and usually result in poorer water quality. Water enters the lake primarily through rain events, snow melt and ground water. The VLAWMO Total Maximum Daily Load (TMDL) study prepared by Wenck and the Ramsey Conservation District Lambert Creek Retrofit report (appendix A & B) goes into more detail on the ground water and watershed effects on Goose Lake.

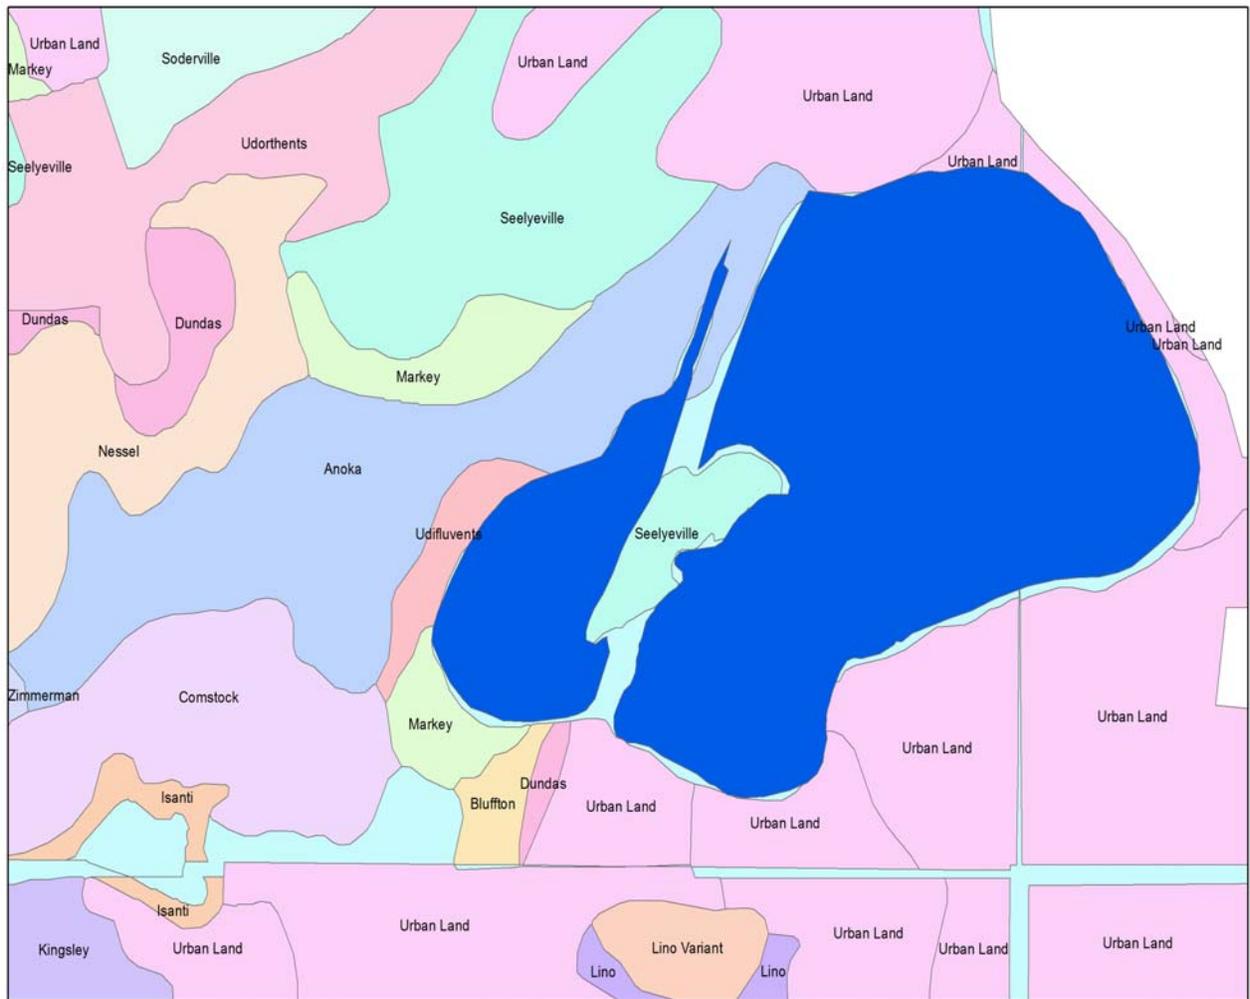
**Soil Types
Goose Lake**

Soils within the Goose Lake sub watershed is dominated by Hayden fine sandy loam. This soil tends to drain well, allowing water to filter into the ground. However, with urban development, much of the soil has been compacted, moved, and covered over, thus pushing rain water into storm sewer systems or away from the lake. Additionally, a survey was conducted to examine the sediment of the lake bottom and address the possible effects of internal phosphorus loading. Detailed results are addressed in the VLAWMO TMDL (Appendix A) and the ERDC report (appendix D). The sediments raise no major concerns but do suggest an internal loading possibility due to the above normal phosphorus levels in the sediment. The rough fish present in the lake can stir up this sediment, releasing the nutrients trapped in it causing the high nutrient levels we see in the lake today. A fish survey was done on Goose Lake summer of 2012 by Blue Water Science (Appendix C).

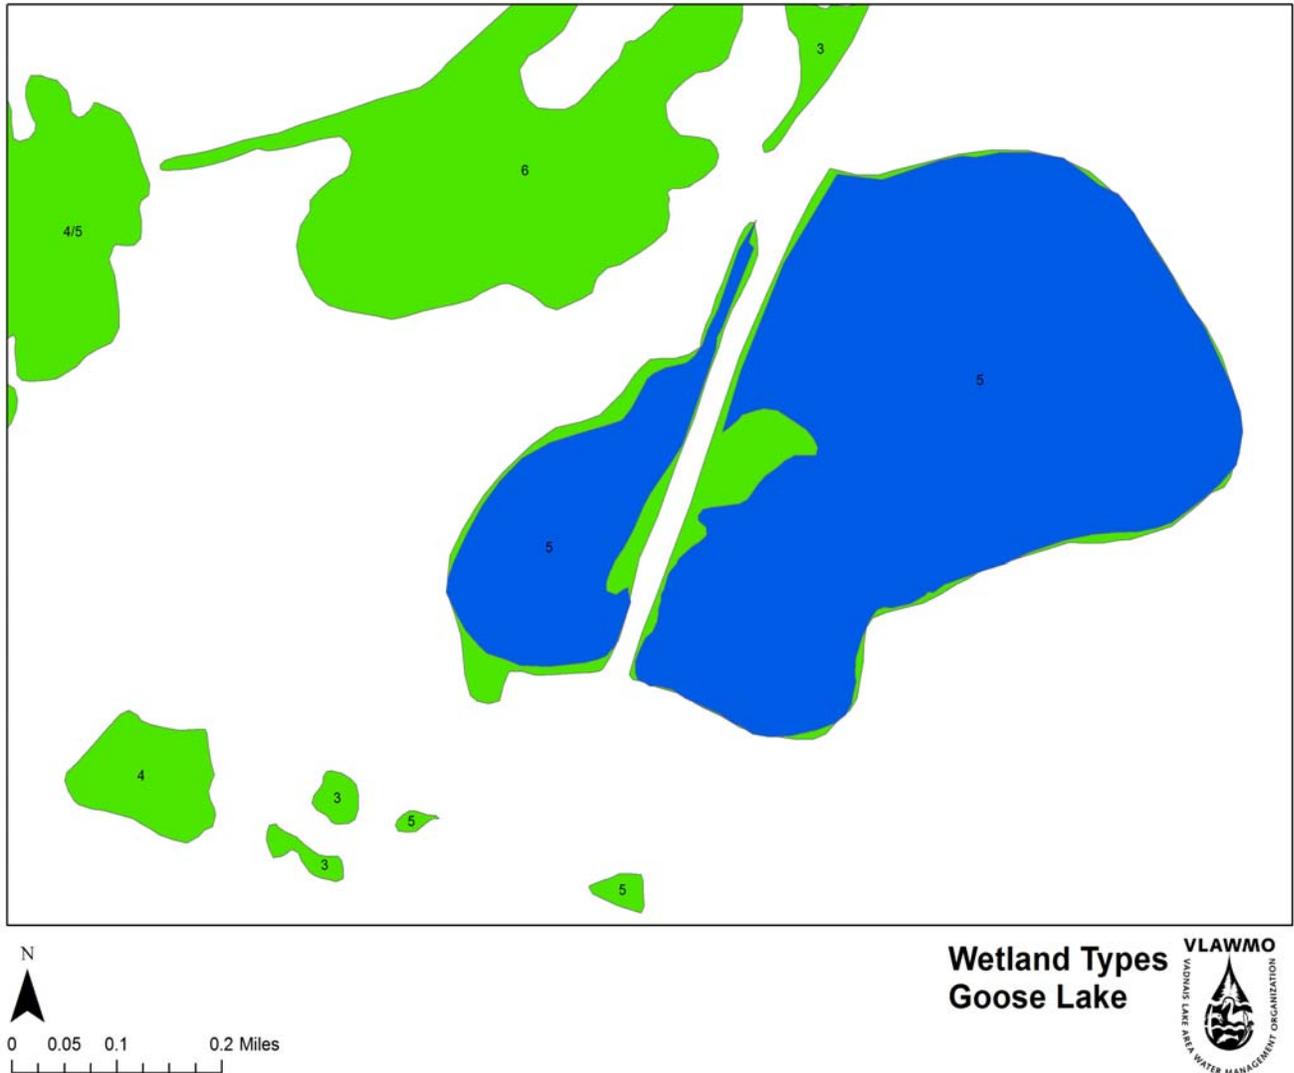
There are few wetlands around Goose Lake. With the large size of the sub watershed surrounding the lake and the high urbanization of the area there is very little relief from rain events in terms of runoff protection and buffers around the lake. This is likely one of many factors affecting the water quality in the lake. The VLAWMO TMDL goes into great detail on the impairment issues in Goose Lake and also provides an implementation plan to address the impairments. Wetlands are numbered on the map and the key is below.

- 1 – Seasonally Flooded
- 2 – Wet Meadow
- 3 – Shallow Marsh
- 4 – Deep marsh
- 5 – Shallow Open Water

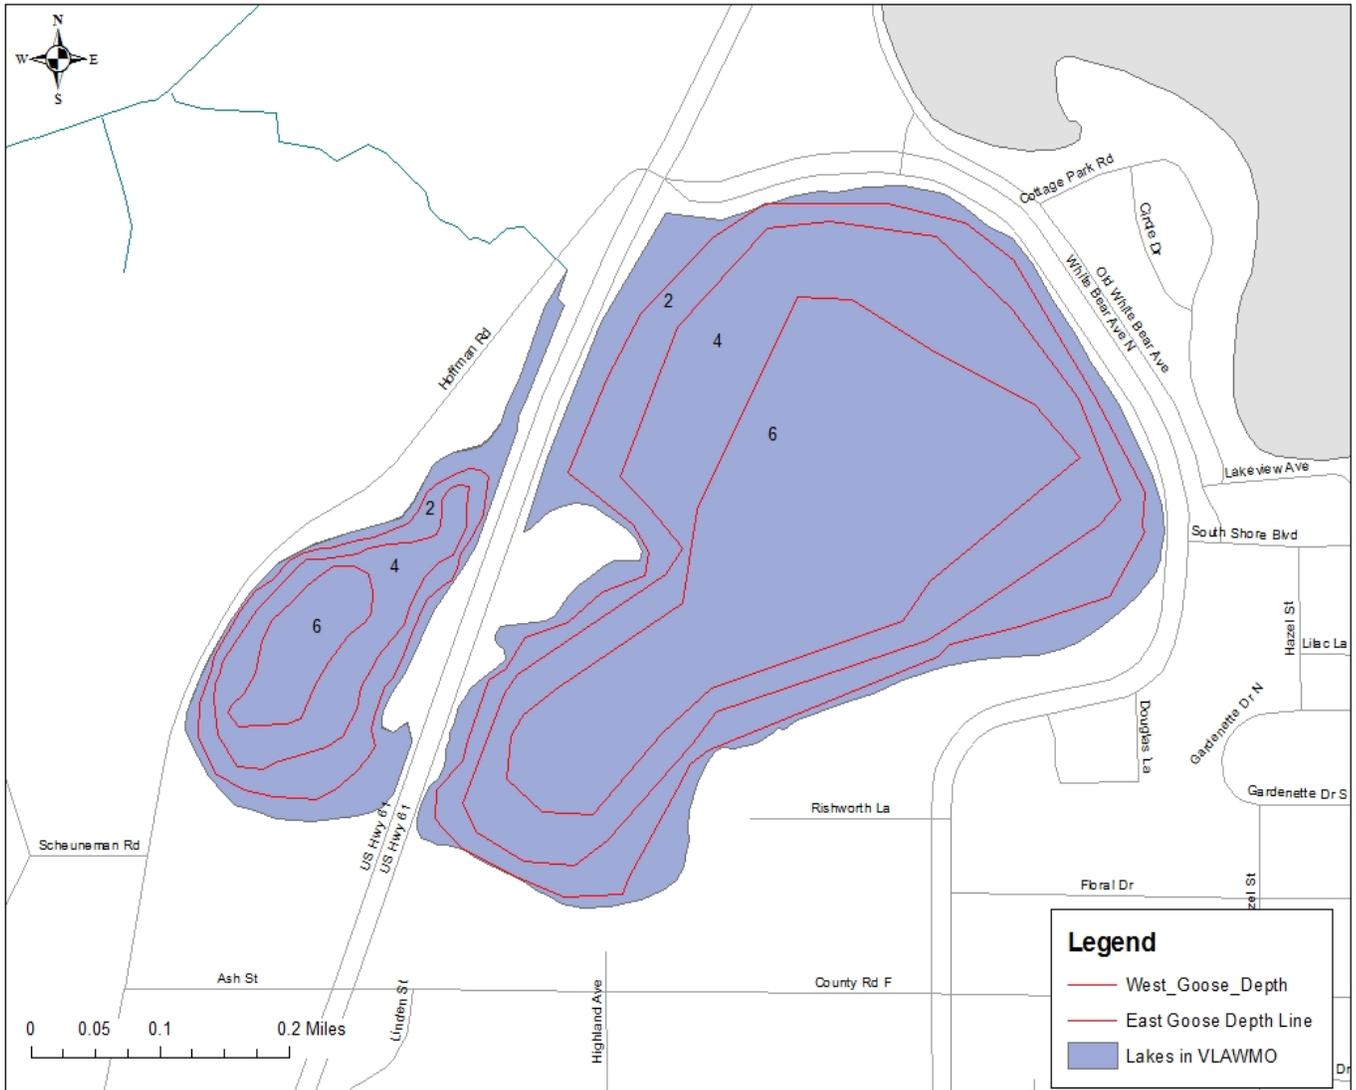
A. Lake Depth

The summer of 2011 VLAWMO conducted a lake depth survey on both the East and West basins of Goose Lake. Both basins are bowl shaped with max depth of 6-8 ft. The official ordinary high water level (OHW) for Goose lake set by the DNR is 925.3ft. VLAWMO does monitor the lake level and it ranges between and elevation of 924-925 ft. Due to the weir structure out letting to Lambert Creek on the north end of the west basin and the inflow of groundwater from the Morning Star plant on the south end of the west basin water levels stay pretty constant throughout the year.

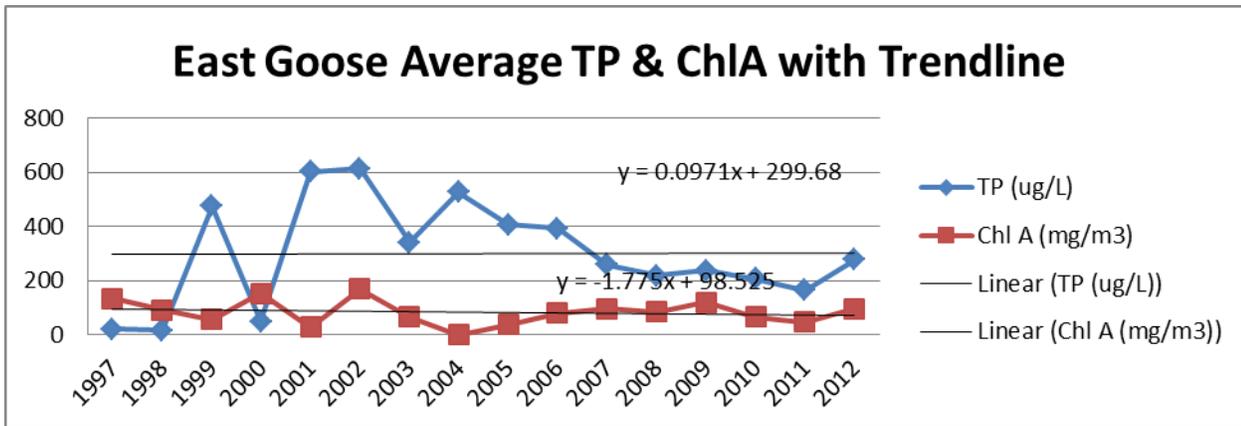
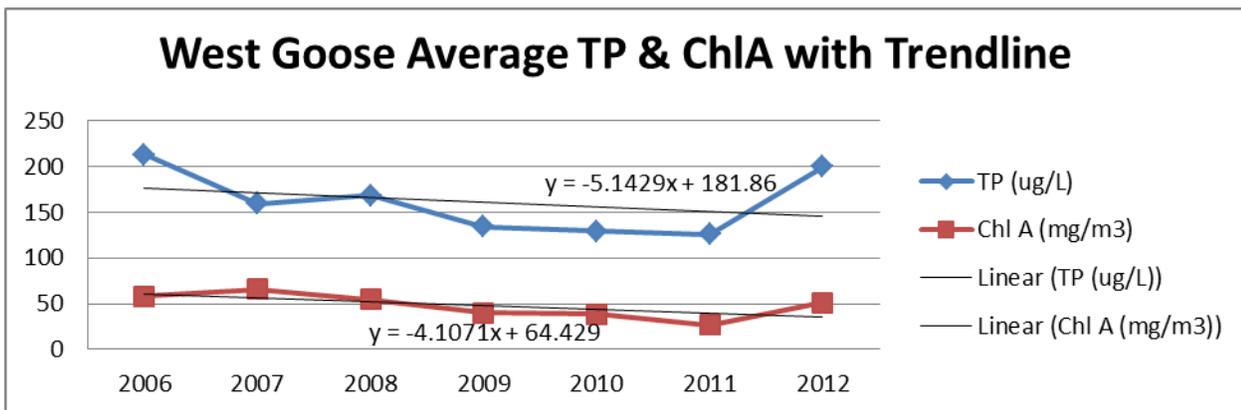
Both the east and west basin of Goose Lake show a flat or slightly declining trend in average nutrient levels over the years. Even though Goose Lake is very high in nutrients, this data shows that the basins are not getting worse on average over time.
