# Sustainable Lake Management Plan

## Wilkinson Lake

### Ramsey County, MN

Prepared by:  
Kristine Jenson  
Vadnais Lake Area Water Management Organization  
November 2011

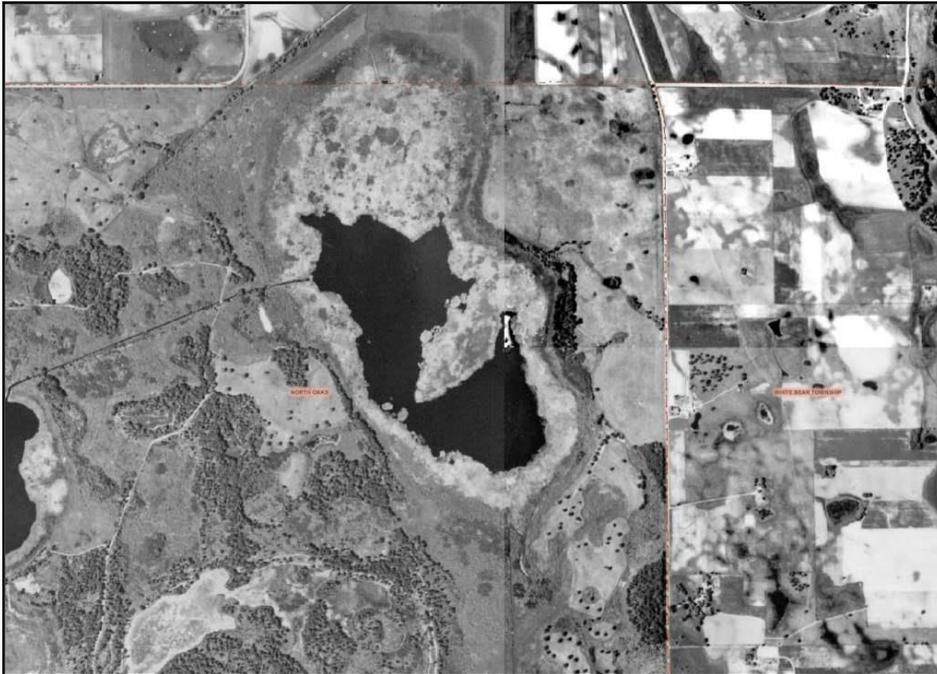
Figure 2: 1940 Aerial photo of Wilkinson Lake

In 1940, the area is largely undeveloped and Interstate 35E has not been constructed yet. The roads now known as County Road J and Centerville Road were constructed. To the east and north of the lake, there is

agricultural land. The “island” in Wilkinson Lake is considerably larger in 1940 than it is currently, perhaps due to lower water levels.

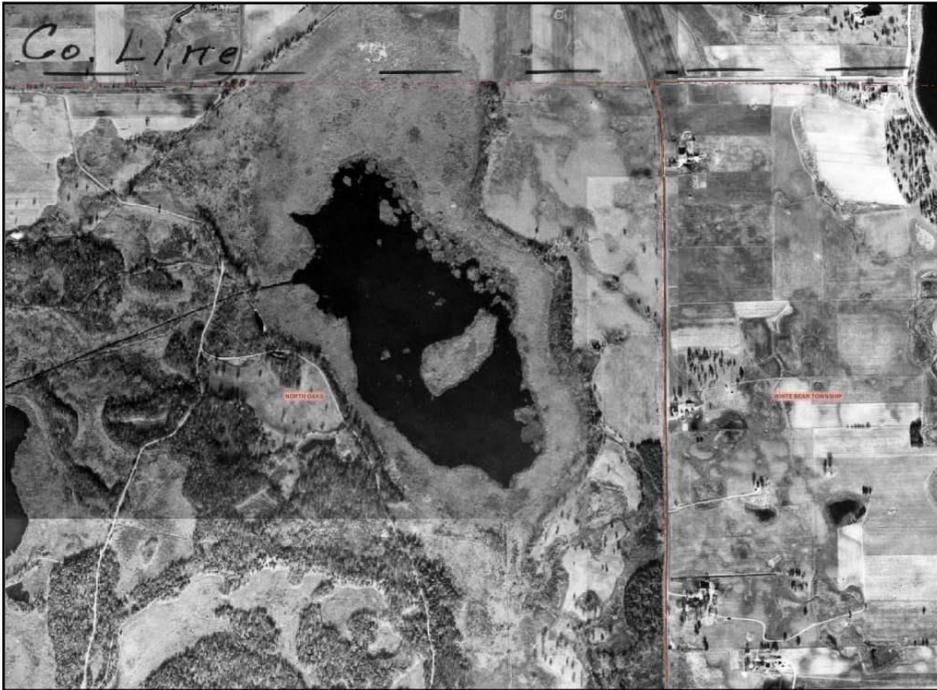
Figure 3: 1953 Aerial photo of Wilkinson Lake

In 1953, there is still no development around the lake. It appears the water levels are higher due to more open water.

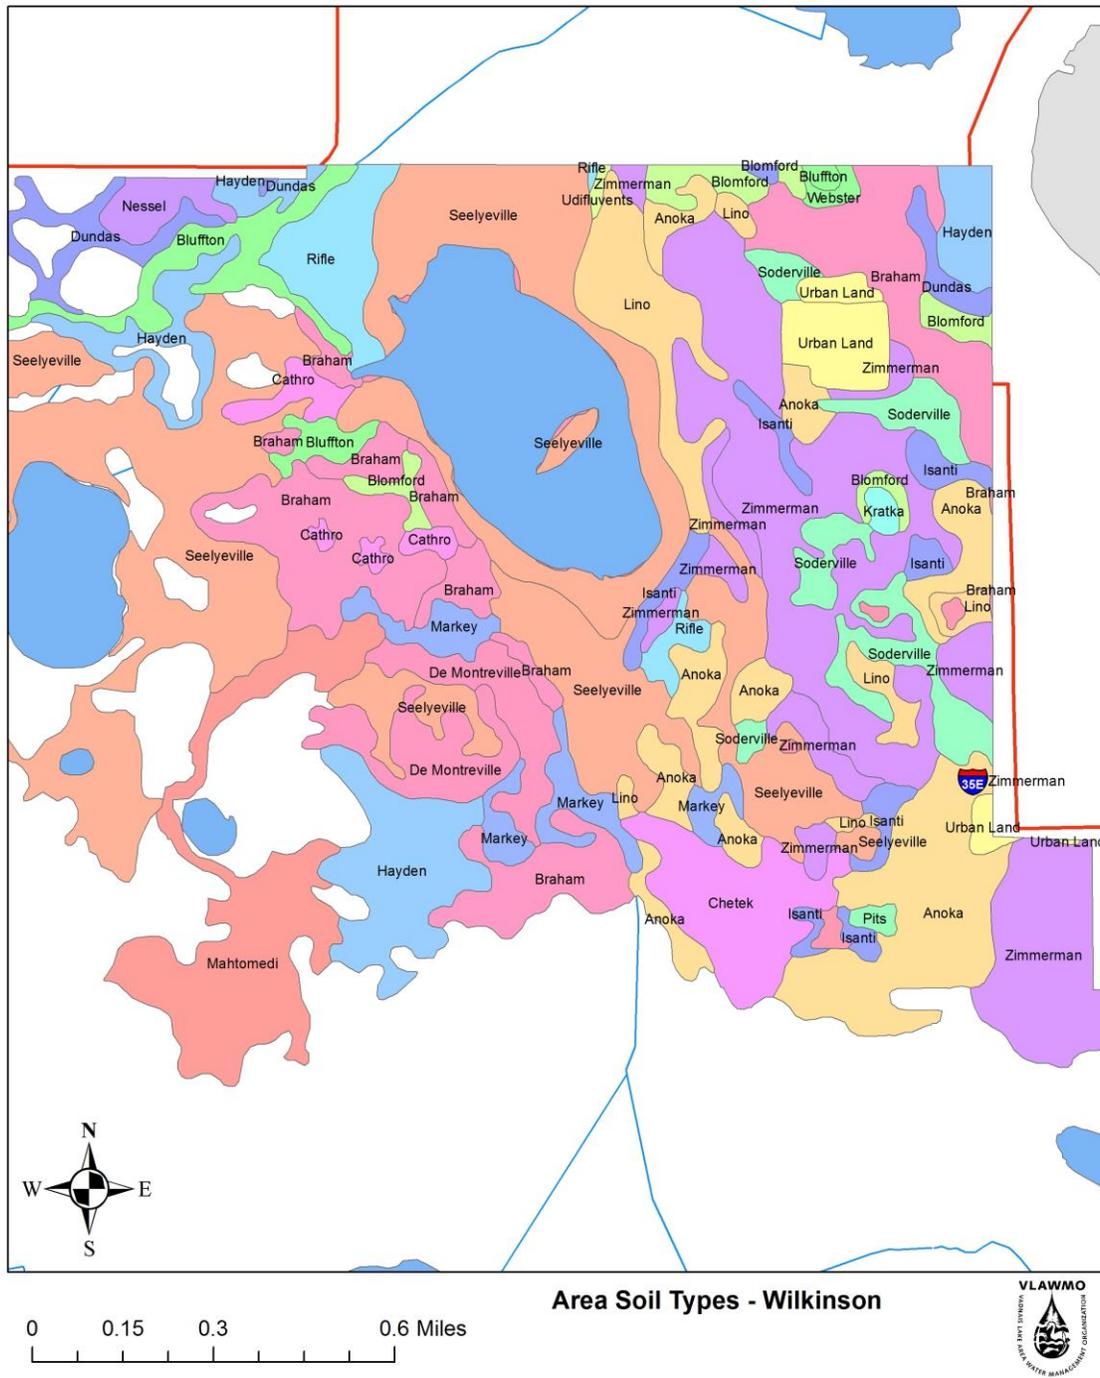
Figure 9: Soils around Wilkinson Lake

The soil directly around Wilkinson Lake is Seelyeville which is an organic muck. The soils near the lake are of the mucky types (Rifle, Markey, Cathro). Soils on the upland areas include Hayden, Zimmerman, Isanti, and Anoka which are all fine sandy loams which are good for parkland and for building on.
