VADNAIS LAKE AREA WATER MANAGEMENT ORGANIZATION
Sustainable Lake Management Plan
Charley Lake, Ramsey County, MN

VADNAIS LAKE AREA WATER MANAGEMENT ORGANIZATION SUSTAINABLE LAKE MANAGEMENT PLAN – CHARLEY LAKE DECEMBER 2017

Pleasant Charley Deep Subwatershed: Urban Stormwater Retrofit Analysis

Prepared for the Vadnais Lake Area Water Management Organization by:
Ramsey Conservation District, December 2015

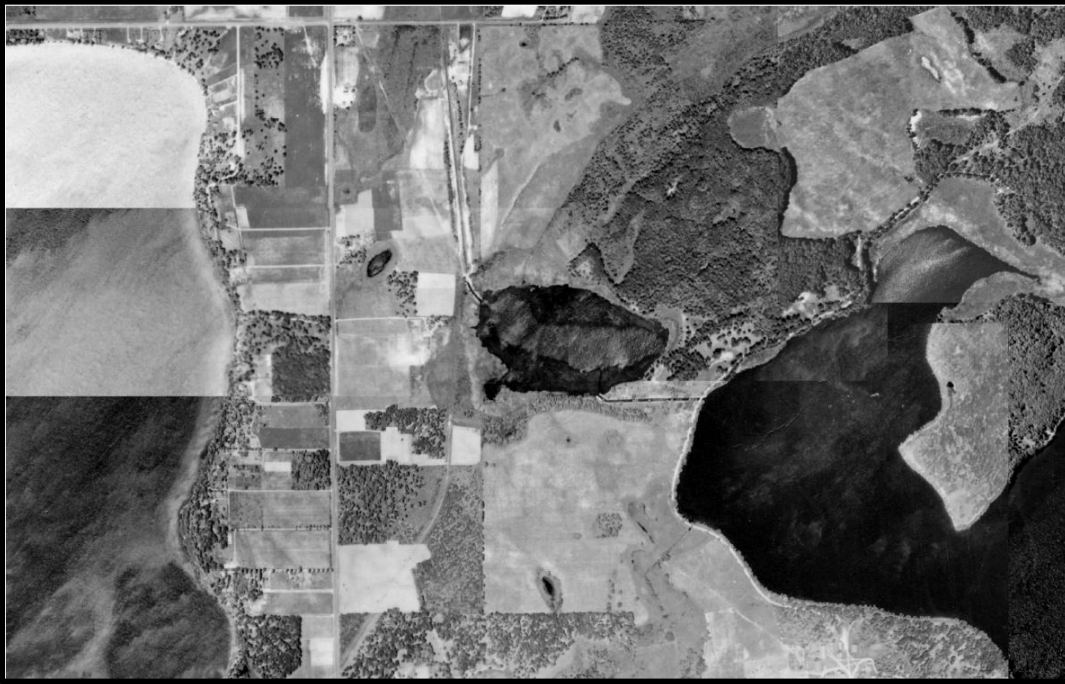
Figure 2: 1940 aerial photo of Charley Lake

In 1940 there are some agricultural clearings and lake homes on Turtle Lake. The channel on the NW side of the lake appears to connect to Baldwin Lake. County Rd I and Hodgson Rd are present.

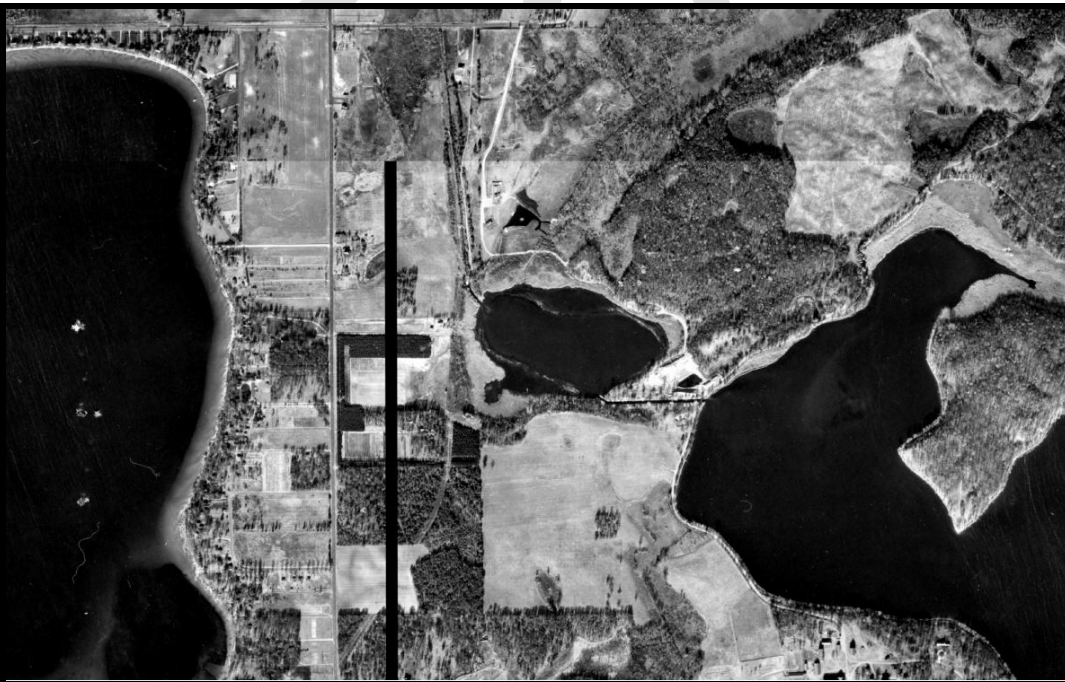
Figure 3: 1953 aerial photo of Charley Lake

1953 aerials show a road as well as a few buildings on the north side of the lake have been built.

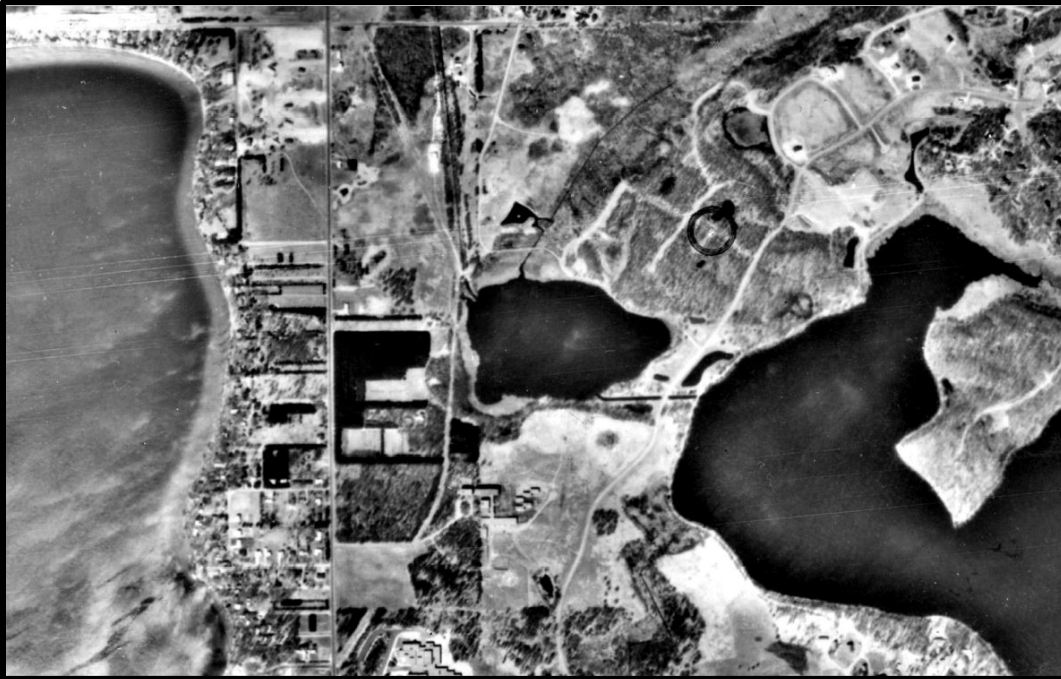
Figure 4: 1974 aerial photo of Charley Lake

By 1974 the residential development of North Oaks is now in progress and the convent south of Charley has been built. The aqueduct pumping water from the Mississippi now connects to the North Oaks chain of lakes by entering through Charley Lake.

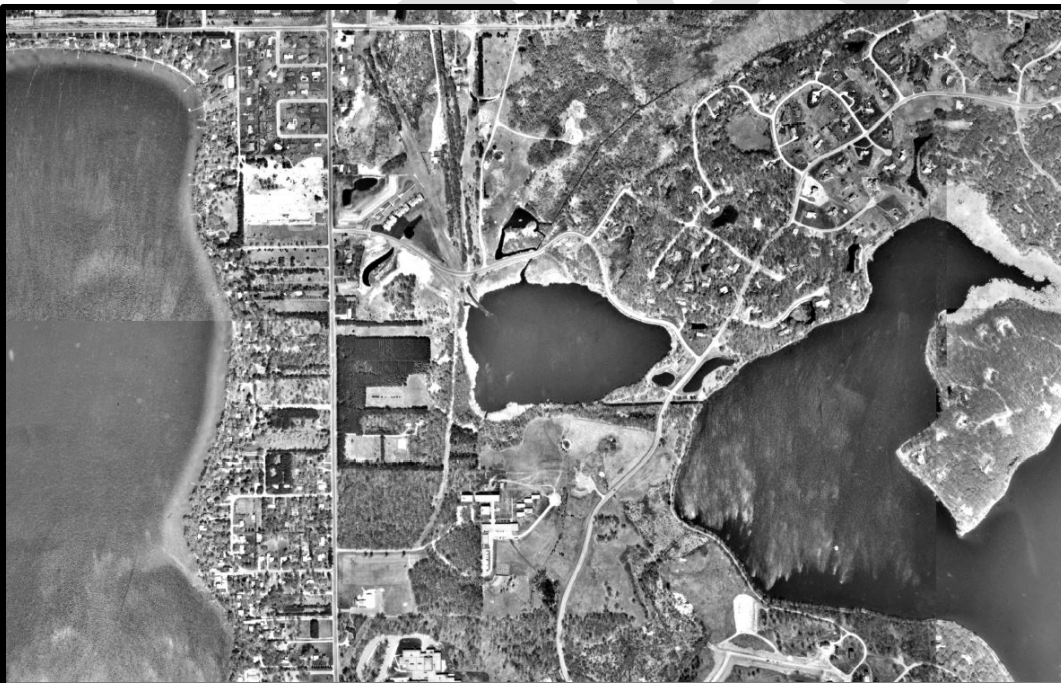
Figure 5: 1985 aerial photo of Charley Lake

In 1985, the early residential development north of Charley is completed, and some homes off of Hodgson Road, on Turtle Lake have been built. Residential development out of frame to the north has begun.

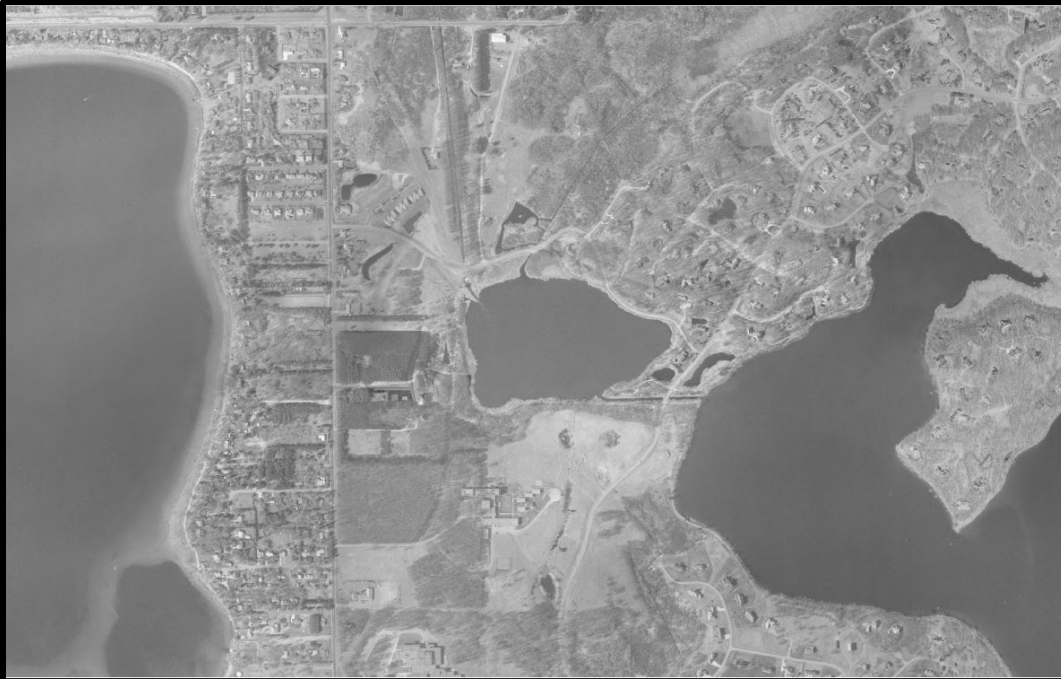
Figure 6: 1991 aerial photo of Charley Lake

All of the first-phase development within the Charley subwatershed catchment has been completed.

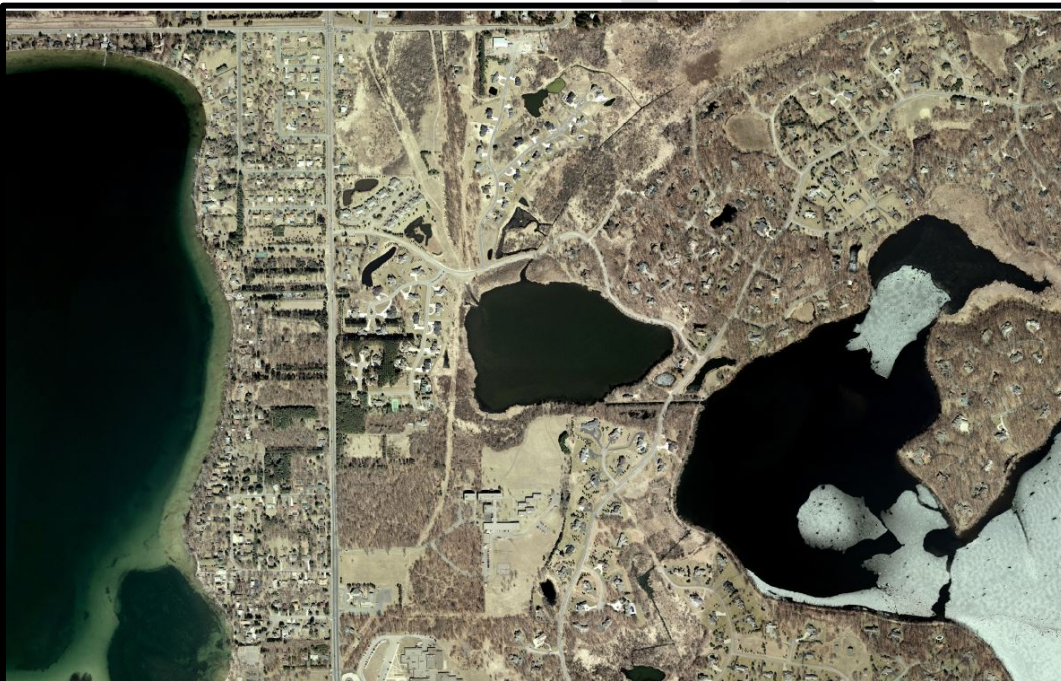
Figure 7: 2003 aerial photo of Charley Lake

More development to the north and west of Charley Lake, and development to the south of Charley Channel.

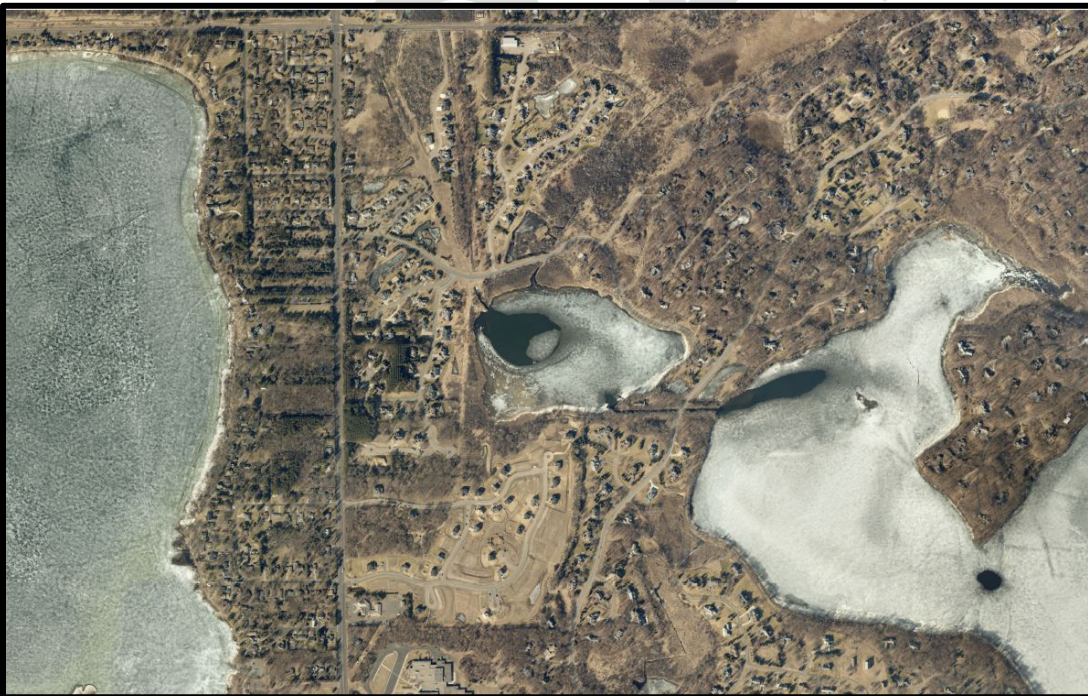
Figure 9: 2015 aerial photo of Charley Lake

The convent south of Charley Lake has been demolished and a new residential development has begun. The development has contributed to sedimentation and nutrient issues in the lake.

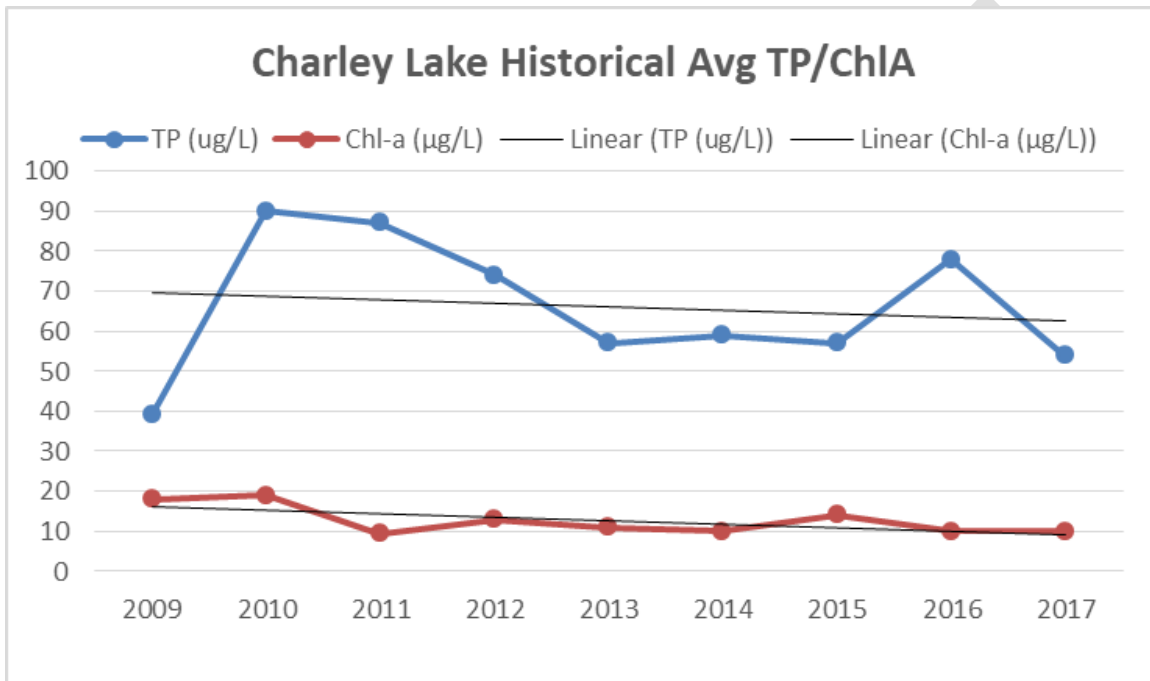
Figure 17: Historical Water Quality Averages in Charley Lake 2009-2017

TP is the primary cause of excessive plant and algae growth in lake systems. Phosphorus originates from a variety of sources, many of which are human related. Major sources include human and animal waste, soil erosion, detergents, septic systems, and storm water runoff. There can also be internal loading in a lake from the sediment. Chl-a is a green pigment in algae. Measuring Chl-a concentration gives an indication of how abundant algae is in a waterbody. The MN Pollution Control Agency (MPCA) has set impairment standards for the levels of TP and Chl-a for lakes in this area. For shallow lakes, the standard level for nutrients is less than 60µg/L for TP and less than 20µg/L for Chl-a to not be considered as impaired for nutrients.

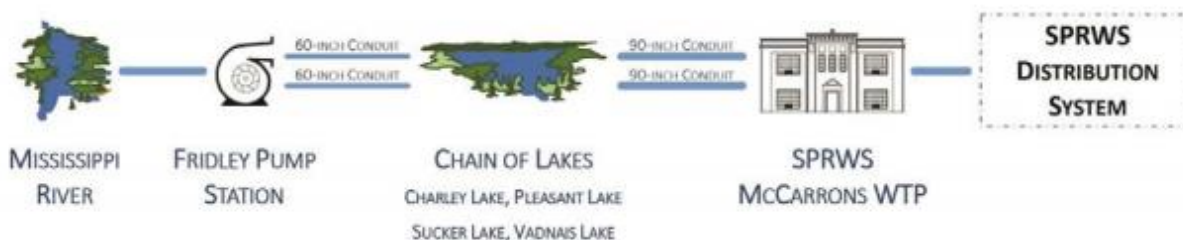
Figure 2. Saint Paul Supply System Schematic (Metropolitan Council, 2014).

It should be noted that the PCD watershed is not a hydrologically closed system. The pollutant base loading reported in this document is based on modeled results from WinSLAMM software, which considers only surface runoff within the catchment boundaries to model TP and TSS loading. However, it must be taken into account that there are additional sources of this pollution – namely, the Mississippi River and Wilkinson Lake. For reference, the amount of river water pumped annually by St Paul Regional Water Services into Charley Lake is roughly ten times the amount of Charley Catchment's annual rainfall, or enough water to completely replace the lake's storage every 1-3 days, depending on the variable pumping rate.

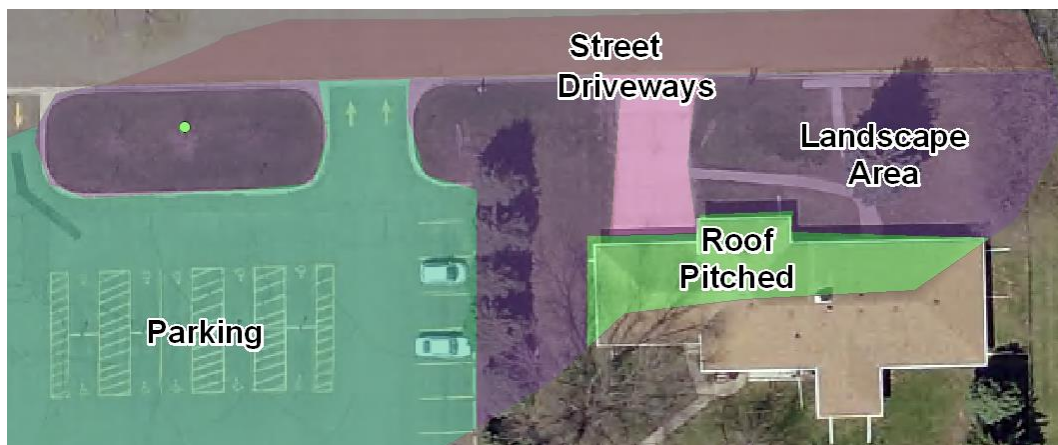
Figure 6. An example neighborshed and the source areas that are entered into WinSLAMM

After the retrofit sites were identified, the bioretention basins' individual drainage areas or "neighborsheds," consisting of runoff from surrounding streets, buildings, and landscaped areas were delineated using GIS and contour data. See an example in Figure 6. This information, in conjunction with land cover and NRCS soil survey data, was used to model the pollutant loads from these sites. The neighborshed acreage was entered into the WinSLAMM program along with its corresponding land use

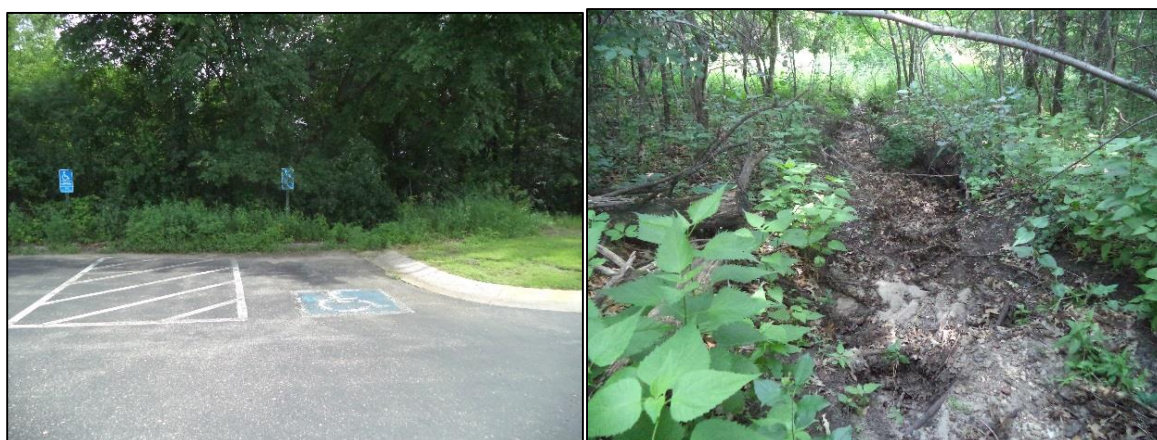
Figure 9. Location for retrofit 7 (left). Proposed removal of 4 parking lots and installation of rain garden to treat Chippewa Middle School runoff currently causing gully formation (right).

In the northeast parking lot of Chippewa Middle School, a complex bioretention retrofit is proposed for water draining toward Charley Lake. In Retrofit #7, four parking spots would be removed to create a raingarden to reduce runoff causing a gully just north of the site (Figure 9).

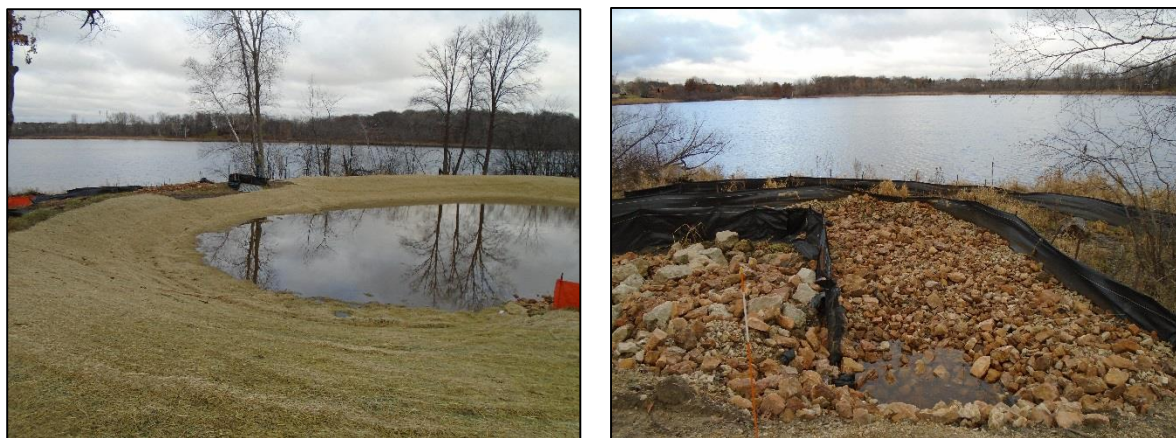
Figure 10. Location for proposed iron enriched sand filter. Filter can take form of a bench in the Charley Lake Preserve stormpond (left) or as an installation in the rip-rap at the outlet (right).

Though the stormwater pond cannot be thoroughly evaluated until construction is complete, initial assessment shows room for improvement in its effectiveness. The North Oaks Homeowners Association noticed overflow of the stormwater pond, causing erosion on the footpath between the pond and the lake (NOHOA, 2015). The design should only permit overflow in 100-year precipitation events, so the capacity of the pond could be enhanced. Native plantings would improve stabilization and enhance infiltration and evapotranspiration of stormwater. Even with the stormwater pond functioning as designed, there is little phosphorus removal for the 28 acres of runoff that are directed toward it, so an additional BMP would be very helpful in reducing algal blooms at the outlet of this stormwater pond into the lake.

A very effective retrofit for the stormwater pond would be an iron-enhanced sand filter that could either be placed within the stormwater pond as a bench feature, or positioned at the outlet in the rip-rap area before draining to Charley Lake. Iron-enhanced sand filters have high pollutant removal rates for removing phosphates from water, often used in conjunction with existing ponds to improve the quality of impaired water (MPCA, 2015).

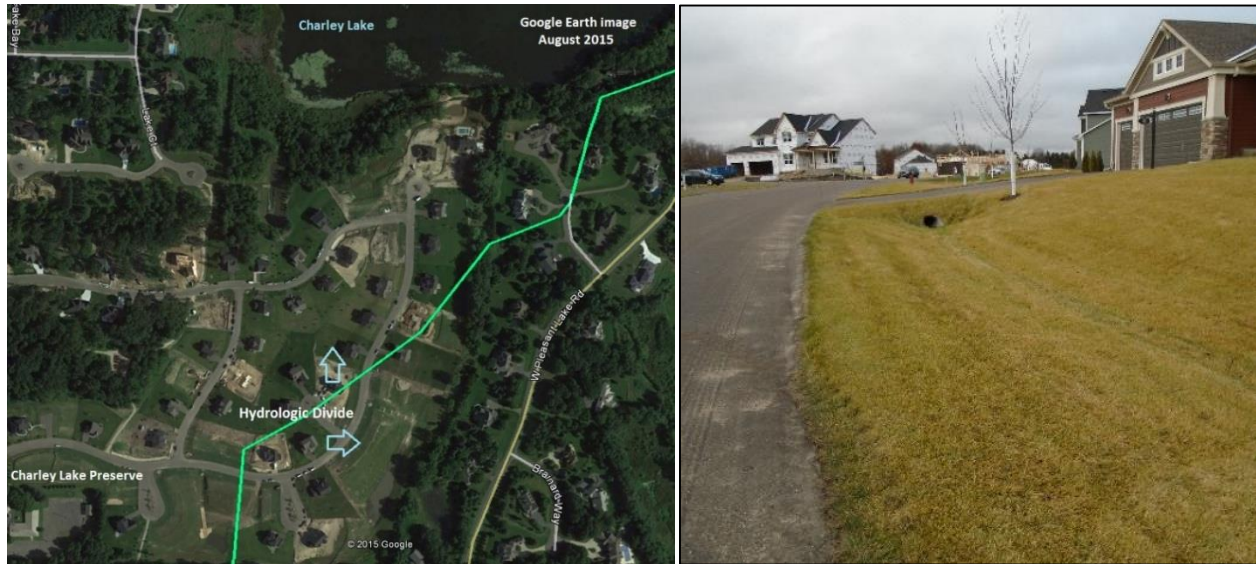
Figure 11. (Left) Charley Lake Preserve’s hydrologic divide between runoff flowing southeast toward Pleasant Catchment and the 28.5 acres of urban runoff flowing north toward the Charley Stormwater Pond. (Right) A typical mowed turf-lined ditch in the Charley Lake Preserve housing development.

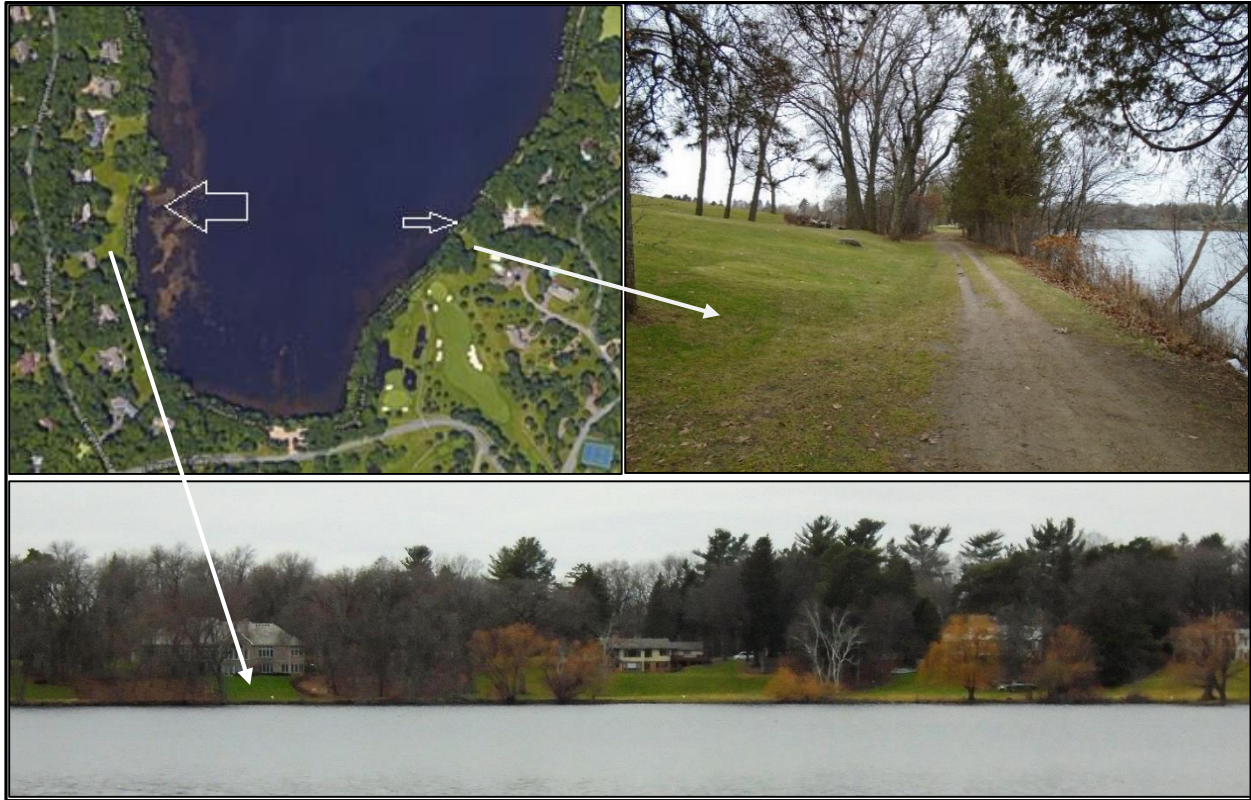
Figure 16. (Top left) Aerial view of lawns on Evergreen Lane (and resultant algal bloom) (lawns visible in bottom image) and the backyard of 5 Skillman Lane (close-up in the upper-right hand photo). These lawns would benefit from shoreline restoration BMPs.

additional shoreline stabilization may be required since these sites were highlighted in the 2009 study as urgent erosive threats to the Pleasant Lake Trail and shoreline. A turf to native vegetation conversion would be beneficial as a strip between the lawn and the lake.

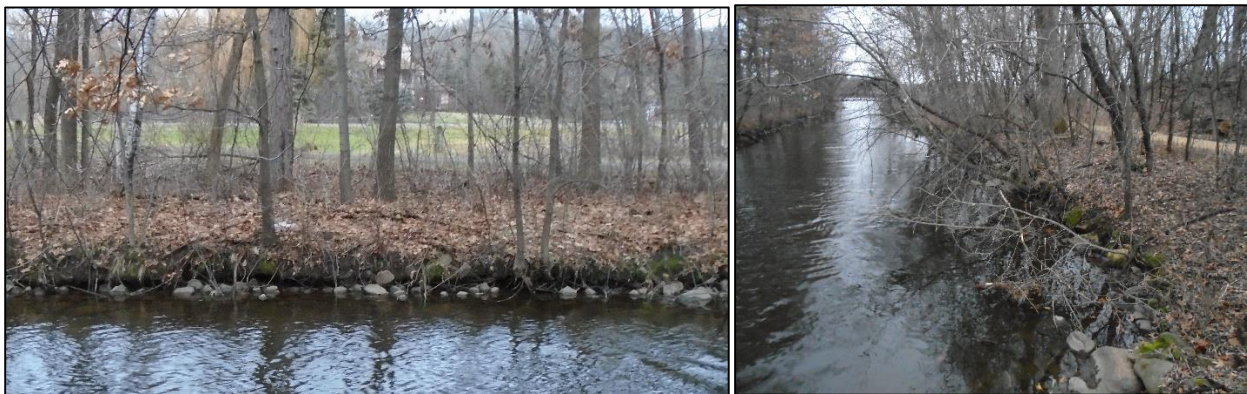
Figure 17. Erosion on the Charley-Pleasant channel, just east of W Pleasant Lake Rd.

The channel connecting Charley Lake to Pleasant Lake, particularly just east of W Pleasant Lake Rd, has erosion and undercutting of the north bank (Figure 17). Though rock is visible from past stabilization, this section of the channel requires improved stabilization to prevent further lost soil and collapsing trees, which are visible on the south bank.

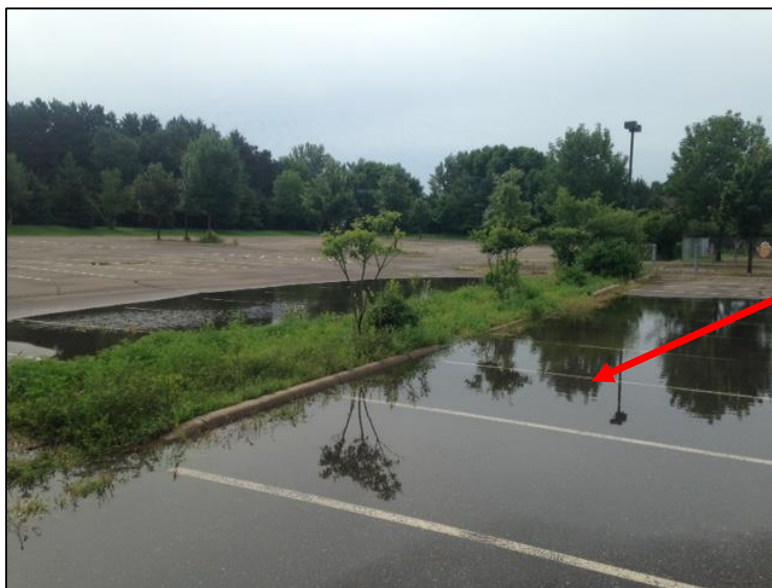
Figure 20. Flooding at Site 6 (left) in the Pleasant catchment (August 2015), Incarnation Lutheran Church parking lot. The proposed BMP involves removing some parking spaces to expand the vegetated area, creating a raingarden to which most of the back parking lot drains. (Right). Map of bioretention sites 1-6, Pleasant Catchment.

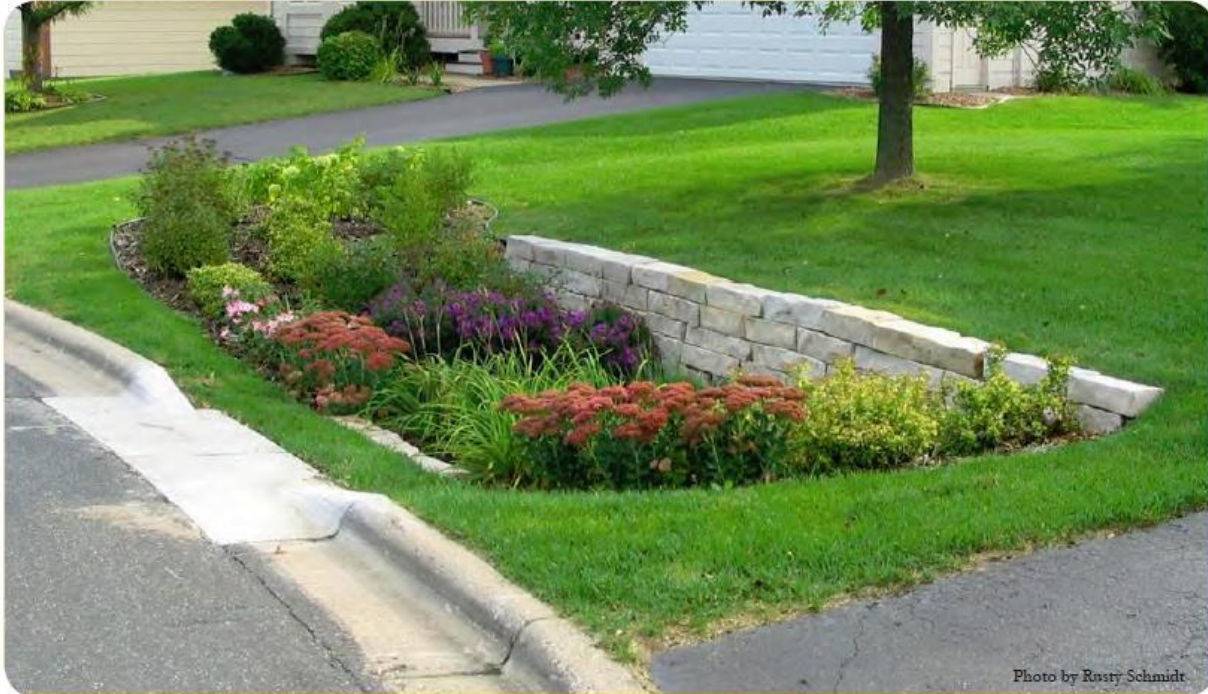
Curb cut raingarden, with 1.5-2ft perimeter wall, in a residential area.
