**VADNAIS LAKE AREA WATER MANAGEMENT ORGANIZATION
Sustainable Lake Management Report
Tamarack and Fish Lakes, Ramsey County, MN**

**Updated by Dawn Tanner, 2023
Originally prepared by Kristine Jensen, 2009**

VLAWMO SUSTAINABLE LAKE MANAGEMENT REPORT (SLMR): TAMARACK AND FISH LAKES

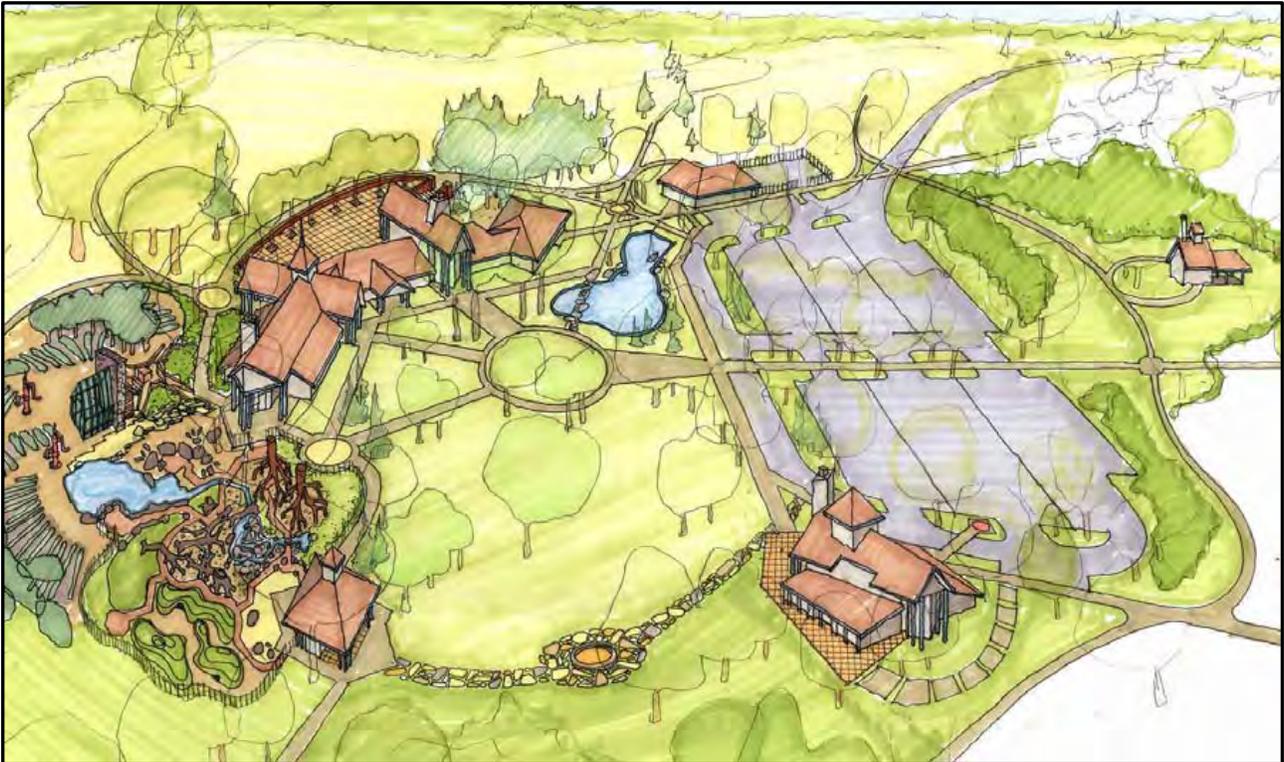
Figure 9: Conceptual plans for Tamarack Nature Center from 2009

Ramsey County worked with contractors to implement changes to Tamarack Nature Center. Not all of the upgrades envisioned in the master plan were built. For example, the master plan included a Tamarack Lake Raft, which was a floating platform powered by paddles to move around the lake, allowing visitors increased access to the lake. A boardwalk was also planned for and built around Teal Pond. As of 2023, site upgrades are still planned for future implementation.

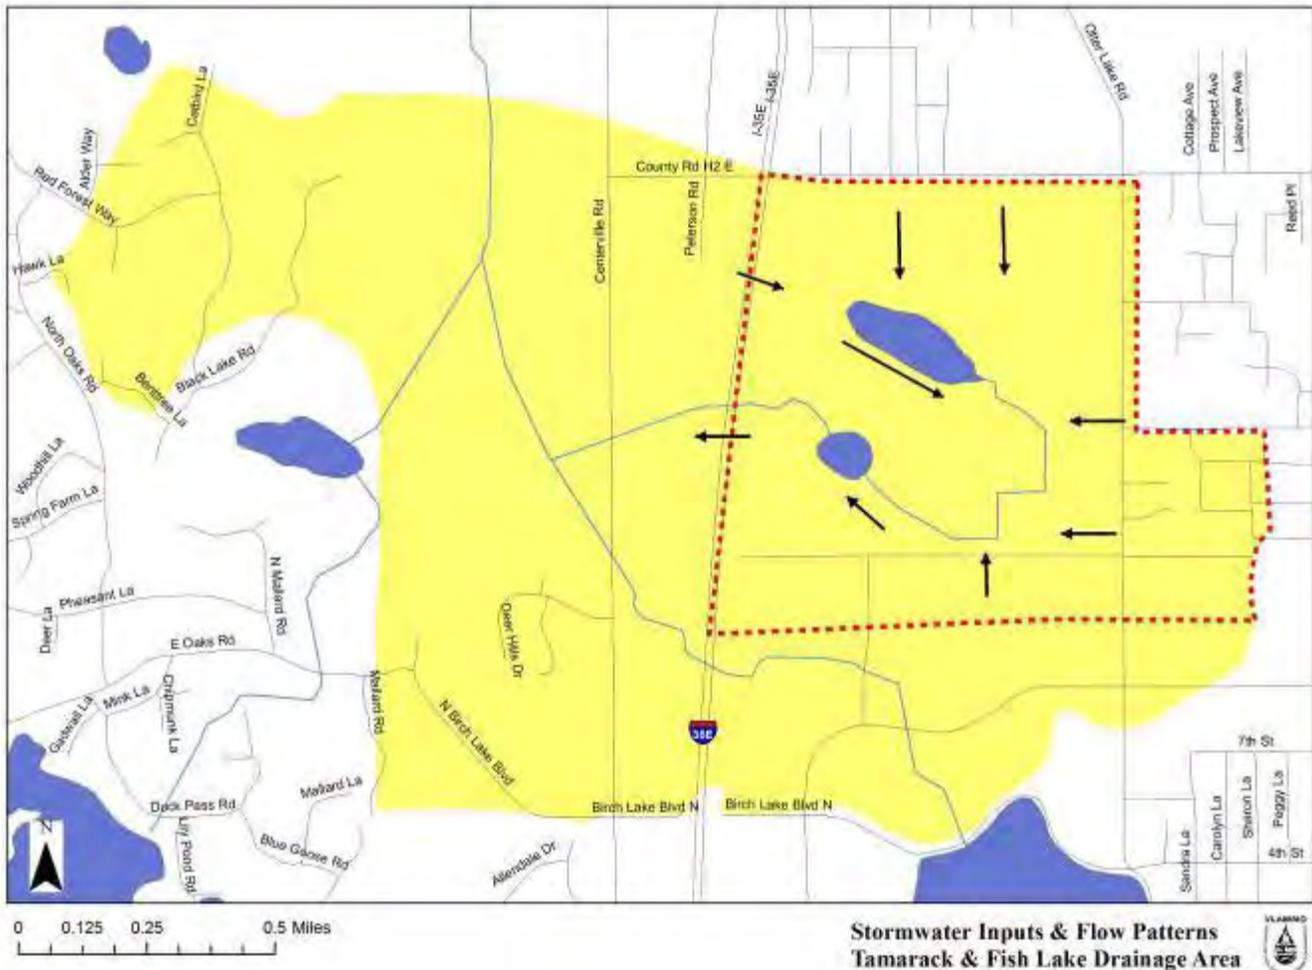
Figure 11: Tamarack & Fish Lakes Drainage Area and Flow Patterns

Tamarack and Fish Lakes are within the Wilkinson Stream Subwatershed (yellow area in Figure 11). The area that drains into the lakes is marked by the red dashed line. The drainage area is approximately 500 acres, which is over 30 times larger than the surface area of the lakes. Lakes with a large drainage area (over 10:1 ratio) tend to have lower water quality. Land use is primarily parkland onsite, with industrial land use on the southern end and residential on southeastern side. Interstate 35E is on the western border of the drainage area. Water flows into the area via storm sewers and ditches, and it flows out through a creek that goes under 35E. Observation well #62039 is located near Tamarack Nature Center and shows a depth to groundwater range of 6.5–9.5 feet. This high water table could indicate groundwater recharge in addition to stormwater runoff.

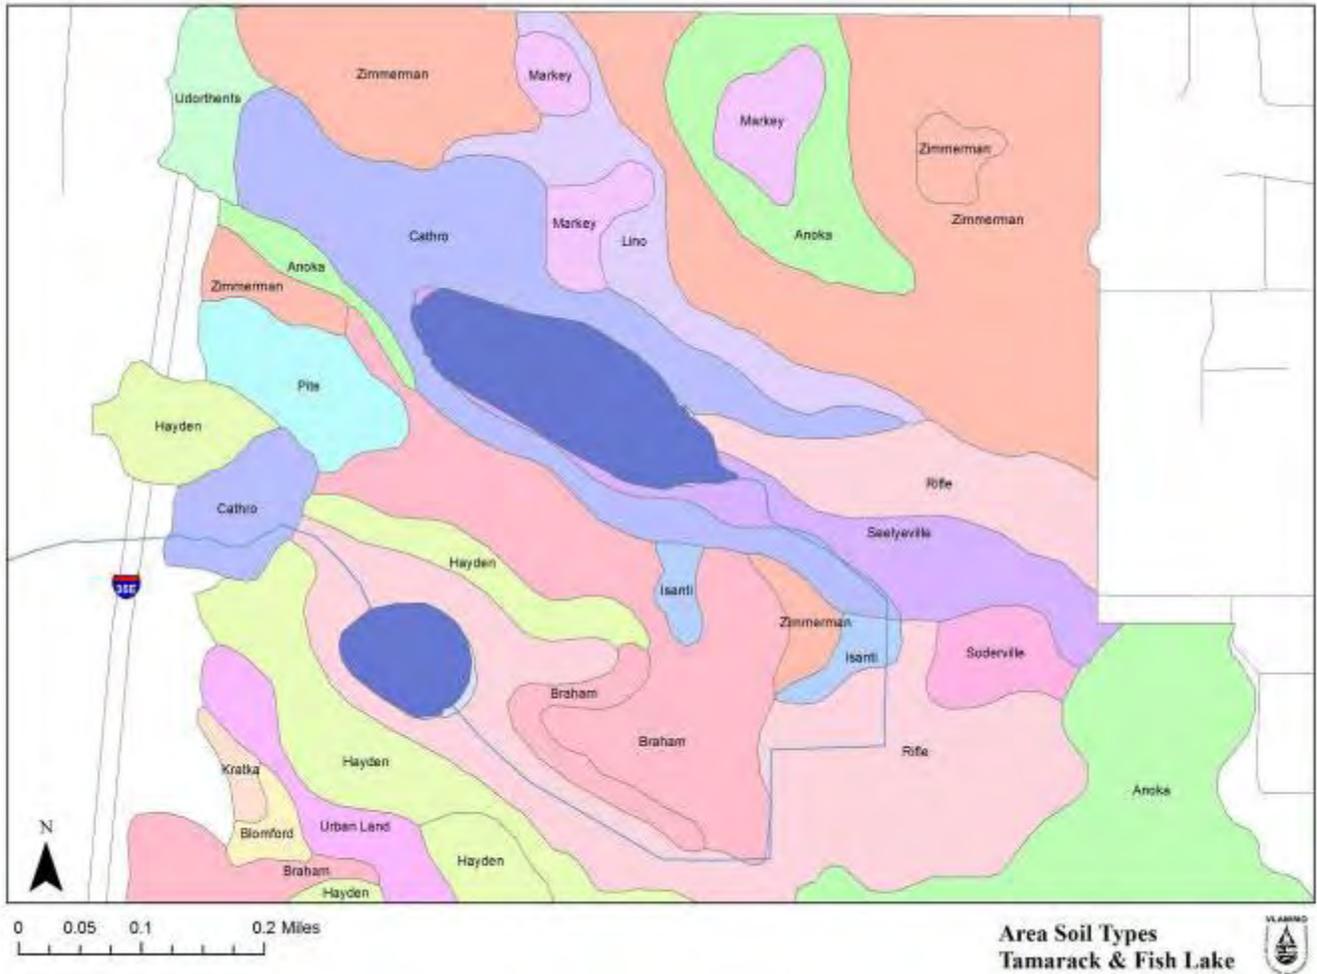
Figure 12: Tamarack and Fish Lake area soils

The soils around Tamarack and Fish Lakes vary from sandy loams to muck; primarily based on the topography of the land. The soils in the lower areas and near the lakes are muck types (Rifle, Markey, Cathro). Soils on the upland areas are fine, sandy loams (Hayden, Zimmerman, Isanti, and Anoka).

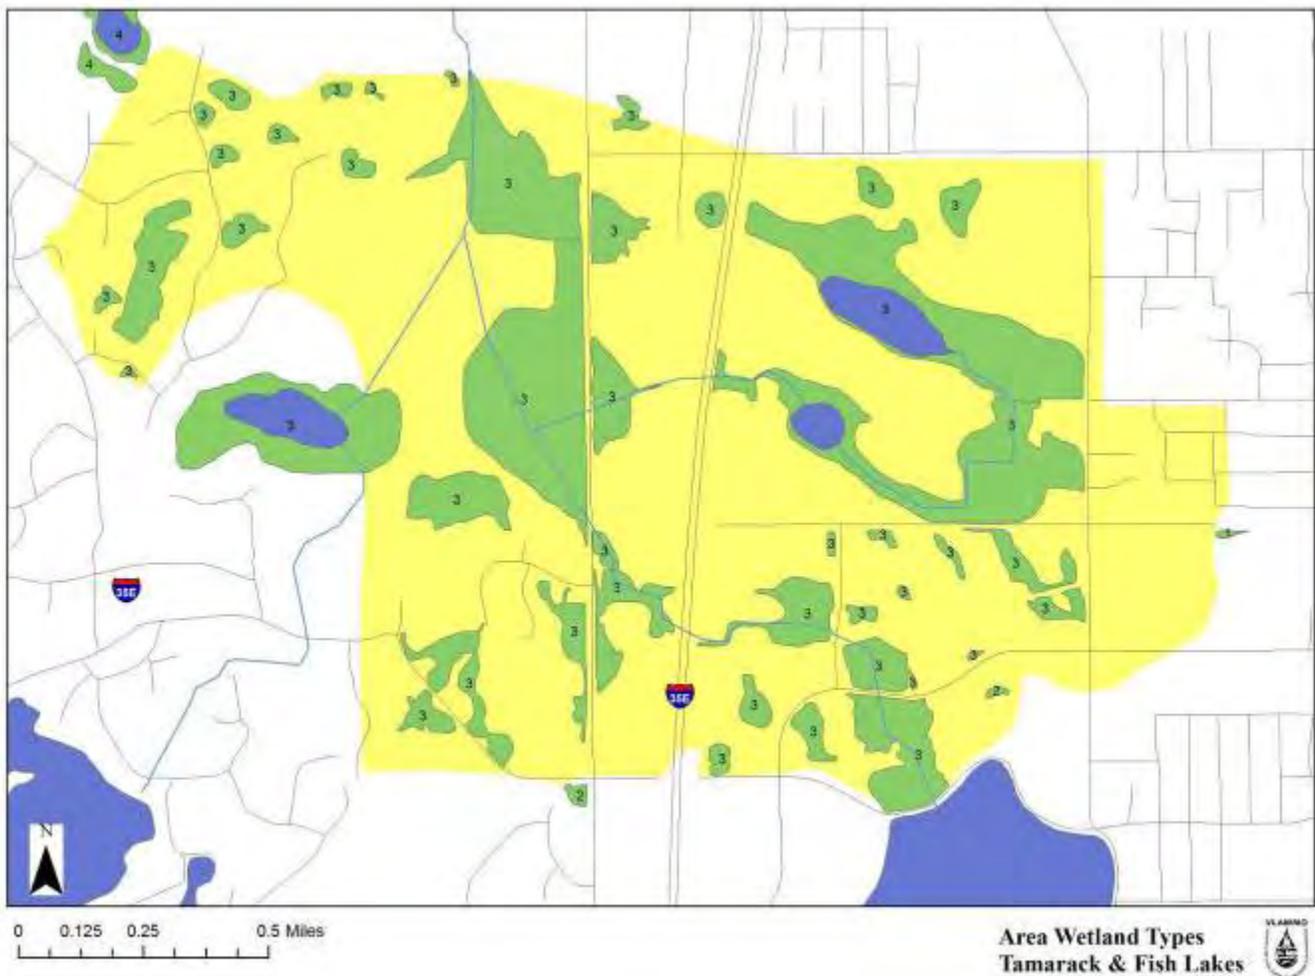
Figure 13: Wetlands surrounding Tamarack & Fish Lakes

Area wetlands are primarily Type 3 - Shallow Marsh. The soil is generally waterlogged early in the growing season and is often covered in 6 inches or more of water.

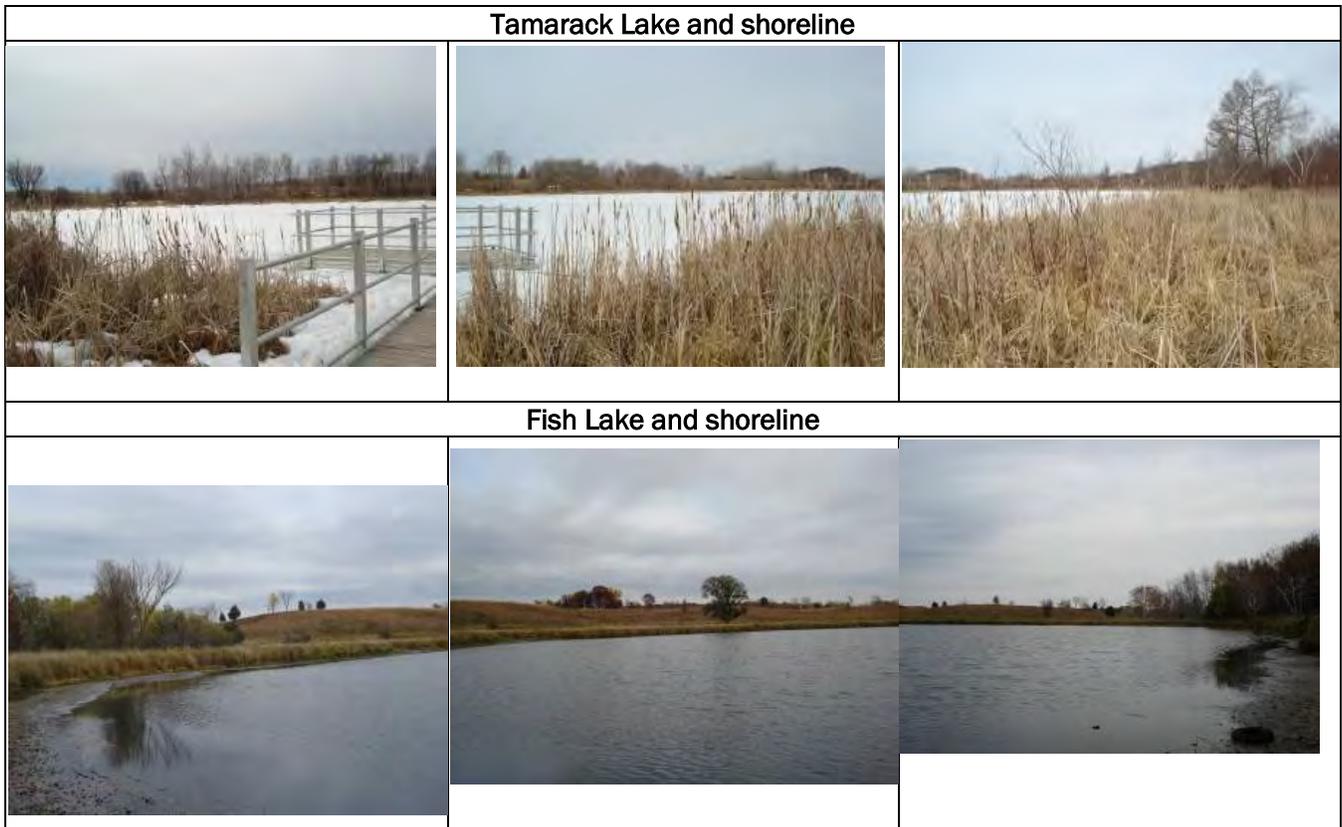
During 2008, the shorelines of Tamarack and Fish Lakes were photographed to provide an overview of what the lakes look like onsite. The land surrounding both Tamarack and Fish Lakes is part of the Tamarack Nature Center. No development is present along the shorelines of either lake.

Figure 14: Shoreline snapshots

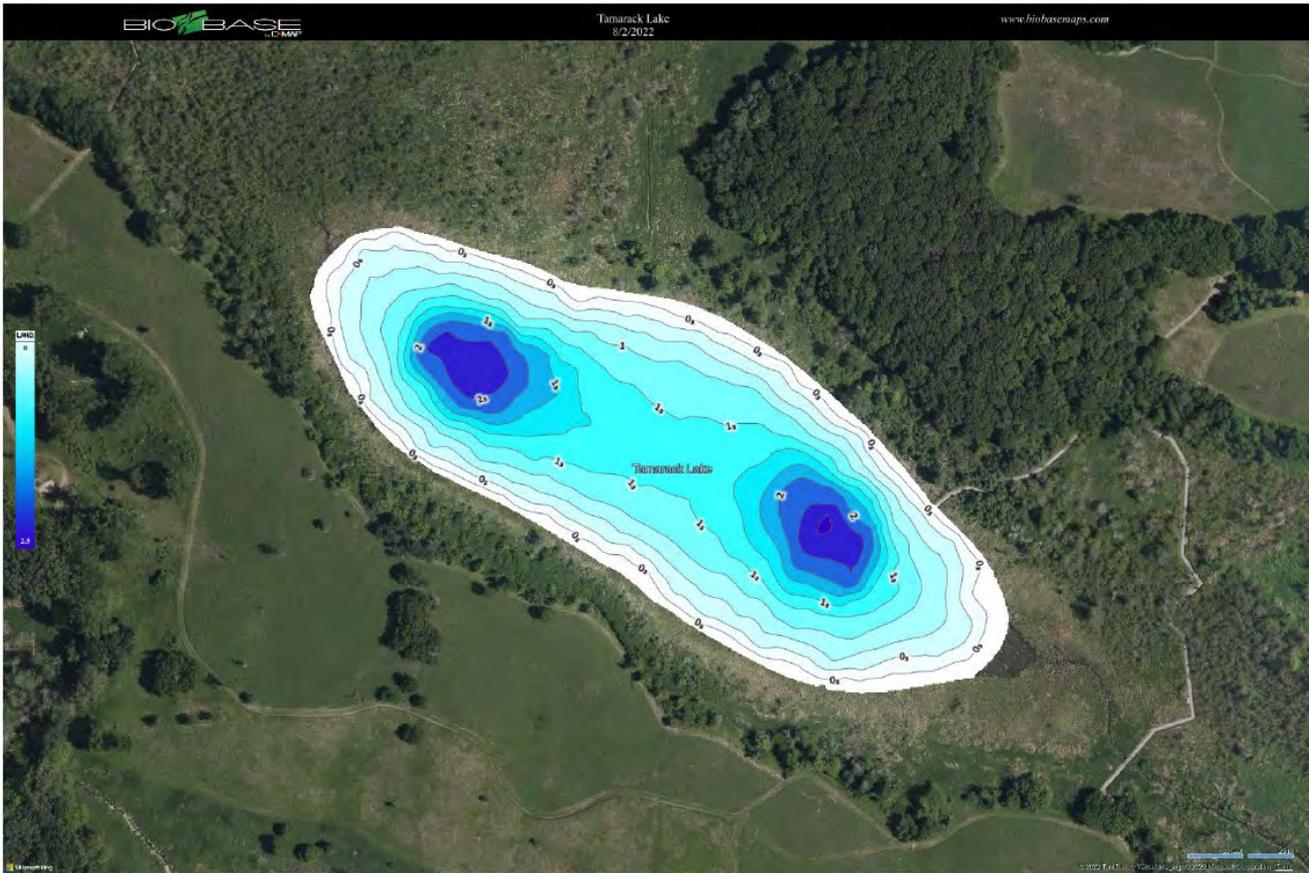
Figure 15: Tamarack Lake depths with 1-meter contours

A bathymetry survey was completed by Ramsey County Soil and Water Conservation Division (RCSWCD) on August 2, 2022, to develop a map of the bottom and determine lake depths. The deepest location detected by sonar was 2.5 m (8.2 ft), and the average was 1.5 m (5.0 ft). Bottom hardness is represented as soft, medium, or hard; with soft bottoms characterized as muck, loose silt or sand, and medium to harder bottoms characterized as compacted sand, gravel, or rock. Tamarack has a primarily medium bottom with softer areas in the deeper pools toward the middle of the lake.

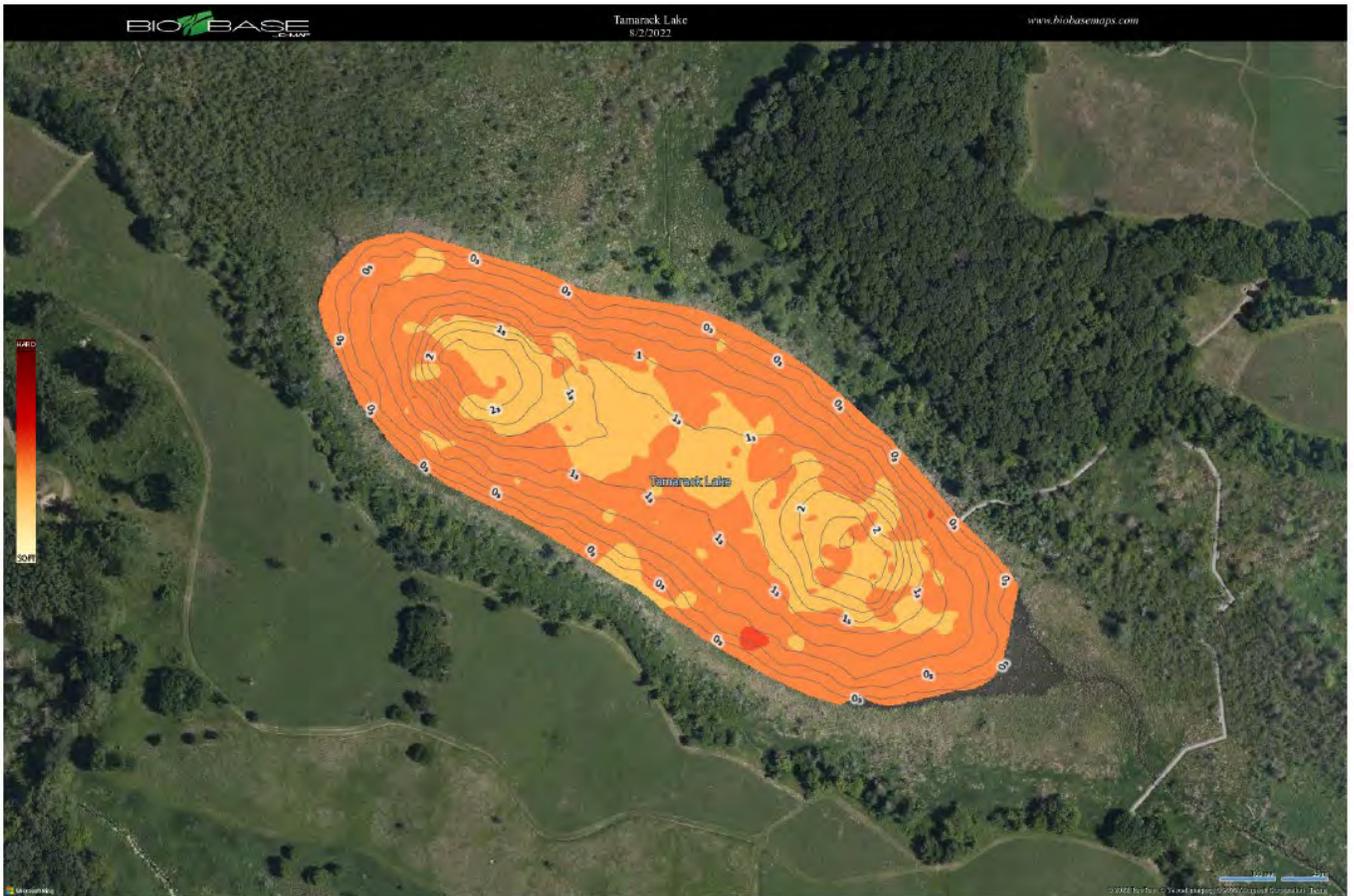
Figure 16: Tamarack Lake bottom hardness

Figure 7. Tamarack Lake bottom composition values with 0.3-m contours taken on August 2, 2022.

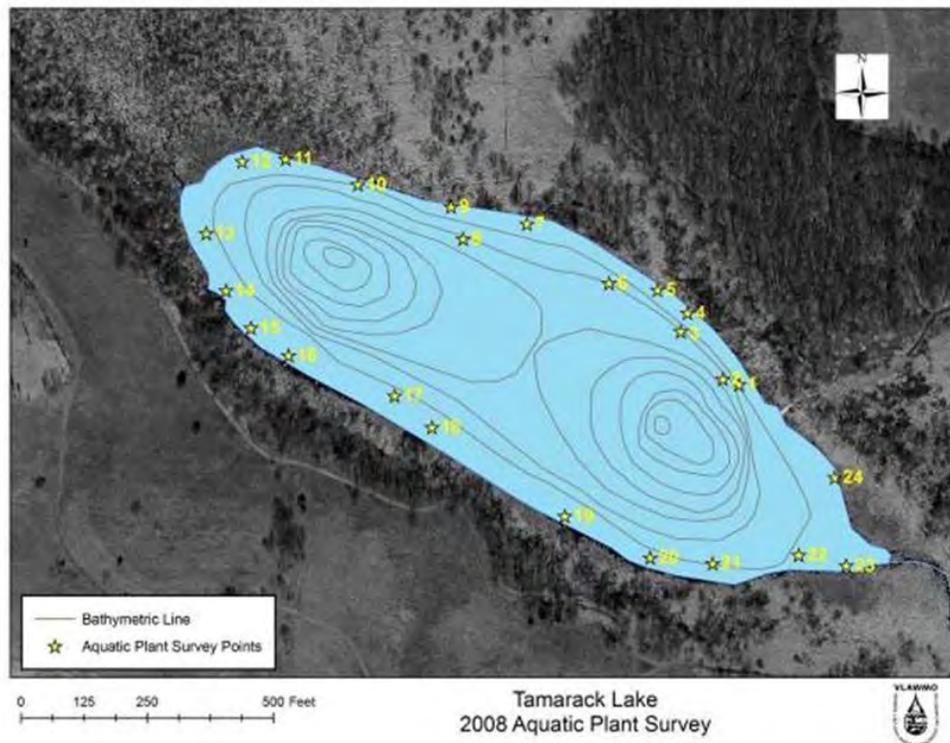
Figure 17: Sample points for aquatic macrophyte survey in 2008

VLAWMO staff worked with Lorin Hatch, HDR Inc. in July to identify aquatic macrophytes in Tamarack Lake. Water clarity was low, so light was determined to not support plant growth past a depth of 4 feet. Therefore, the survey was conducted around the perimeter of the lake. At 24 points, a rake was dragged from the lake bottom up through the water column, and the identification and abundance of plants was recorded.

Sago Pondweed was found at nearly every survey point around the lake and was thickest at points 12-15 and 20-23. Coontail was found at many survey points but was only dominant at point 24. Water lily was mainly found between points 11-18. *Najas flexilus* was most prominent from points 13-21. The plants documented in this survey are native to Minnesota. According to the MN DNR, Sago pondweed provides food for waterfowl and supports aquatic insects. Coontail is tolerant of nutrient-rich water and provides food for waterfowl. Water lilies grow in mucky bottoms of lakes and are an excellent habitat component for

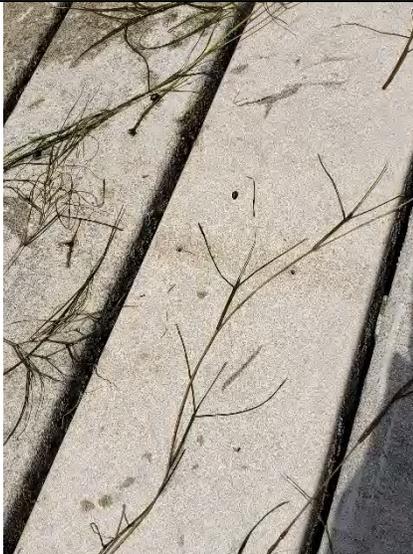
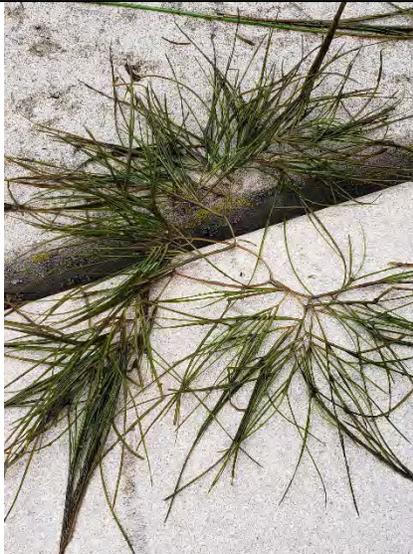
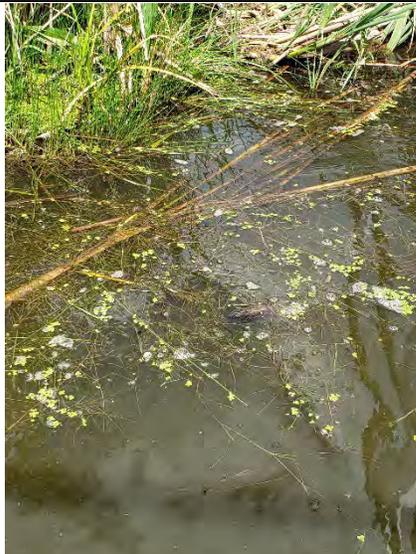
For the aquatic macrophyte survey, 21 evenly spaced (50 m) georeferenced points were surveyed using the metal portion of a rake/tines tied to a rope. Aquatic macrophytes were found at 6 of 21 points surveyed. The four species found on Tamarack Lake were Coontail (*Ceratophyllum demersum*), Flat-stem pondweed (*Potamogeton zosterformis*), Naiad (*Najas* spp.), and Sago pondweed (*Stuckenia pectinata*). No aquatic invasive plant species were detected.

Figure 18: Macrophyte sampling with RCSWCD and VLAWMO staff.

Flat-stem pondweed at Tamarack Lake	Sago pondweed at Tamarack Lake	Duckweed was not detected on the survey but has been noted in other checks at Tamarack Lake

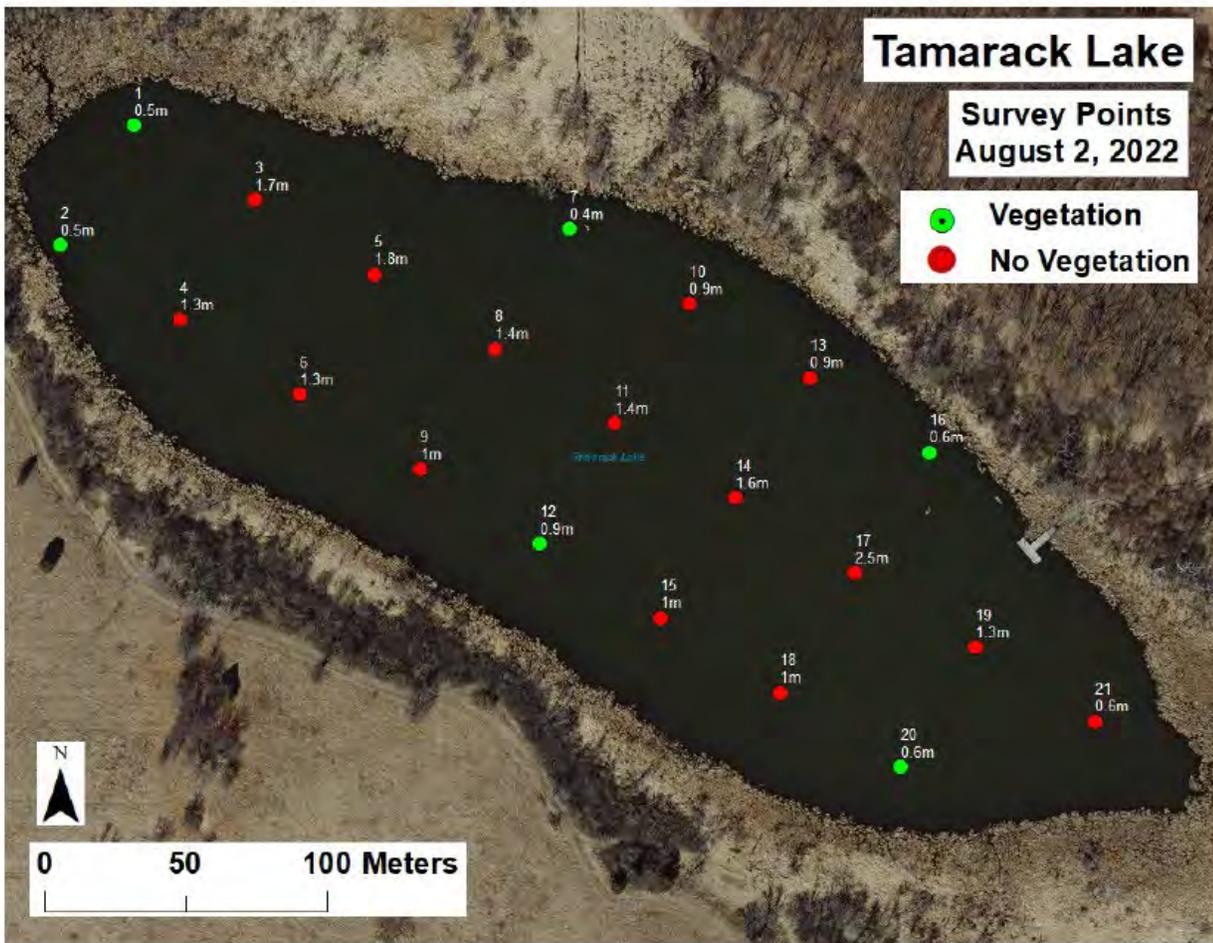
Figure 19: Tamarack Lake survey points with depths

Figure 2. Tamarack Lake vegetation point intercept survey locations. N=21.

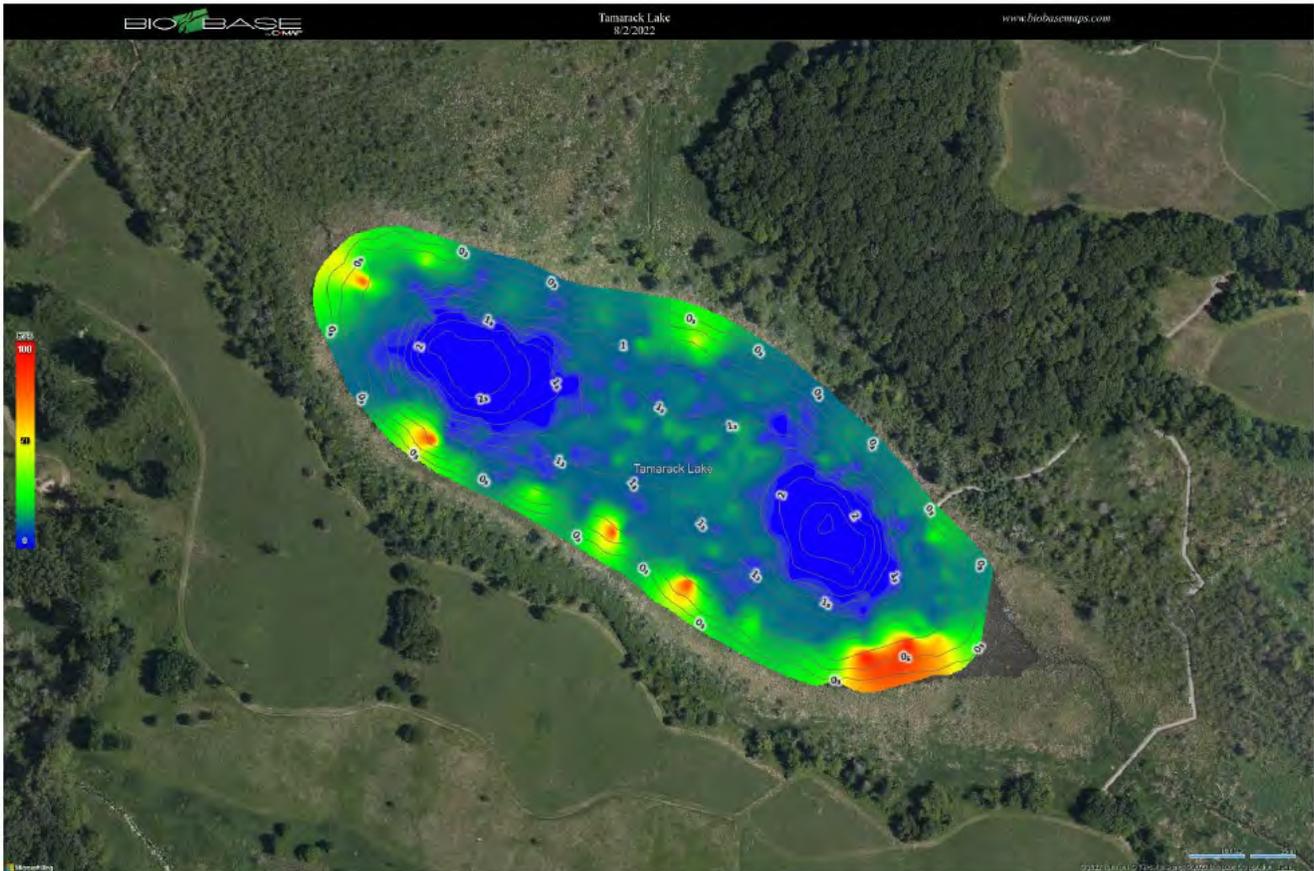
Figure 20: Tamarack Lake biovolume

Ramsey County Soil and Water Conservation Division (RCSWCD) conducted a biovolume and aquatic vegetation survey on August 2, 2022, in Tamarack Lake. Biovolume measures the density of plant life within the lake. Blue signifies 0% plant life, and red signifies 100% plant life. At depths greater than 4-6 feet, there is commonly no plant life in Minnesota lakes. Plant growth is limited because the sun does not penetrate into the water column below those depths enough to allow photosynthesis to occur.

Figure 6. Tamarack Lake vegetation biovolume with 0.3-m contours taken on August 2, 2022. Percent values range from zero to one hundred; Blue = 0%, Yellow = 50% and Red = 100%.

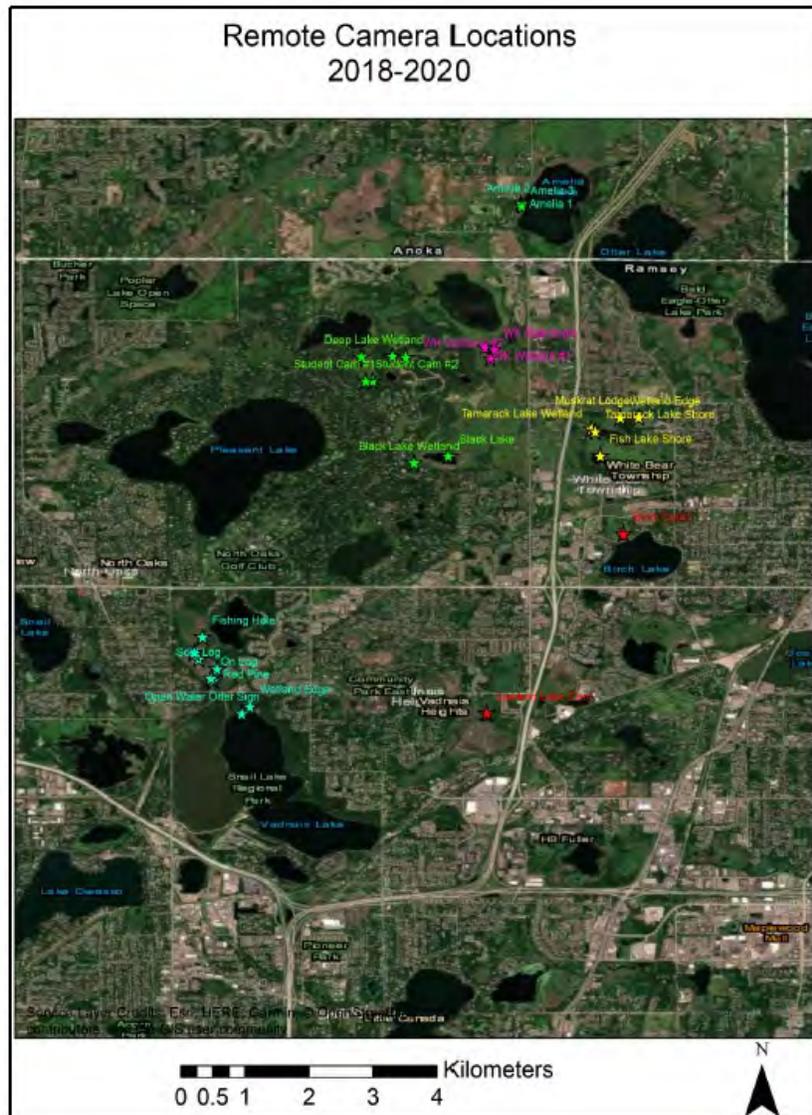
Figure 22: Remote-camera monitoring locations watershed-wide

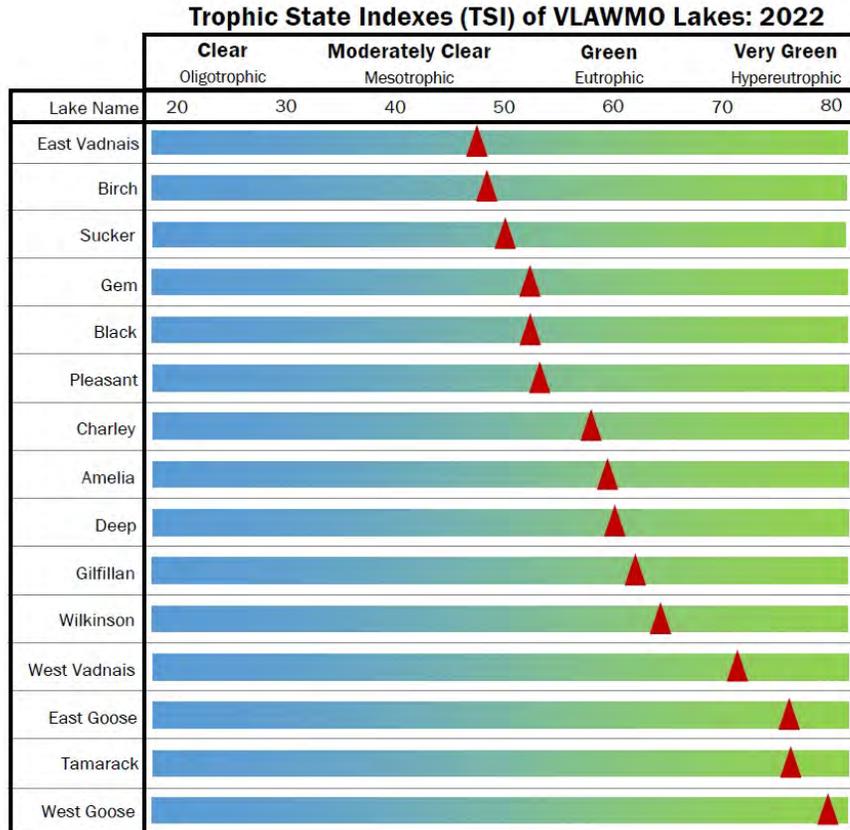
Figure 24: TSI scores for VLAWMO lakes

Tamarack Lake is shallow and falls in the area of very green/hypereutrophic on the Trophic State Index (TSI) (shown below using the Carlson scale, MPCA). Fish Lake is not monitored, so history and trends are unknown. Tamarack Lake had a score of 76 in 2022 (a lower number translates to better water quality), down from 78 in 2021.

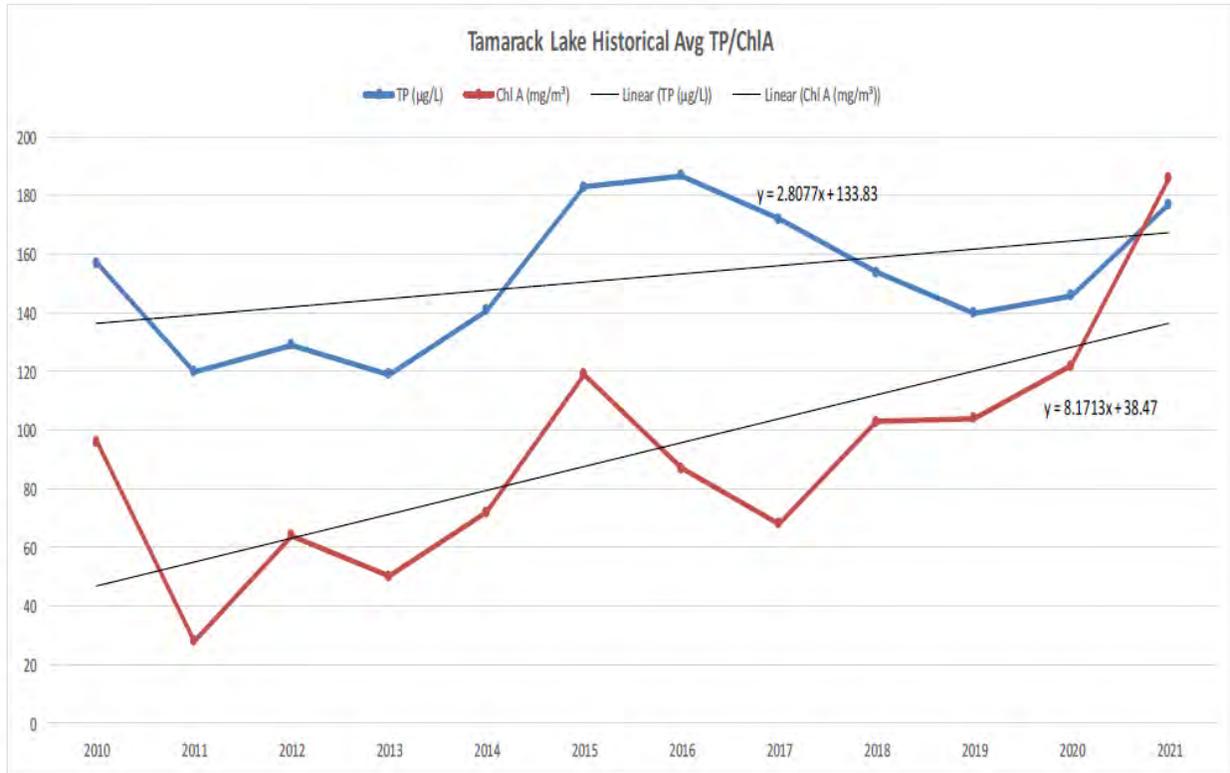
Figure 25: Water quality trends in Tamarack Lake

Monitoring is essential in understanding the status of the lake and establishing progress over time. Seasonal average TP (micrograms/L) has fluctuated over the years. TP has ranged from an outlier in 1997 of 17 to a high of 187 (2016). In 2021, the average was 177. A summary graph of the trends through time is shown below. This graph was taken from the annual monitoring report that is prepared by VLAWMO and available on the VLAWMO website.

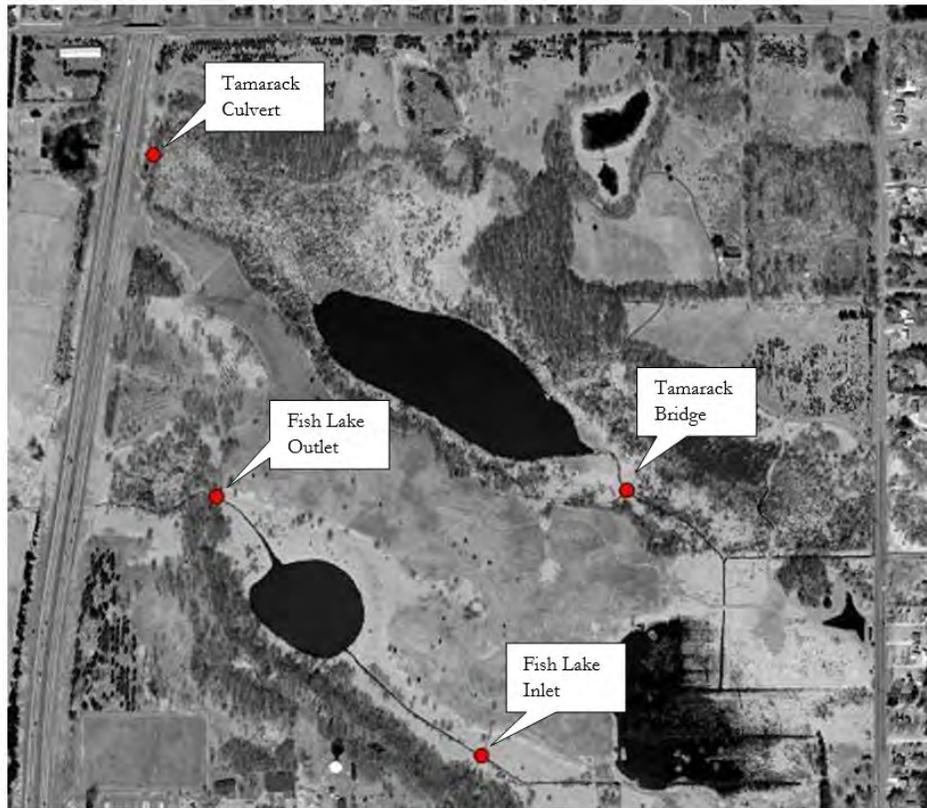
Figure 26: Storm sampler locations in Tamarack Nature Center

Four storm samplers were installed within the drainage area to study the change in pollutants and nutrients as water enters the Nature Center property, flows through Tamarack Lake, through the wetland banking area, and as it leaves Fish Lake. Table 7 shows results of sampling (2008-2009).

Samples were collected in March 2008 at the Tamarack Culvert and Tamarack Bridge sites to determine how much salt is coming off the roads from snowmelt runoff. The results were 600 mg/L at the culvert and 26 mg/L at the bridge. This indicates a high level of salt in the runoff from 35E but that it is not at a high level by the time water reaches the bridge. In 2009, 2 samples were collected at the culvert. On 2/10/09, chloride was 779 mg/L and on 3/6/2009 it was 528 mg/L. VLAWMO will continue collecting chloride samples.

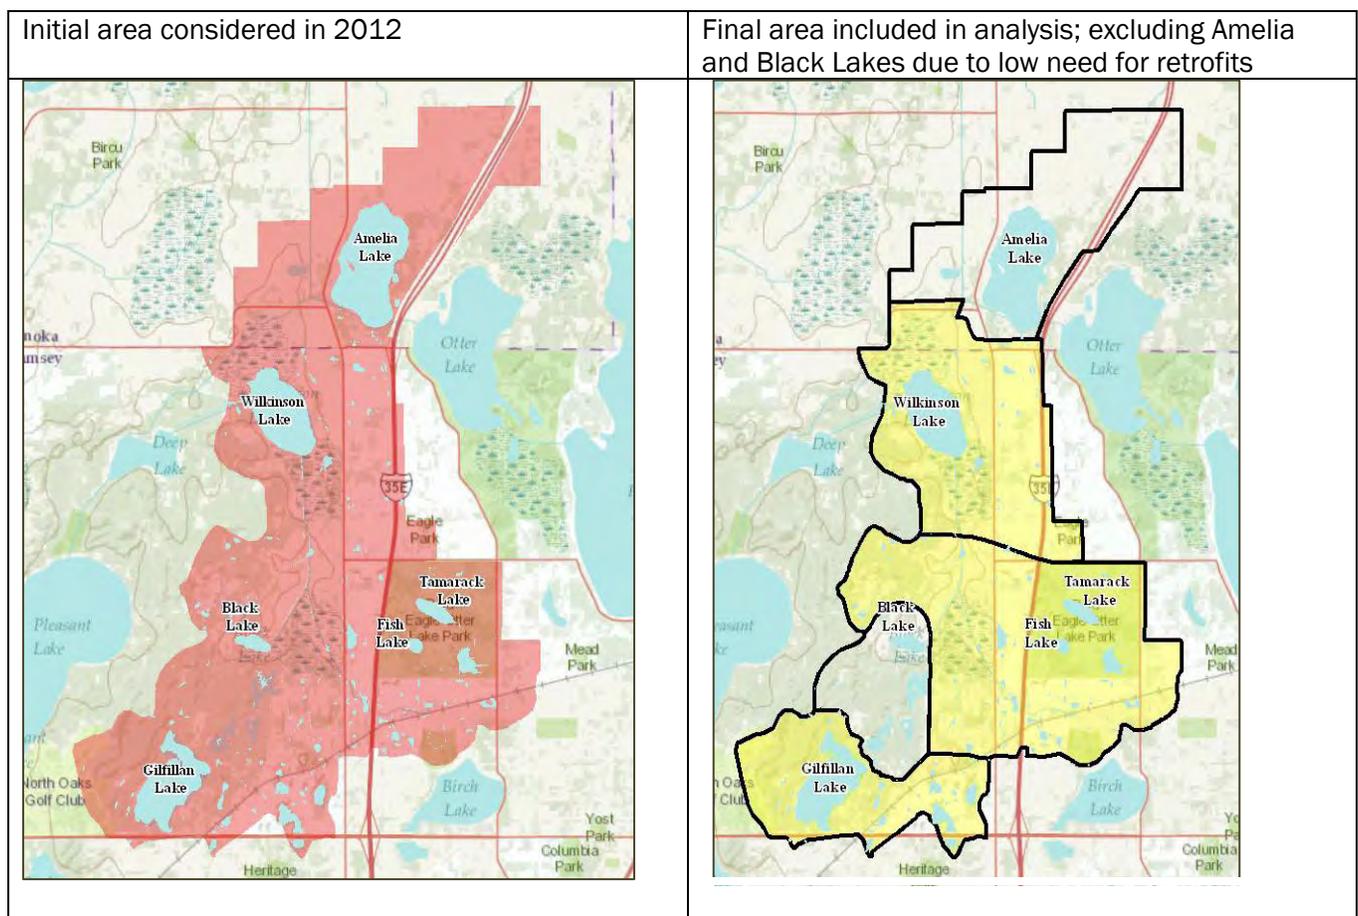
Figure 28: Initial and final areas considered for retrofit analysis

In 2012, the Ramsey Conservation District (RCD), now Ramsey County Soil and Water Conservation Division (RCSWCD), completed a Retrofit Report for the Gilfillan, Black, Wilkinson, Amelia, Fish, and Tamarack Lake chain of waterbodies. This was part of a larger effort to assess the full watershed and subwatershed scales and identify optimal locations for BMPs. Amelia and Black Lakes were excluded from the final area because these subwatersheds consisted of primarily open space.

The Tamarack and Fish Lake subwatershed areas were grouped into a catchment called “Wilkinson Stream” for this analysis. A large portion of this catchment is open space consisting of lowlands, wetlands, and buffers. The southern portion of the catchment consists of low to medium-density residential single-family housing, commercial, and light industrial land use. A series of wetlands, ditches, and stormwater ponds exist within this catchment, contributing runoff to Tamarack and Fish Lake. The soils within the area where retrofit opportunities were identified consist of Urban land-Zimmerman complex and Anoka and Lino loamy, fine sand which would allow for simple bioretention practices, if found to not be compacted or polluted.

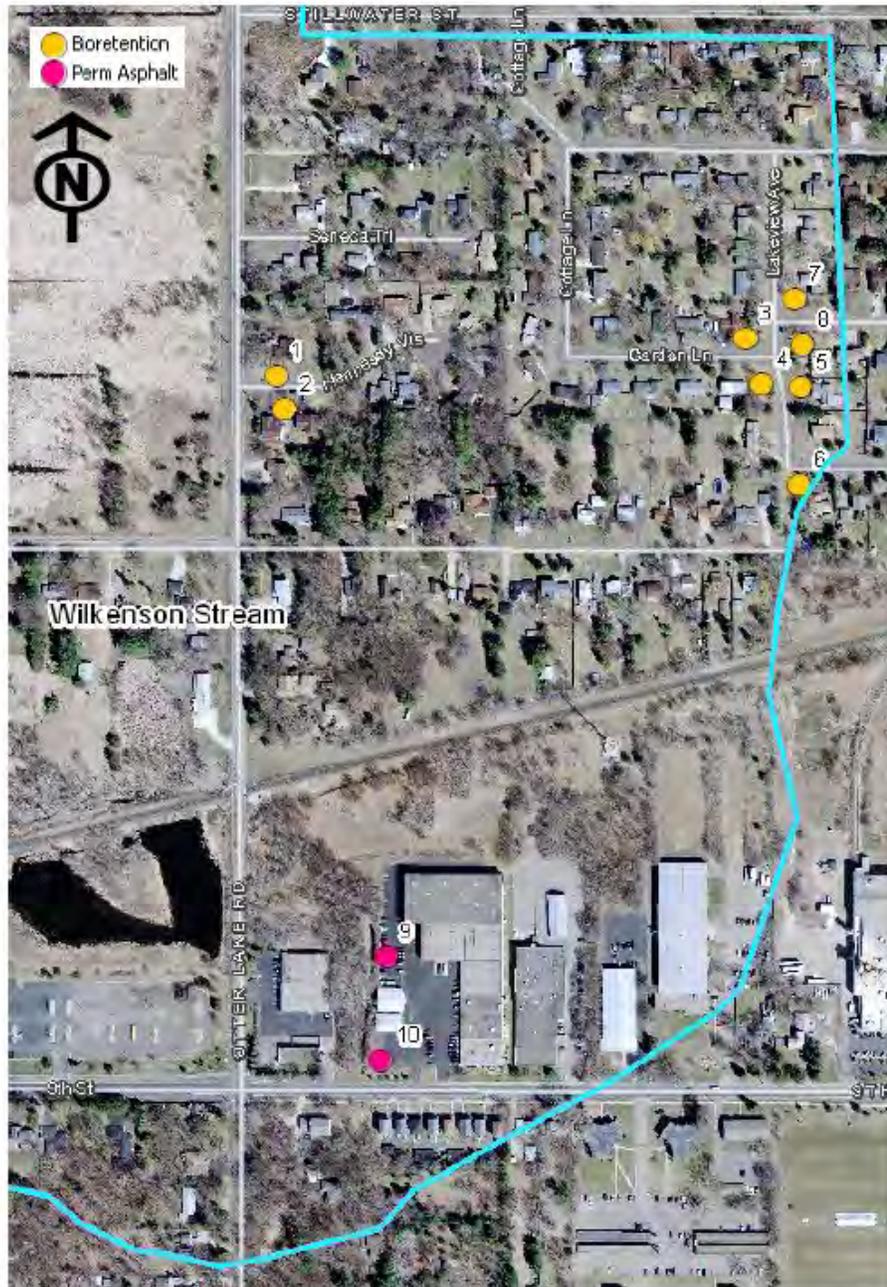
Three localized areas for this 1399-acre area were identified with total possible reductions of 681 lb/yr of Total Phosphorus.

Figure 29: Bioretention and permeable asphalt BMP locations identified to reduce pollutant loads to Tamarack and Fish Lakes.

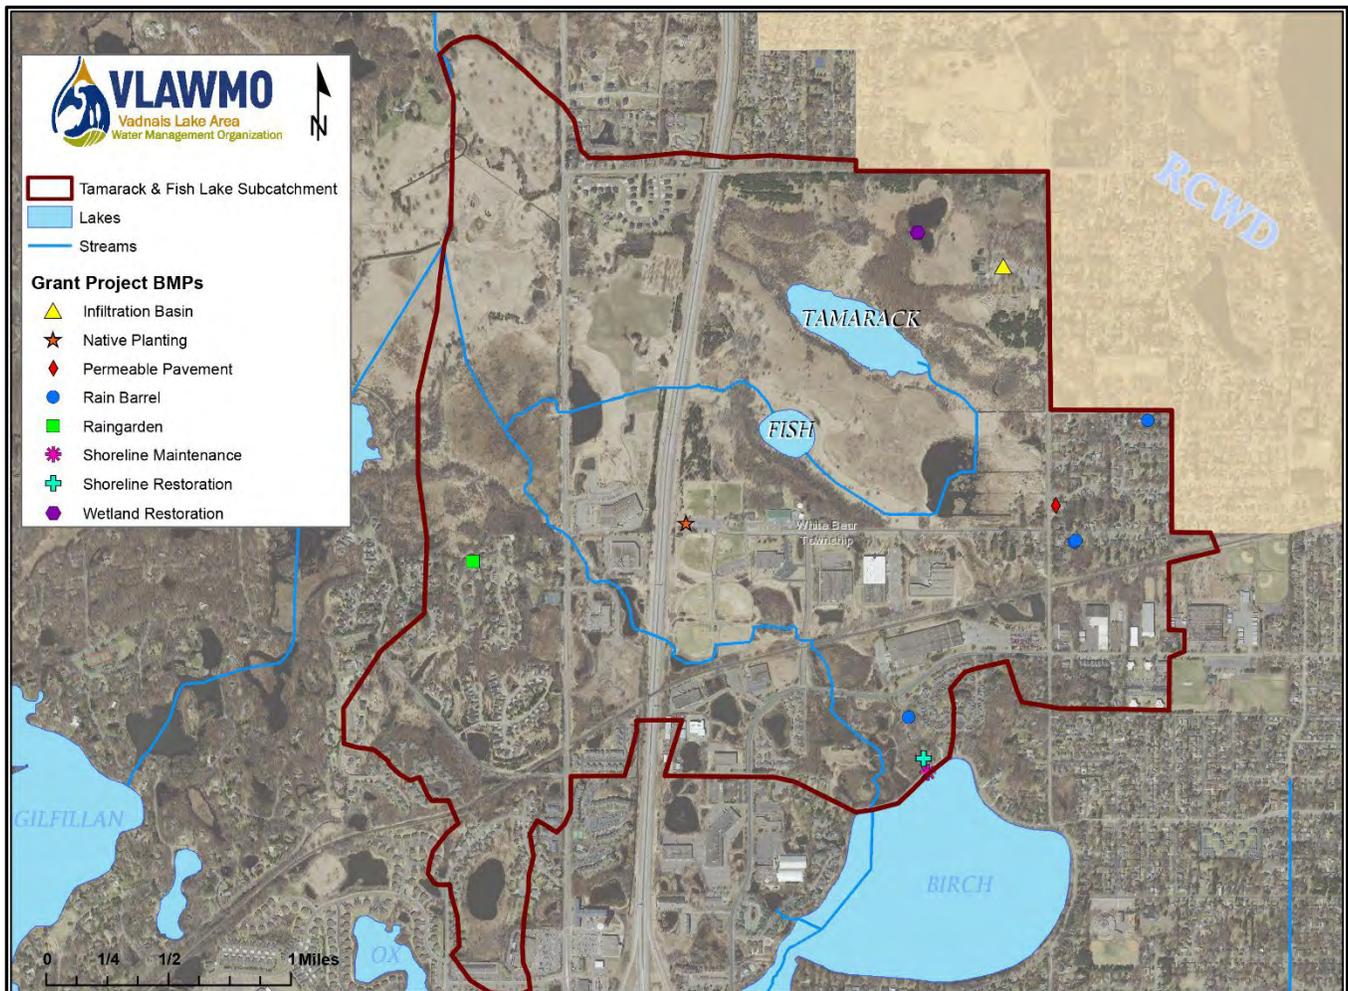
As one of VLAWMO's core program areas, VLAWMO's grant programs work to implement in-ground BMPs within VLAWMO's boundaries, for the improvement and preservation of water quality. For more information, visit www.vlawmo.org/grants/. Within the Tamarack and Fish Lake subwatershed, 11 VLAWMO grant projects have been implemented since 2007.

Figure 31: Tamarack and Fish Lake subwatershed implemented projects and BMPs. Note that 2 of the rain barrel grants appear overlapping on the map below.
