Vadnais Lake Area Water Management Organization

2018 Water Monitoring Report Summary

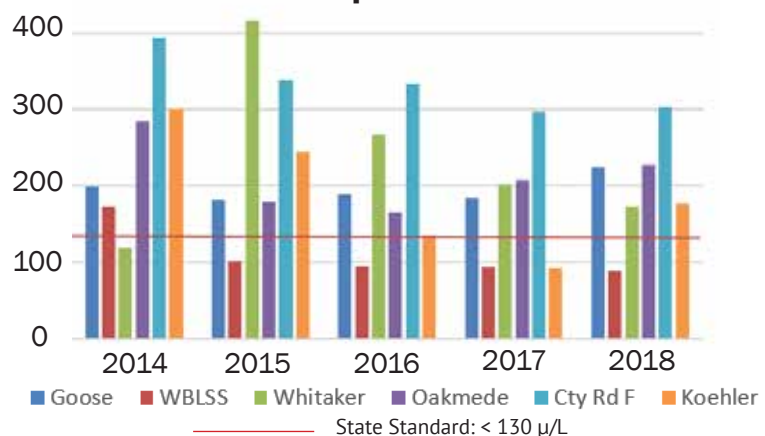
Historical Total Phosphorus of Lambert Creek

Lambert Creek is impaired for being high in nutrients and bacteria. Six sample sites are taken along the creek to assess contaminants in different parts of the watershed. E. coli levels have been detected as primarily avian and canine.

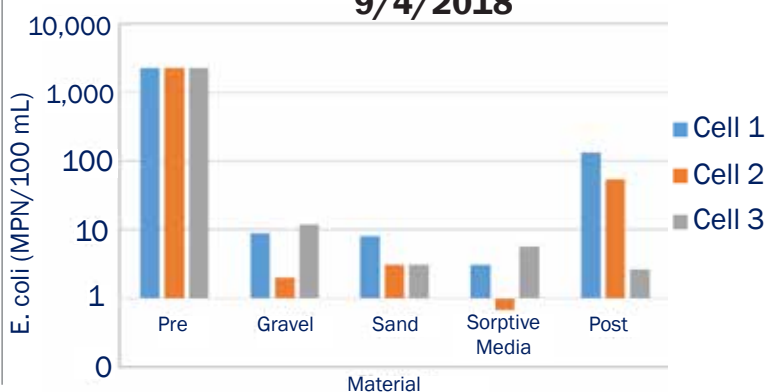
Whitaker Treatment Wetlands E. coli Samples Surrounding a Storm Event: 9/4/2018

Samples are gathered before (pre) and after (post) storm events and at various points within the 3 treatment cells. Each cell consists of layers of gravel, sand, and a unique mix of specialized sorptive media (concrete, peat, clay, tire crumb). Sampling is staggered over a period of days as water moves through the system. At right, E. coli levels are lower after water travels through the cells. The lowest level is seen in cell 3. These results may indicate that the composition in cell 3 is the most beneficial for removing E. coli bacteria. Research will continue until 2020 to replicate and investigate these results, making recommendations for future water treatment projects.

The Whitaker Treatment Wetlands is a research project investigating new ways to treat stormwater runoff. Completed in 2018, data will be collected until 2020 to analyze how various materials treat contaminants such as phosphorus, nitrogen, and E. coli bacteria.

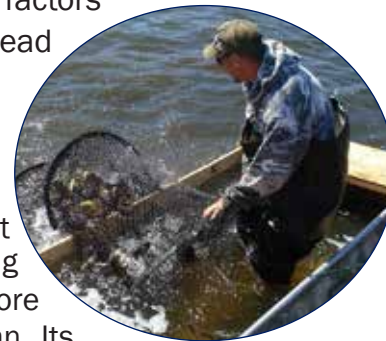
Goose Lake (East & West): Goose Lake has had high nutrient levels since VLAWMO began monitoring in 1997 (East) and 2006 (West). A 2015 bullhead removal (pictured right) made minor impacts to lake health, serving to reduce internal loading, which is one of several factors contributing to the lake's impairment. A 2017 fish survey indicated that the bullhead population is under control. Wood Lake/Oak Knoll Pond is a neighborhood pond that feeds into Goose Lake, is the focus of a spent lime treatment study in 2019.

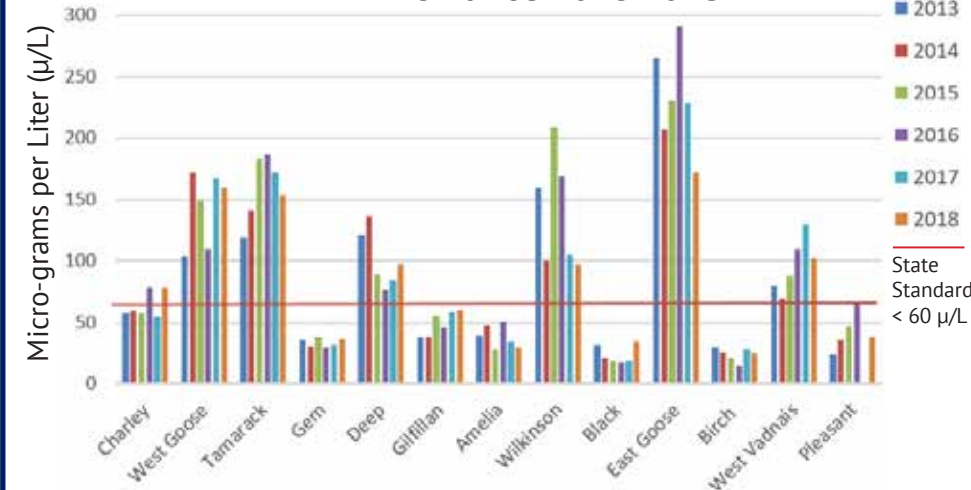
Average Total Phosphorus (TP) in VLAWMO Lakes 2013-2018

6 of our lakes exceed the State phosphorus standard.

A naturally occurring nutrient. In water, phosphorus is a main driver of algae growth. 1 lb. of phosphorus can produce up to 500 lbs. of algae in a lake. Increased algae levels create a variety of lake issues, including low oxygen, poor light penetration, and reduced fish and wildlife habitat.

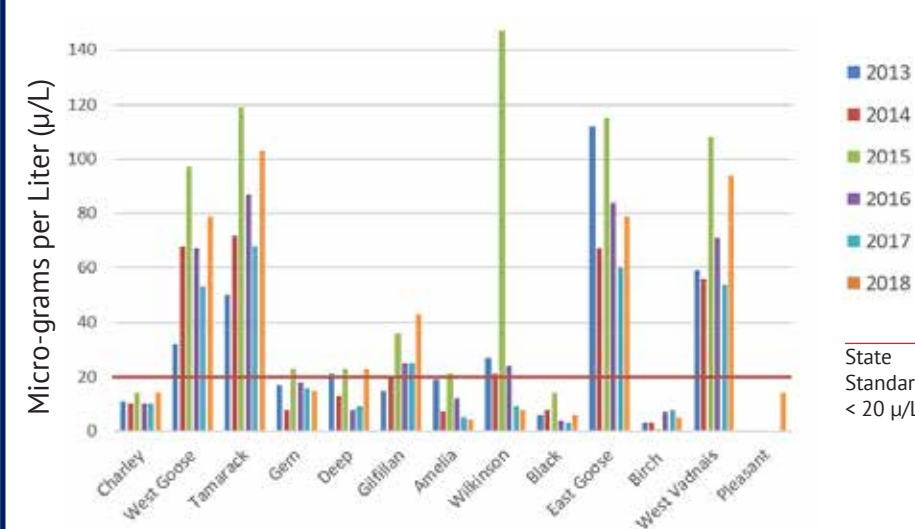
Average Chlorophyll-A (Cl-A) in VLAWMO Lakes 2013-2018

6 lakes of our exceed the State Chlorophyll-A standard. They are the same lakes that are high in TP, demonstrating the relationship between Cl-A and TP. For a lake to be listed as "impaired", it must show a trend in being above standards in 2 of the 3 readings: Cl-A, TP, and/or Secchi disk (turbidity).

A pigment that helps plants produce food. It is the green color found in algae and other plants. The concentration of chlorophyll present in the water is directly related to the amount of algae living in the water.

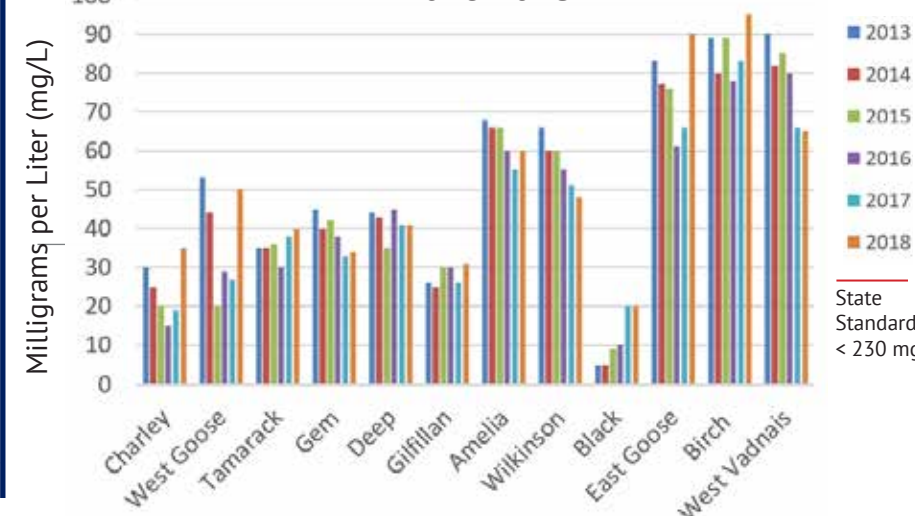
Average Chloride (Cl) in VLAWMO Lakes 2013-2018

We have no water bodies impaired for chloride. As water flushes through lakes, overall chloride level can drop over time. However, Birch, Black, and Gilfillan are showing gradual upward trends.

A common ingredient in de-icers such as sodium chloride (rock salt). Chloride is a permanent pollutant to water quality, requiring only 1 tsp. to pollute 5 gallons of water. Toxic to aquatic life, chloride also interrupts natural temperature and nutrient cycles in lakes.
