**PROPERTY ACCESS AGREEMENT  
VADNAIS LAKE AREA WATER MANAGEMENT ORGANIZATION**

**Exhibit A: Feasibility study**

# Tamarack and Wilkinson Lakes In-Lake Treatment Feasibility Study

Prepared for  
Vadnais Lake Area Water Management Organization (VLAWMO)  
and Ramsey County Soil and Water Conservation Division

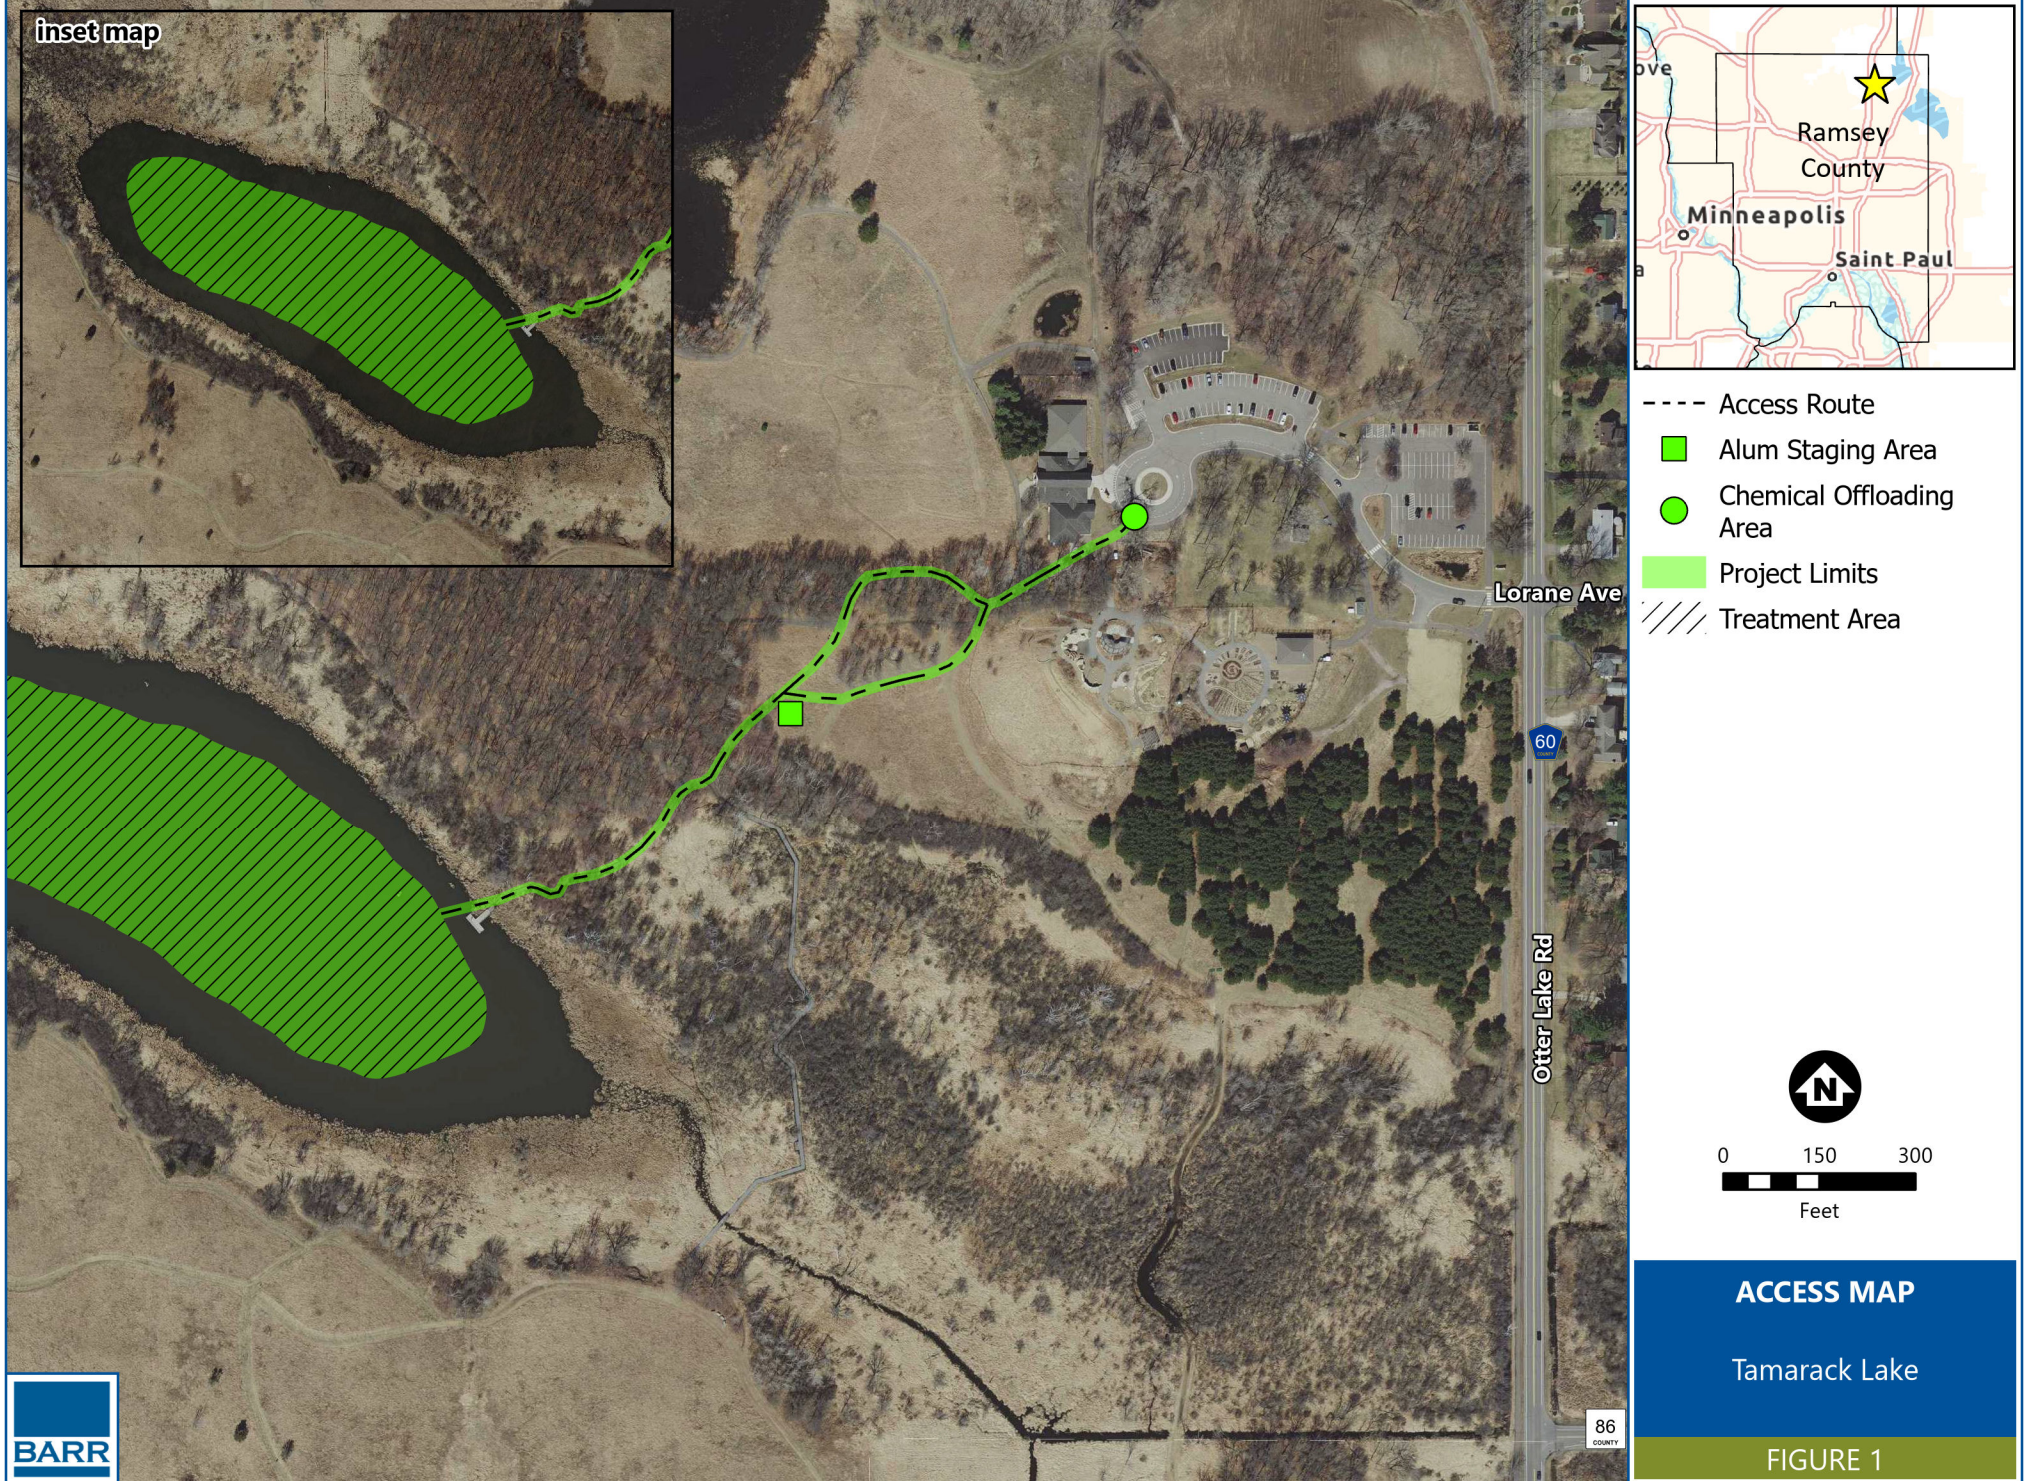
**Exhibit B: Map of anticipated use area**

The work consists of staging and conducting an alum treatment in Tamarack Lake in two phases. Phase 1 is anticipated to be completed during fall 2024. **Exhibit B** shows the anticipated use area for project delivery, staging, and the possible location for temporary storage tanks. The final use area will be defined by the contractor as part of the quote/bid received and will be shared with the Owner by VLAWMO once a contractor has been selected and approved by the VLAWMO Board to complete the work. Staging may include setting up and maintaining storage tanks with double containment for alum (aluminum sulfate) and a buffer (sodium aluminate), delivering the chemicals to the site, and filling the tanks onsite. Chemical delivery and maintenance will be conducted consistent with bid or quote documents that will include a management/safety response plan. Conducting the alum treatment will include a contractor using the parking lot area and vehicle access trails to bring a small boat (e.g., pontoon or other similar watercraft) near the application location. Once supplies are close to the application area, they will be transported along the boardwalk using wheeled carts or hand-carried. The small watercraft will be launched at or near the observation platform. Chemicals will be loaded onto the watercraft and applied to the lake in accordance with the description that will be provided by the contractor in the quote/bid documents and successful quote/bid. Staging will begin prior to each phase of the alum treatment, with communication and coordination between VLAWMO and the Owner. The application of alum is anticipated to take a few days over the course of 1-2 weeks, dependent upon weather and pH response in the lake. Monitoring will be conducted by the project engineer during the alum application as per MPCA requirements, and VLAWMO will be conducting ongoing monitoring once the application has been completed. Phase 2 will be conducted in the same manner as phase 1 and will be timed according to recommendations made by the project engineer.
