Sustainable Lake Management Plan

Gem Lake, Ramsey County, MN

Gem Lake Stormwater Retrofit Assessment

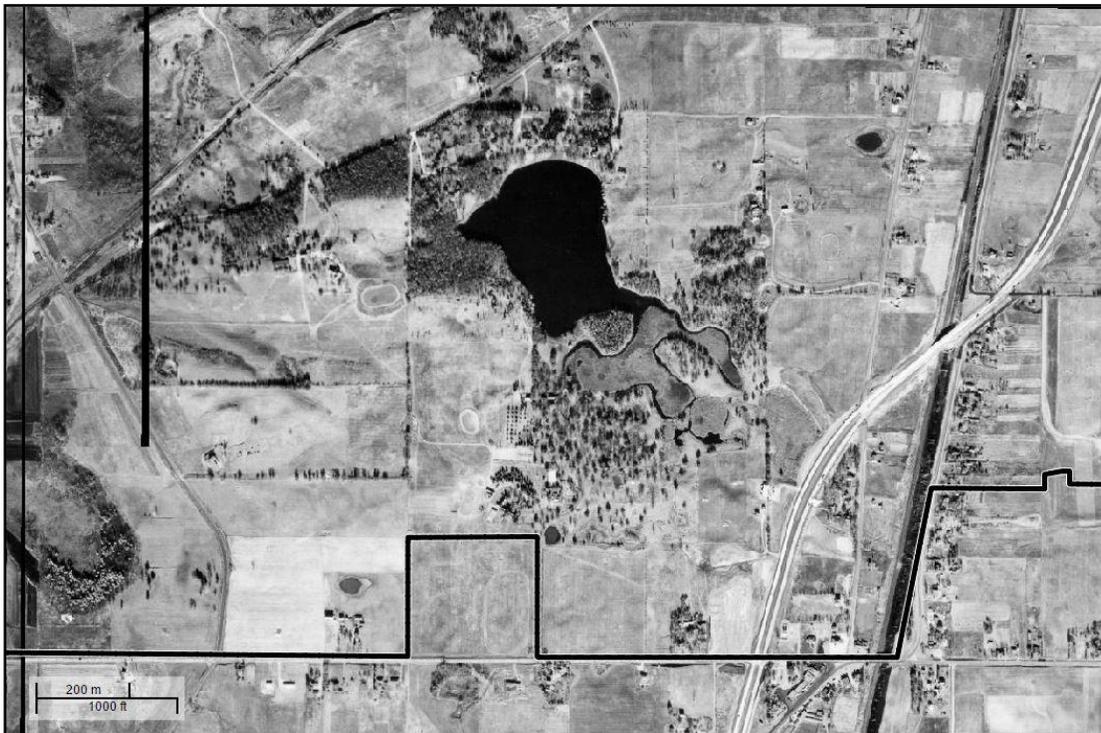
Figure 3: 1953 Aerial photo of Gem Lake

In 1953, a few more homes are cropping up in the subwatershed area. Highway 61 has been built and some development is occurring on the eastern side of the intersection of what is currently called County Road E and Highway 61.

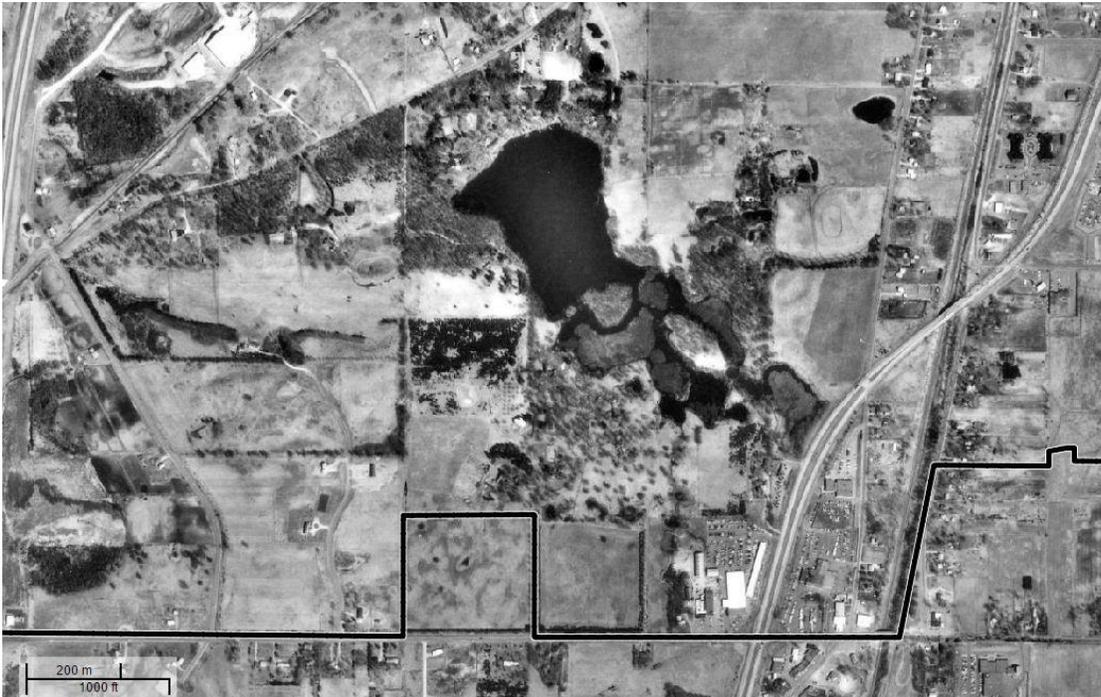
Figure 4: 1974 Aerial photo of Gem Lake

By 1974, commercial development is occurring at the intersection of Highway 61 and County Road E, along with more residential development along Scheuneman Road. Along the western edge of this photo, you can see that what is now known as Interstate 35E has been built.

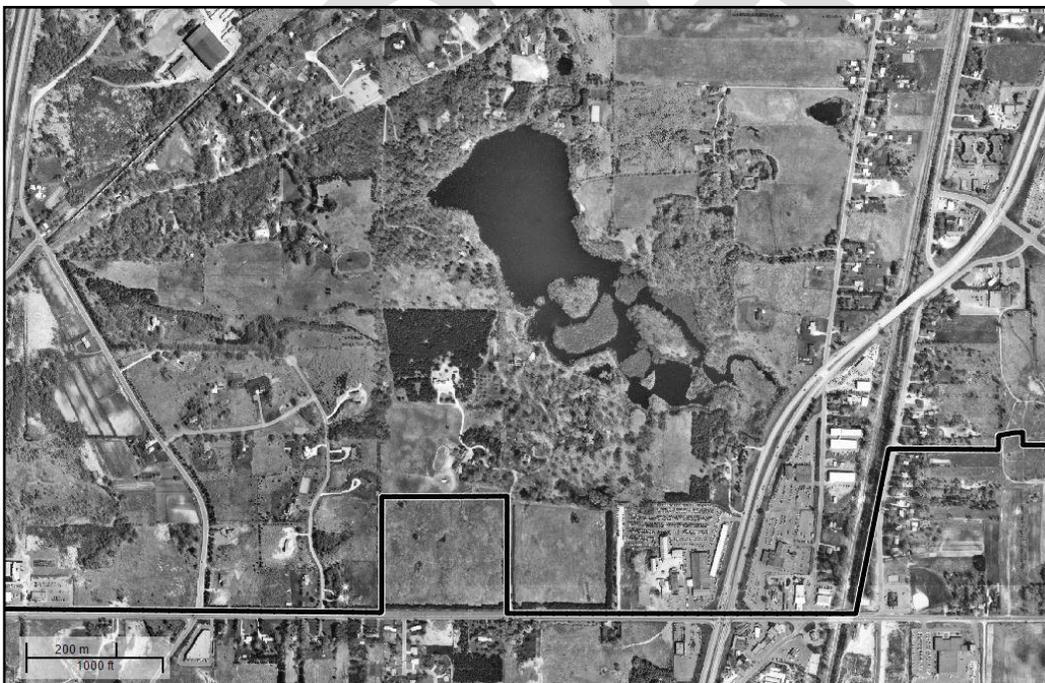
Figure 5: 1985 Aerial photo of Gem Lake

In 1985, more development has occurred in the area, especially between Scheuneman Road and the railroad tracks. Additionally, the residential developments around Daniels Farm Road and Big Fox Road are starting to show up.

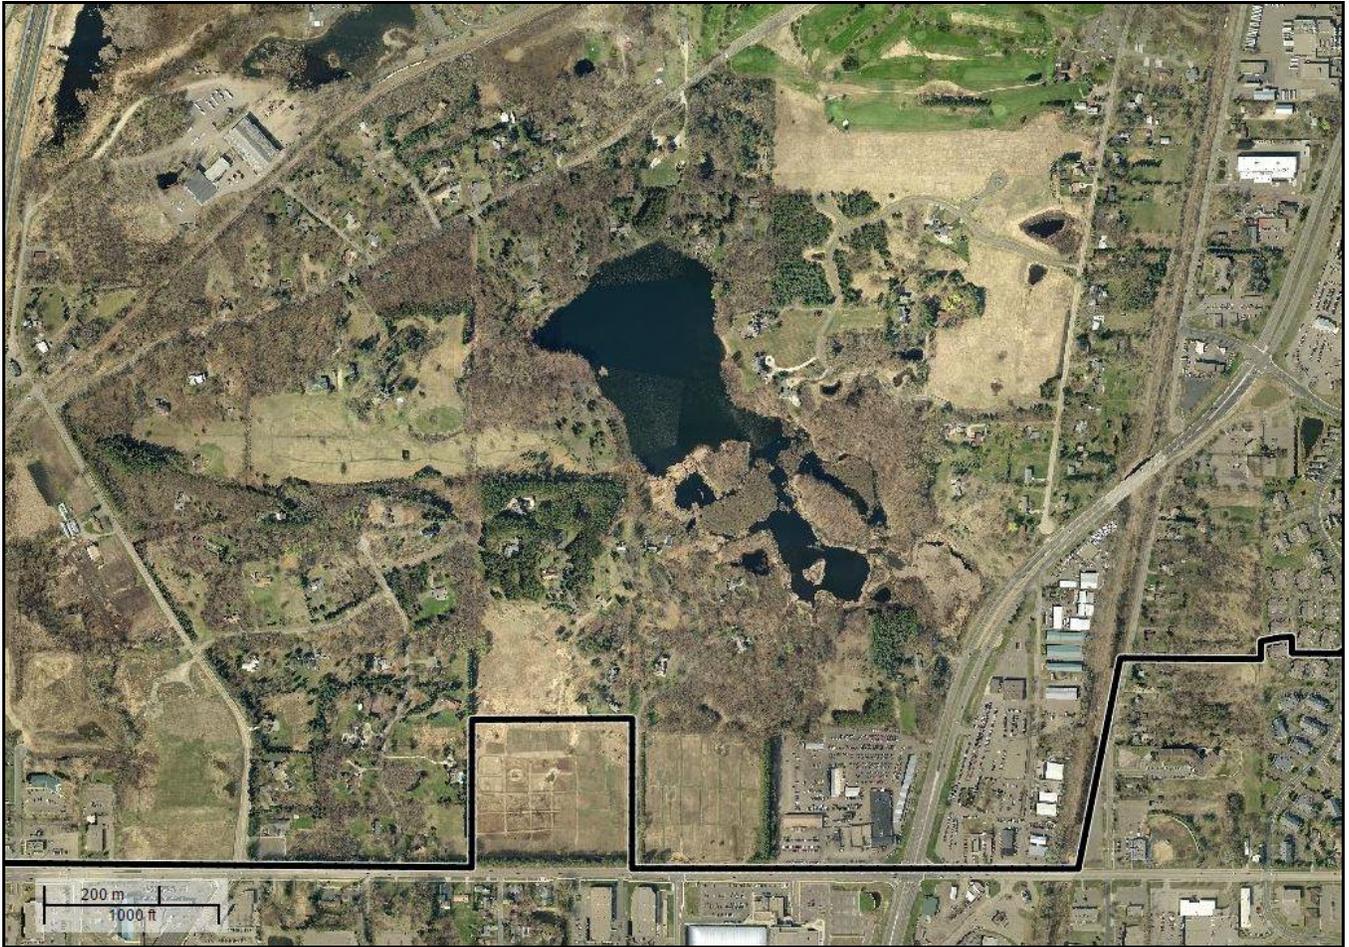
Figure 7: 2012 Aerial photo of Gem Lake

By 2012, there are more homes in the Hillary Farm area. More homes are planned for the Hillary Farm development.

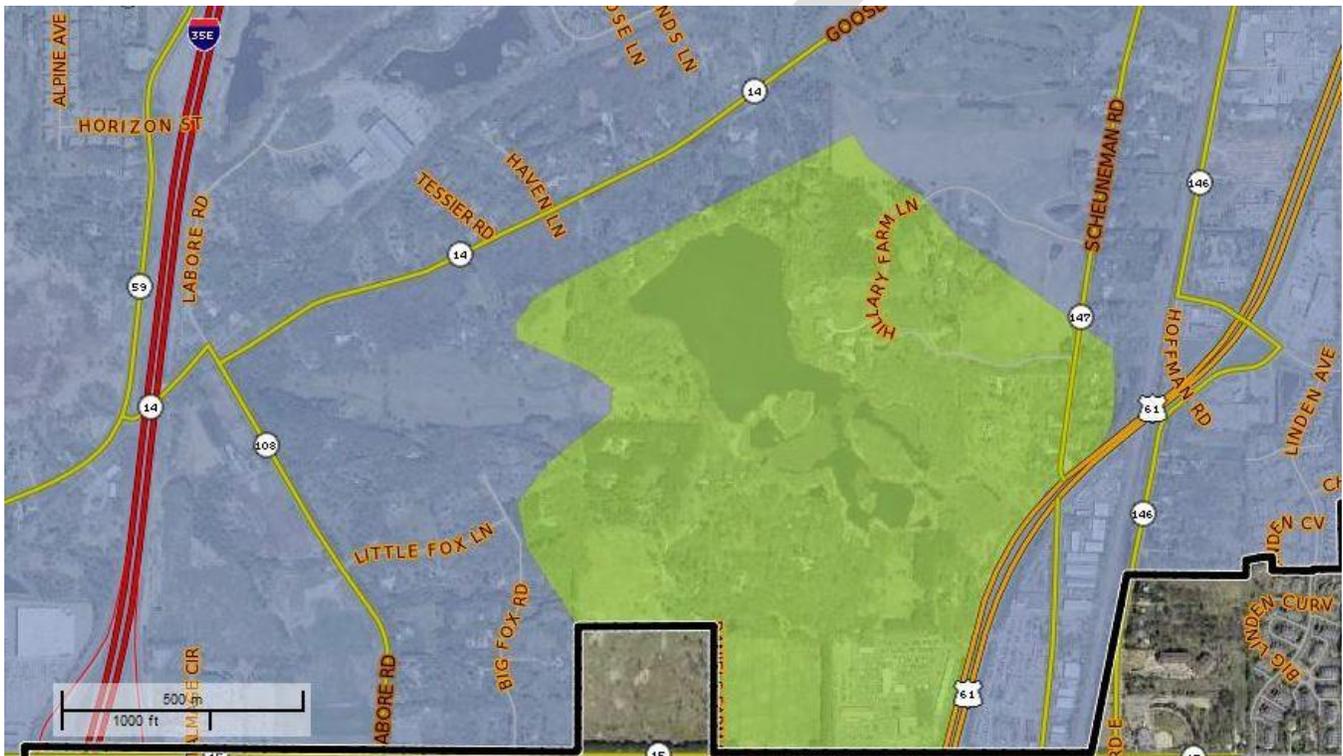
Figure 8: Gem Lake Subwatershed

Gem receives water from various sources. The subwatershed is shown in the green area of the map below and is 306 acres in size. The subwatershed area is about 15 times larger than the surface area of the lake. This is relatively small for a subwatershed. A positive aspect of a small subwatershed area is that there is not a lot of land contributing to stormwater runoff into the lake. The land use within the subwatershed is primarily undeveloped or residential. A large source of possible stormwater runoff comes from Highway 61. Gem Lake is slightly unusual in that water doesn't flow out of the subwatershed area. Gem Lake is the end point of stormwater runoff for this area and doesn't outflow into another part of the watershed. That means all stormwater runoff must be filtered and infiltrated within the subwatershed rather than moving on to another waterbody.

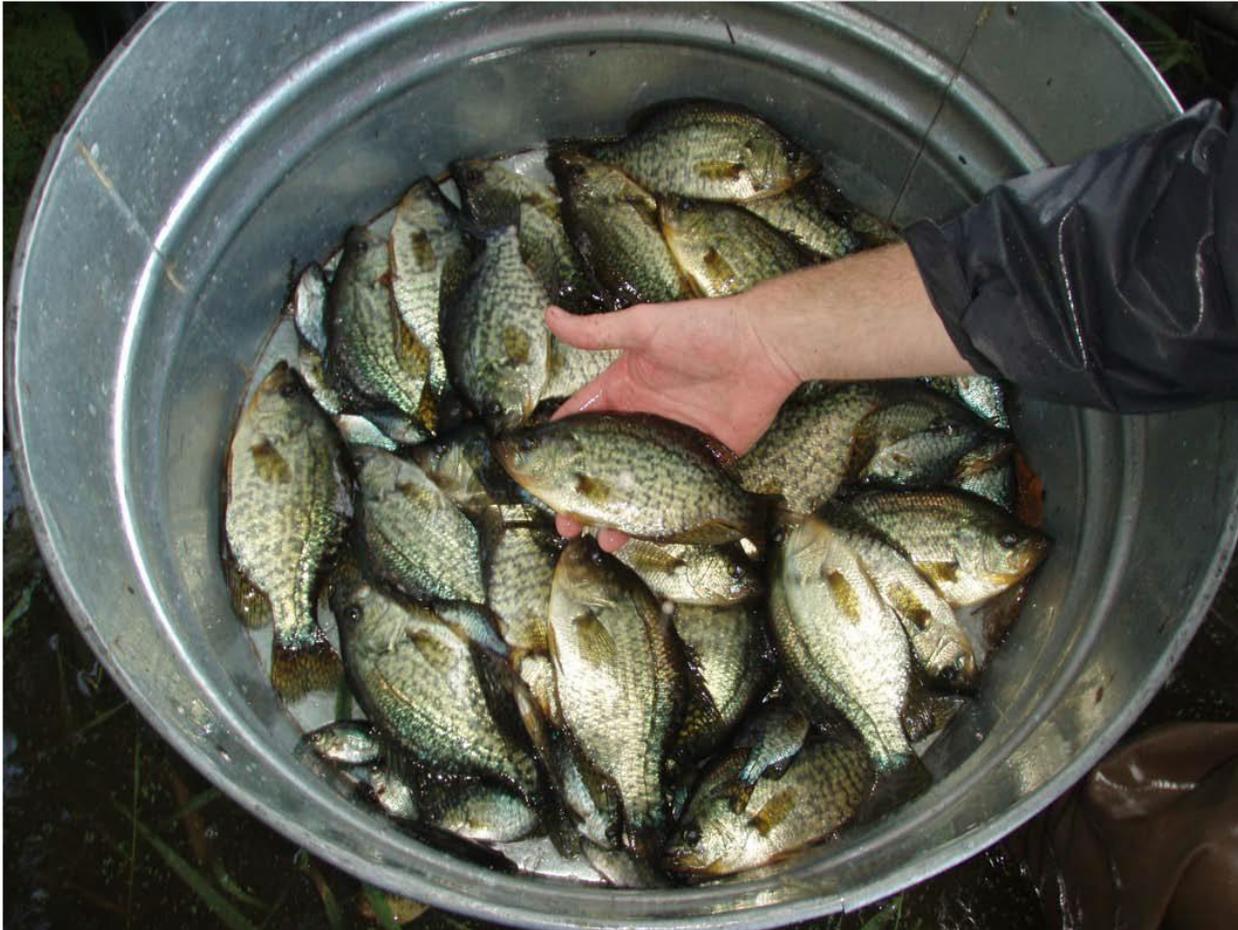
Crappies from Gem Lake, September 2011

Blue Water Science was hired to conduct a fish survey in September 2011. The report is attached as Appendix C. The survey found that the lake had a healthy supply of black crappies. The report concluded that Gem Lake is susceptible to winter fish kills and that if the lake were to experience another fish kill, the crappies would be eliminated and minnows would be the dominant species. Since Gem Lake is land locked, there is no opportunity for fish to migrate naturally. The report also stated that it is not recommended that fish be stocked unless a winter aeration system is installed since the fish would all be lost with a winter kill. Installation of an aeration system was discouraged because the lake is in a natural setting and letting nature take its course is a good management strategy for a lake like Gem which is more conducive to wildlife rather than a recreational fishery.

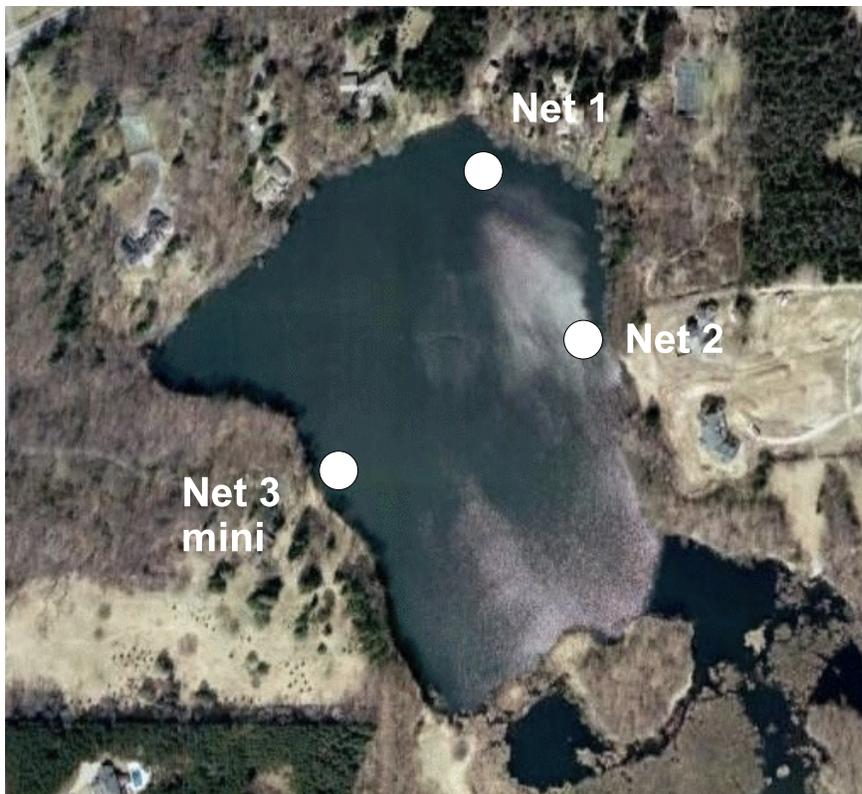
Figure 1. Map of trapnet locations in Gem Lake.

Two standard trapnets and one mini-trapnet were used for two days for a total of four standard lifts and two mini-trapnet lifts to survey fish in Gem Lake. The standard trapnet was a MnDNR-style with a 4 x 6 feet square frame with two funnel mouth openings and 50-foot lead. Net mesh size was 3/8 inch. The mini-trapnet was a MnDNR-style with a 2 x 3 feet square frame with one funnel mouth opening and a 25-foot lead. Net mesh size was 1/8 inch. The trapnets were set on Monday morning September 26, 2011. The nets were fished for the following 2 days (September 27 and 28). Trapnet locations are shown in Figure 1 and pictures of a typical trapnet are shown in Figures 2 and 3.

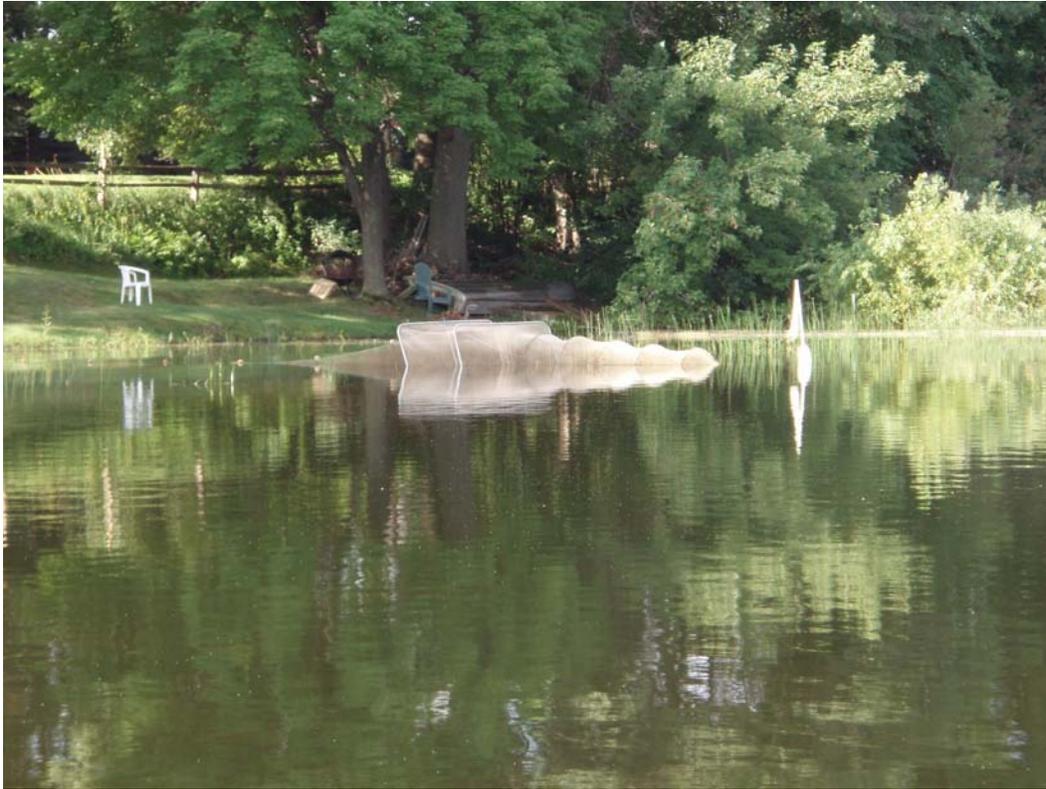
Figure 2. A trapnet is a live fish trap. Fish run into the 50-foot lead net and follow it back through a series of hoops with funnel mouths. Fish end up in the back hoop. The flag marks the end of the back hoop.

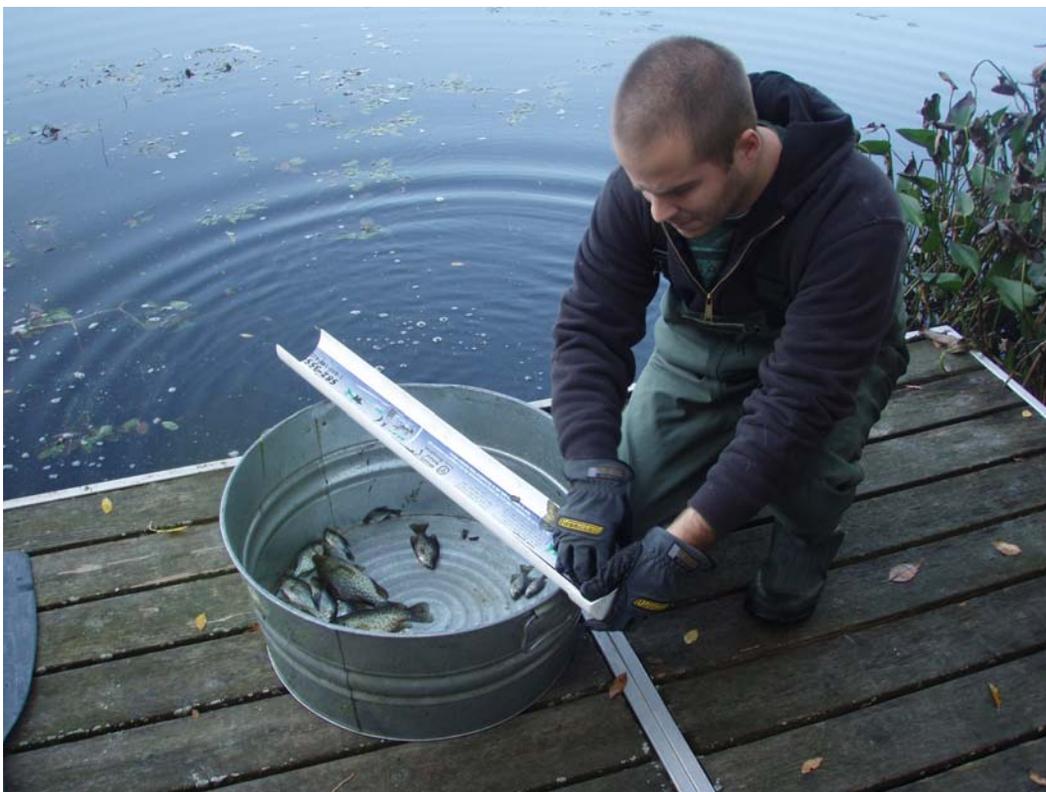
Figure 3. Fish are transferred to tubs, then they are counted and measured and released.

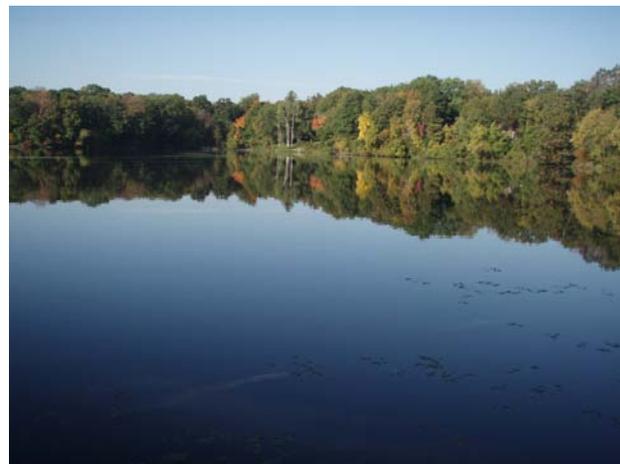
Figure 4. [left] Gem Lake is shallow and prone to winterkill events. [right] Much of the Gem Lake shoreline is lined with natural vegetation.

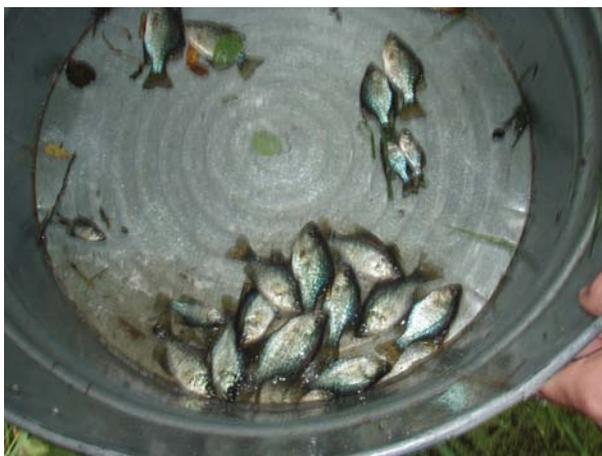
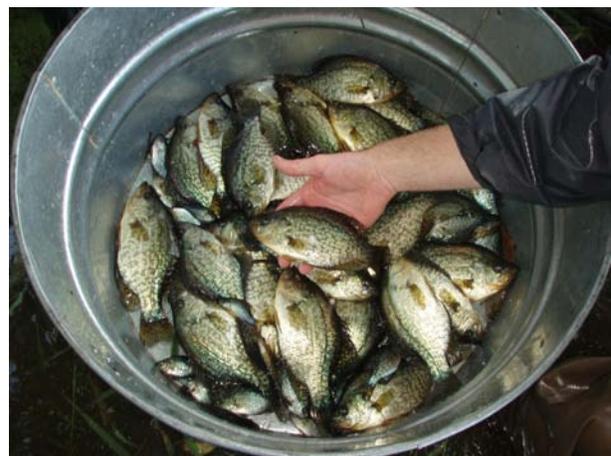
Figure 5. [left] Smaller sized black crappies. [right] Normal size distribution of black crappies from a standard fyke net.

Although black crappies were the only species, there were at least a couple of year classes present.

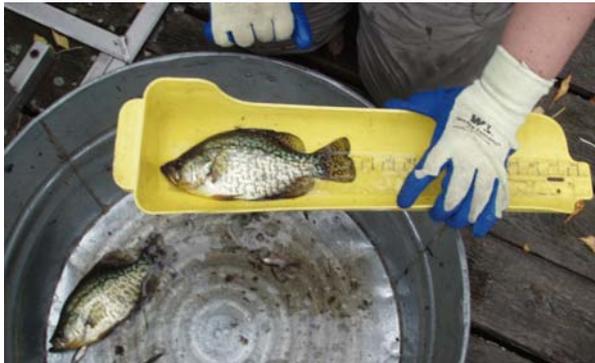
Several year classes of crappies were observed in Gem Lake including many in the 8-9 inch range.

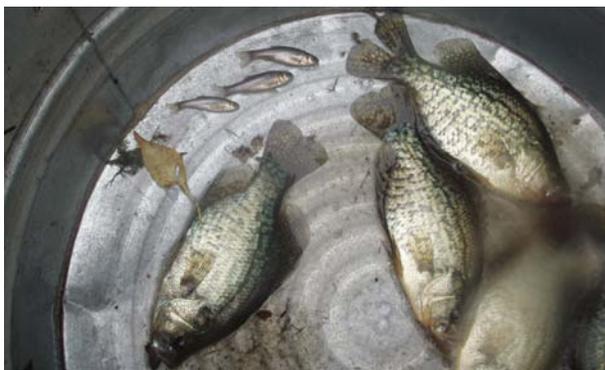
Fathead minnows and crappies from a mini-trapnet.

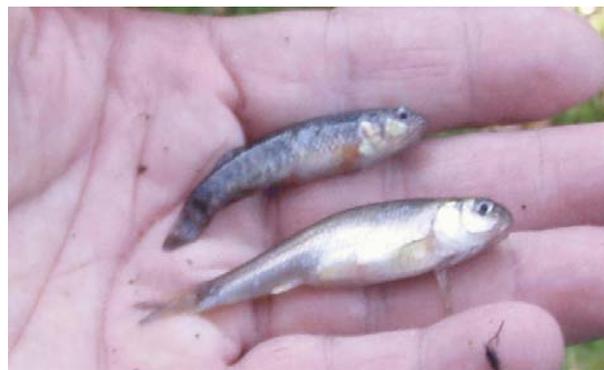
Mudminnow were present, but in low numbers. Mudminnow is shown on top and a fathead minnow is on the bottom.
