# BIRCH LAKE

## QUICK FACTS

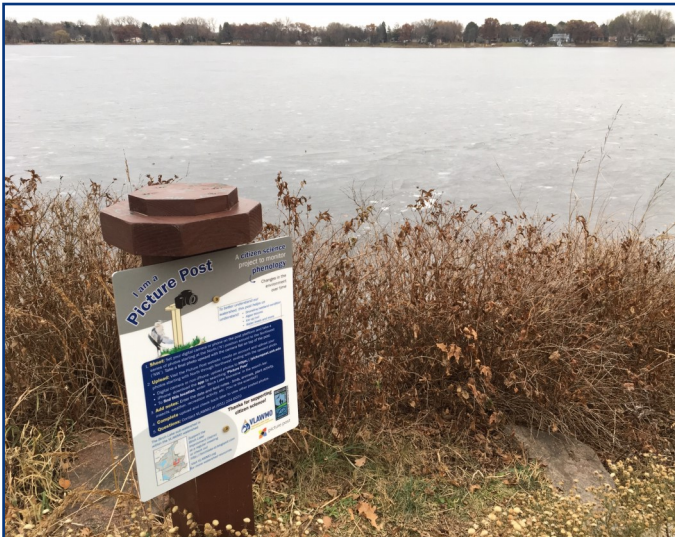
Levels of phosphorus (TP) and chlorophyll-a (ChlA) are well below state standards, which is a rare occurrence for such an urbanized water body. TP and ChlA have had a slight down trend in the last 16 years. The financial support and volunteer time from the BLID plays a large role in maintaining the

Birch Lake	2019	Clear		Moderately Clear		Green		Very Green	
		Oligotrophic		Mesotrophic		Eutrophic		Hypereutrophic	
		20	30	40	50	60	70	80	
Trophic State Index (TSI): Overall									
TSI Transparency: Secchi Disk									
TSI Chlorophyll A: ChlA									
TSI Total Phosphorus: TP
