VLAWMO

VADNAIS LAKE AREA WATER MANAGEMENT ORGANIZATION
Sustainable Lake Management Report
Sucker and East Vadnais Lakes, Ramsey County, MN

VLAWMO SUSTAINABLE LAKE MANAGEMENT REPORT (SLMR): SUCKER AND EAST VADNAIS LAKES, MONTH 2021

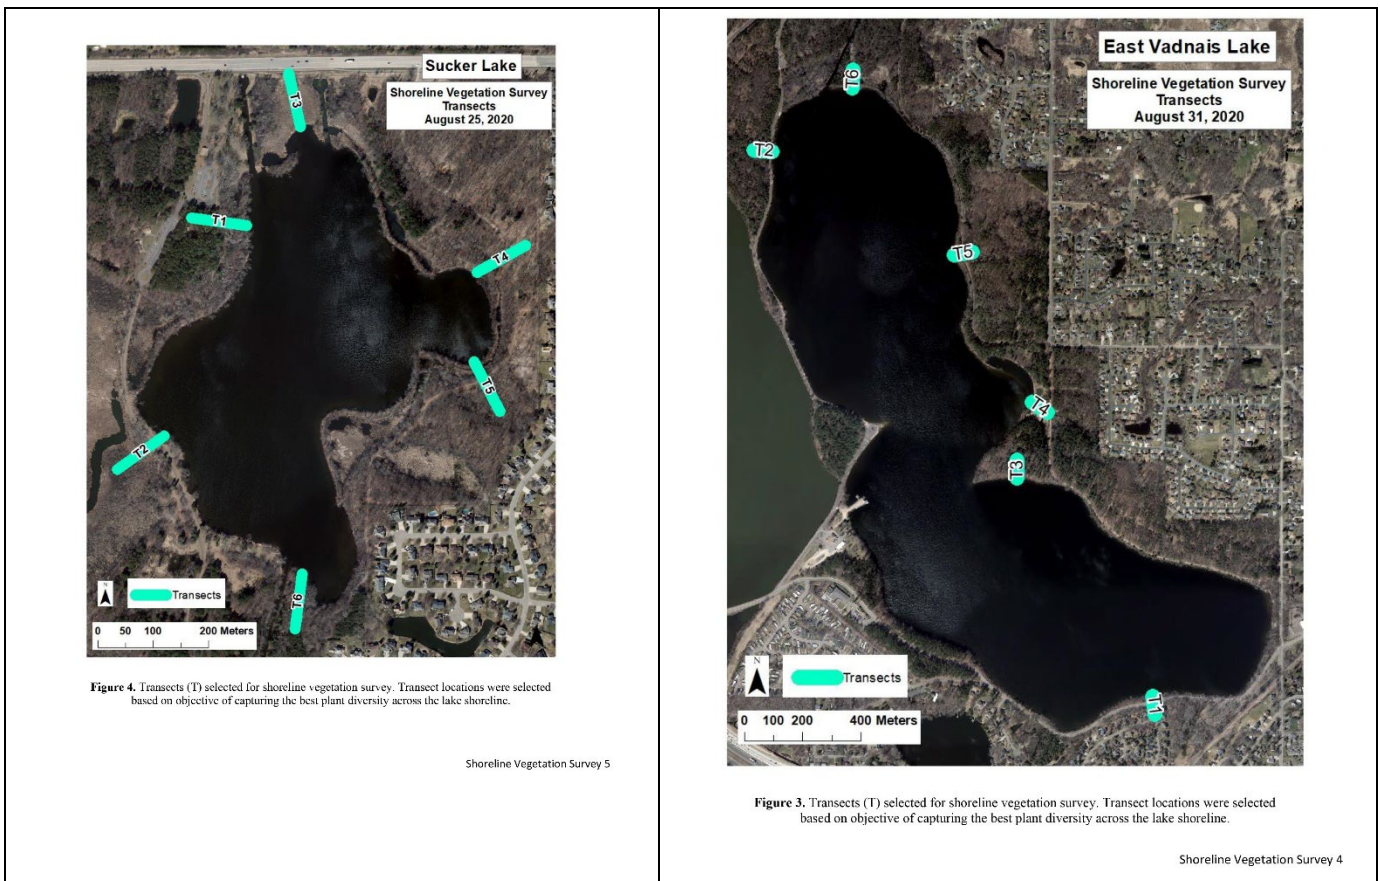
Figure 18: Sucker and East Vadnais Lakes Transect Locations

A shoreline survey was conducted by RCSWCD and VLAWMO staff for Sucker Lake on August 25, 2020, and for East Vadnais Lake on August 31, 2020. The full shoreline vegetation reports are available on the VLAWMO website. A synopsis is included here.

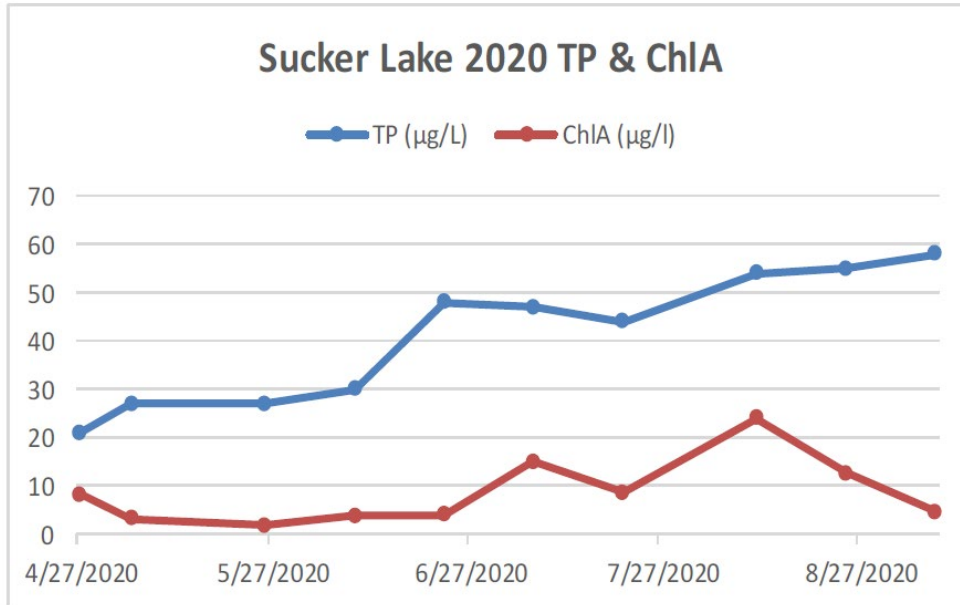
Figure 31: Water Quality Trends in Sucker Lake

VLAWMO has collected water quality (WQ) data on Sucker Lake only since 2019 and on East Vadnais Lake since 2020. SPRWS has more long-term monitoring for these lakes. VLAWMO staff collects WQ data and water samples biweekly, May-September, for water clarity (secchi disk), nutrients (TP, Chl-a, SRP, nitrogens), and chemistry (temperature, conductivity, dissolved oxygen, and potential hydrogen [pH]). Total Phosphorus (TP) and Chlorophyll A (Chl-a) analyses are conducted by a contracted lab.

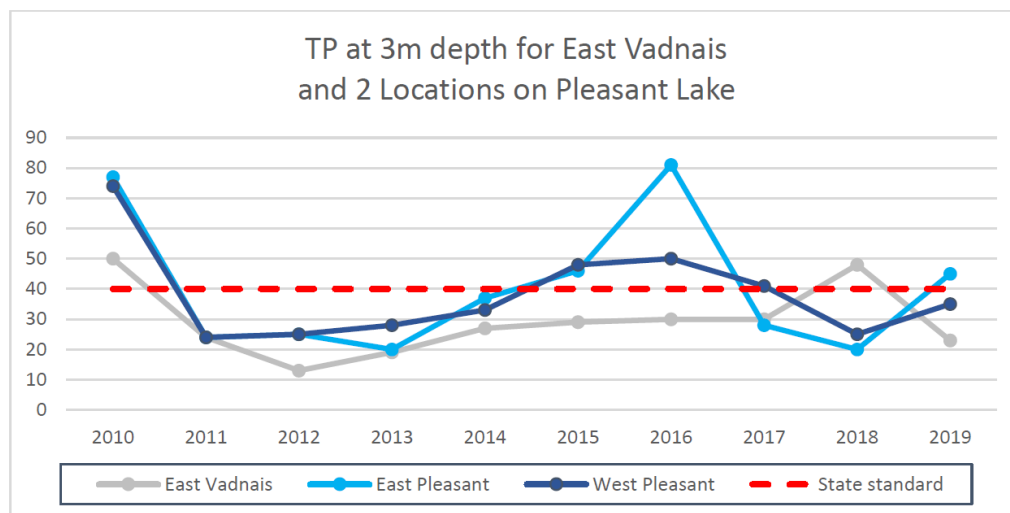
Figure 33: Total Phosphorus Comparison between East Vadnais Lake and Pleasant Lake

East, West Pleasant, and East Vadnais all exceeded the TP standard in 2010. In 2011, all 3 were below the standard. During 2015-2016, Pleasant Lake exceeded the standard. It was below the standard in 2017-2018, but appears to be approaching if not exceeding the standard as of 2019. East Vadnais has remained below the standard since 2010 except for 2018.

The spikes in 2016 at East Pleasant Lake and 2018 in East Vadnais are at first curious. Data are shown at 3 m. Data are also available at 13m. To decide if these data points might be outliers, we checked the TP level at 13 m. In both cases, that measurement was also high and provides evidence that these were not data-collection or lab-analysis errors but are accurate data points.

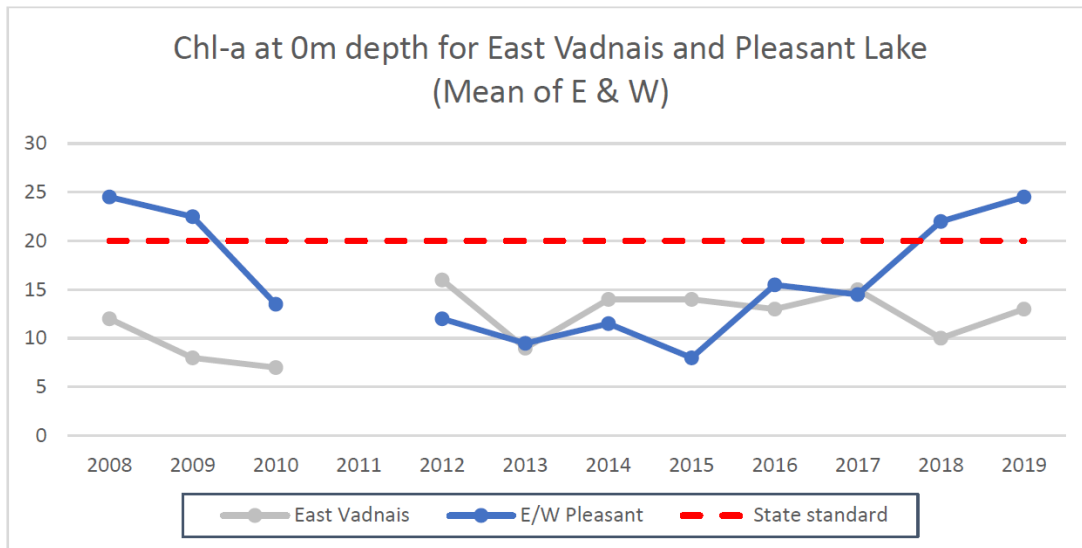
Figure 34: Chl-a in East Vadnais and Pleasant Lake

SPRWS treatment techniques changed over the course of the monitoring time period (2008-2019). Aeration systems (Hypolimnetic Aeration/HA) were in place on East Vadnais Lake from 1987-2010. There was a 1-year gap between when the HA system was stopped and the liquid oxygenation system (Hypolimnetic oxygenation/HO) began. The HO system has been running continuously at 2 locations on East Vadnais since it was installed. The 1-year gap on East Vadnais was 2010-2011. On Pleasant Lake, the gap was longer. It was 7 years, from 2006-2013. Pleasant Lake had HA in place from 1994-2006. HO began in 2 locations on the lake in 2013 and has been running continuously since, except for several days in Jan. and Feb. of 2019 when ice built up on the vaporizer.

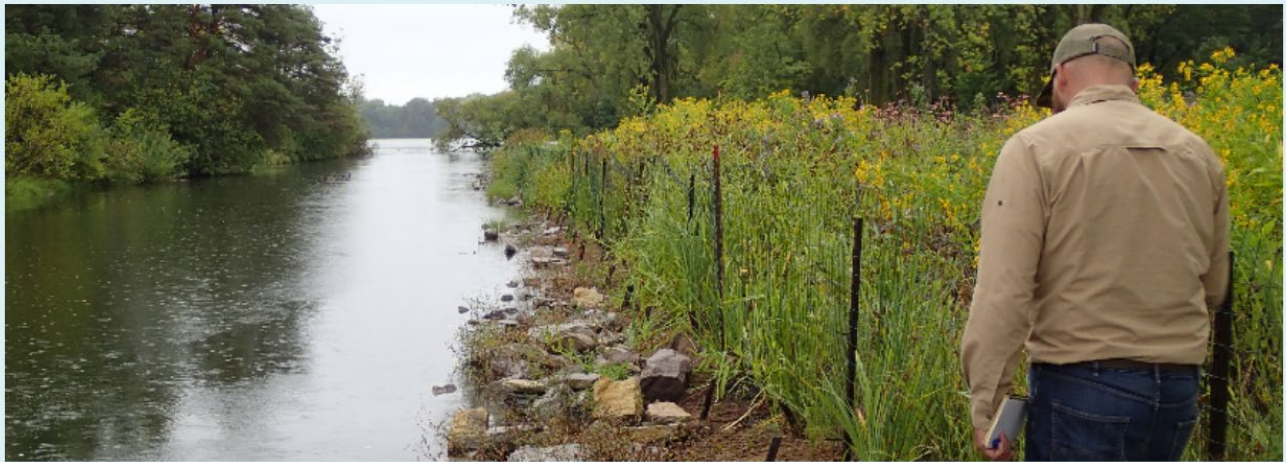
– Ramsey County – Restoring Sucker Channel

The shoreline of the Sucker Channel in northern Ramsey County is a heavily used fishing area. After decades of wear, the paved paths that lined the banks of the Channel were falling into the water and rainfall was washing pollutants into the Channel that serves as the City of St. Paul's drinking water supply. Ramsey County Parks Soil and Water Conservation Division worked with the Vadnais Lakes Area Watershed Management Organization to stabilize the shoreline, provide a vegetated buffer for rainwater, and create pollinator habitat with flowering native plants. Ongoing monitoring and maintenance will ensure the continued success of this project's multiple benefits.

A restoration was completed in 2018 to upgrade and stabilize Sucker Channel at Sucker Lake. The project was a joint restoration effort between VLAWMO, Ramsey County Parks, Ramsey Soil and Water Conservation Division, and SPRWS. The channel between Pleasant and Sucker lakes, south of Co. Hwy. 96 is highly visible and in a well-used section of the Vadnais-Sucker Regional Park. It was in poor condition and in need of restoration.
