# **Sustainable Lake Management Plan Birch Lake**

**Prepared by Blue Water Science & the  
Vadnais Lake Area Water Management Organization  
In Partnership with the Birch Lake Improvement District**

**2007 – 2008  
(Revised May 2009)**

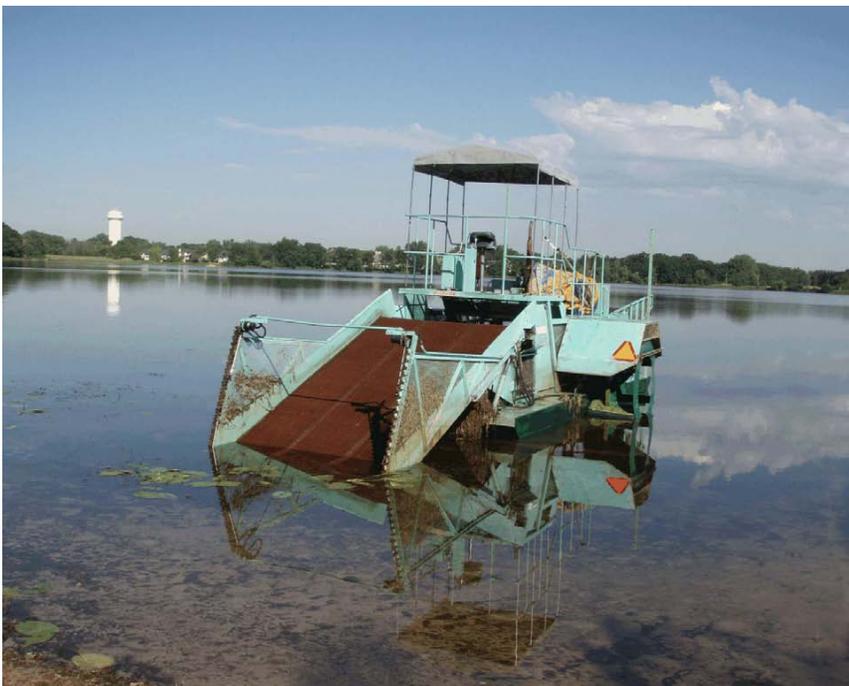
A variety of options are available for managing dense aquatic plant growth. Manual methods, such as weed rakes, can be used to create a channel and remove plants at the same time. Mechanical harvesting is a better option for large projects.

The harvesting option should continue to open channels about 20-30 feet wide through the surface matted growth which allows unrestricted navigation and should not harm the lake. Mechanical harvesters pick up most of the plants that are cut.

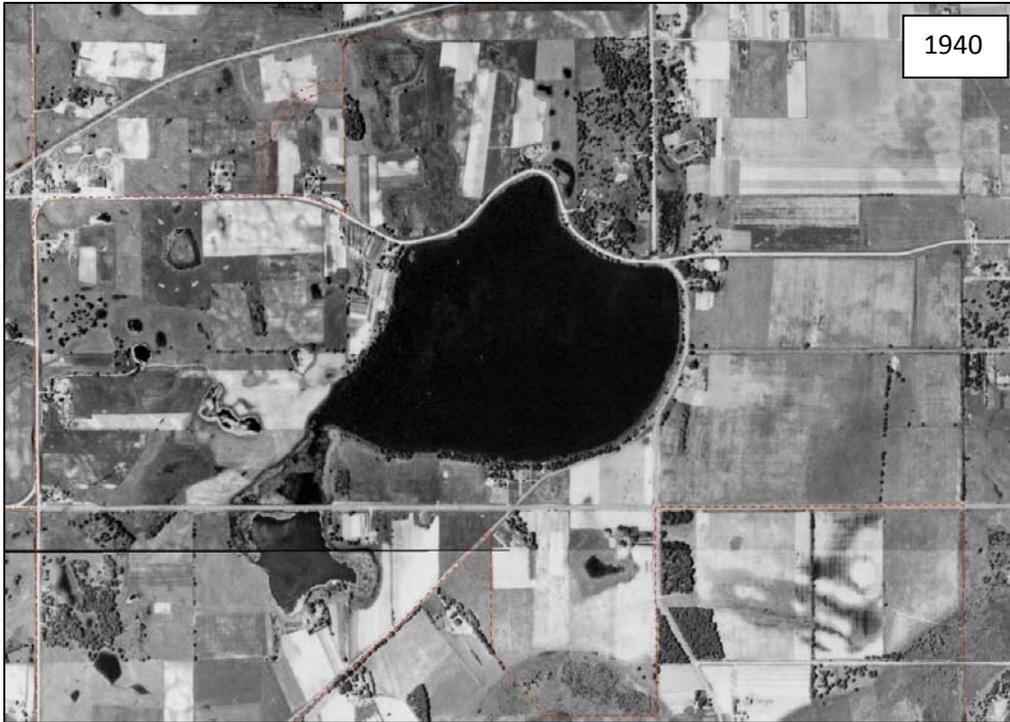
Aerial photos from Ramsey County show that the land surrounding Birch Lake was largely agricultural in 1940. The road that is now Highway 96 was already in place and it appears that the water in the bay on the northern side of the highway had quite a bit of vegetation in it.

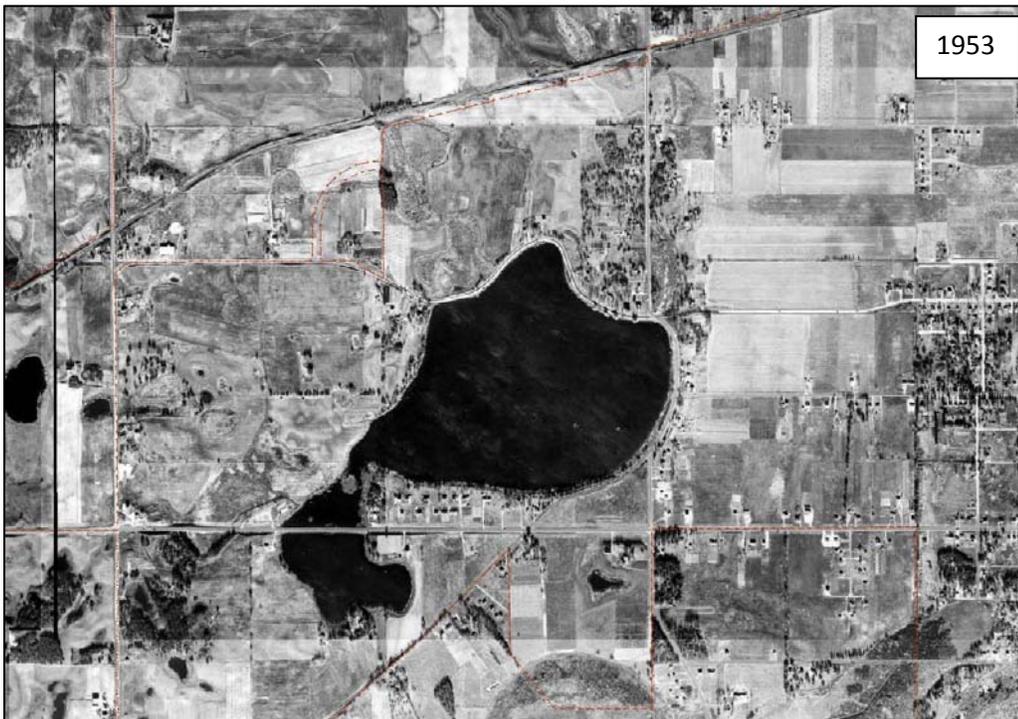
By 1953, residential development is showing up around the lake and the water on both sides of Highway 96 is more cleared of vegetation.

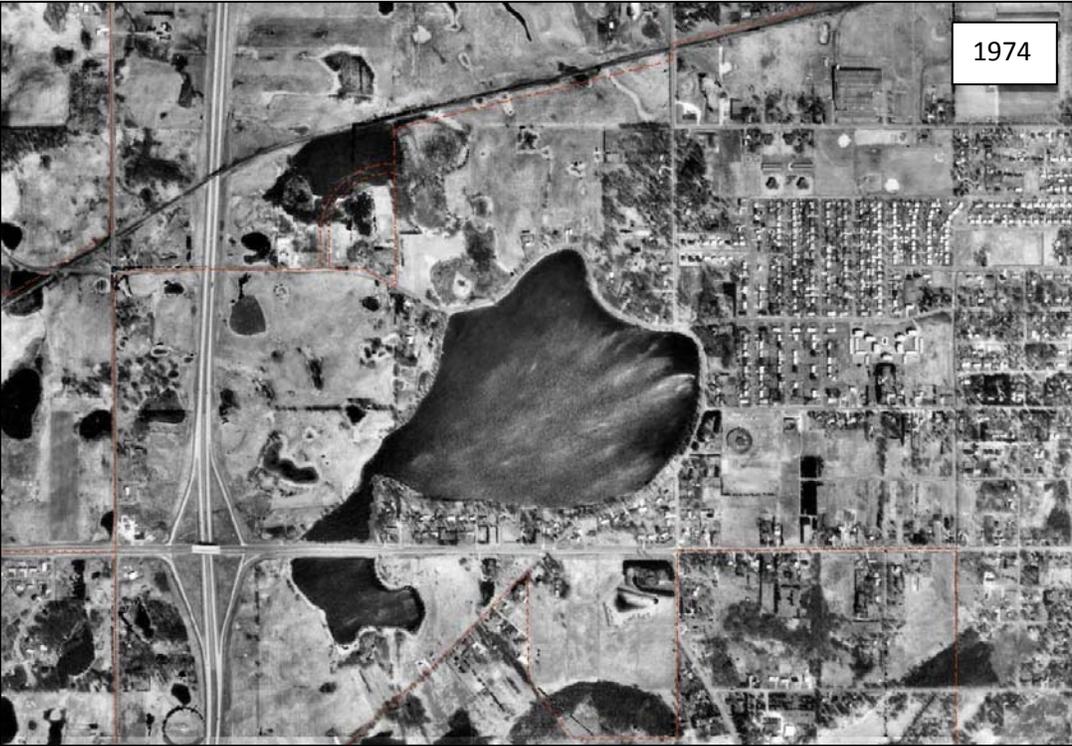
By 1974, Interstate 35E has been built and development east of Birch Lake has increased.

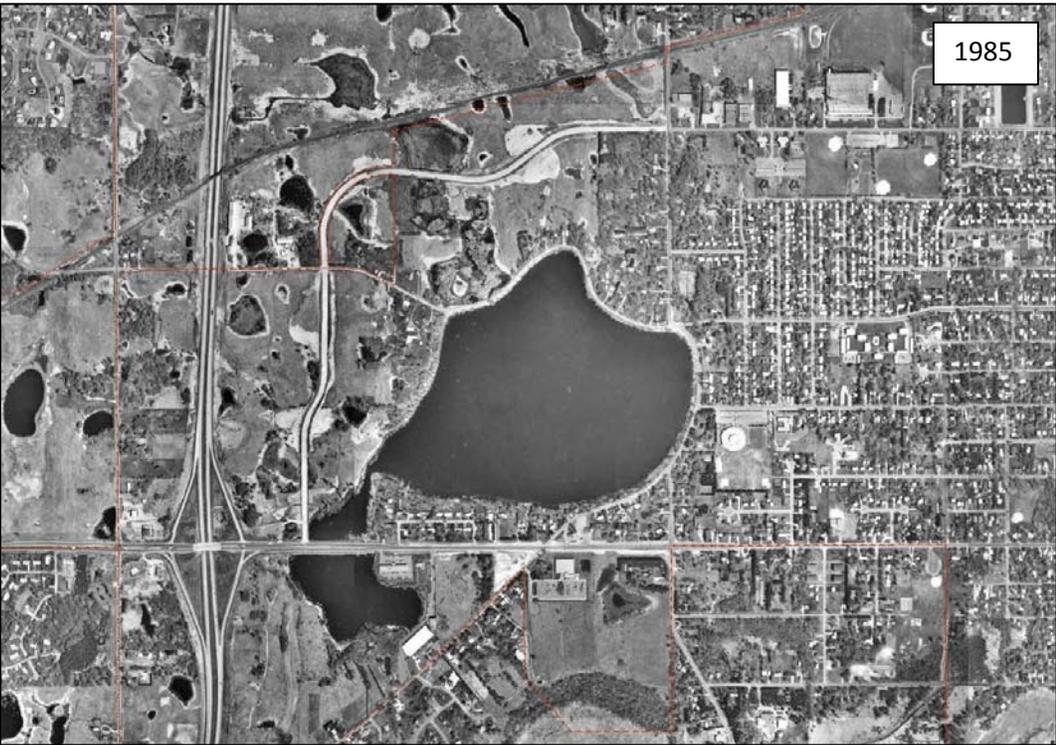
By 1985, White Bear Parkway has been constructed and residential development has continued to grow east of Birch Lake as well as commercial development on the southern side.

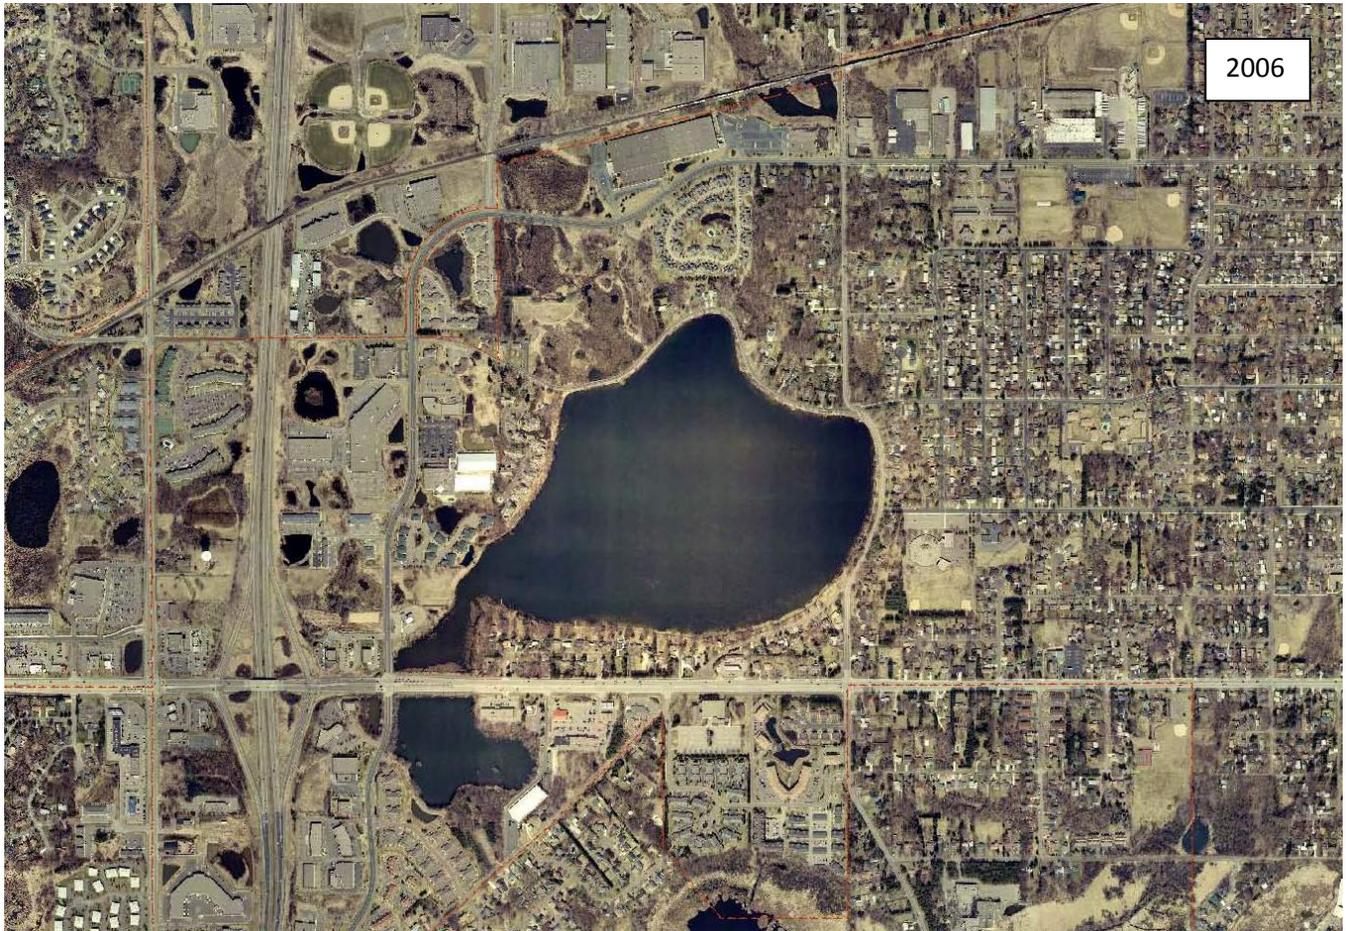
The 2006 aerial photo above shows the area as it currently exists. Commercial development has been built west and south of the lake along with townhome developments on the western and northern sides. The area is basically fully developed. White Bear Parkway has been extended to cross Highway 96 and it cuts through a portion of the southern basin of Birch Lake (hereinafter referred to as Little Birch).

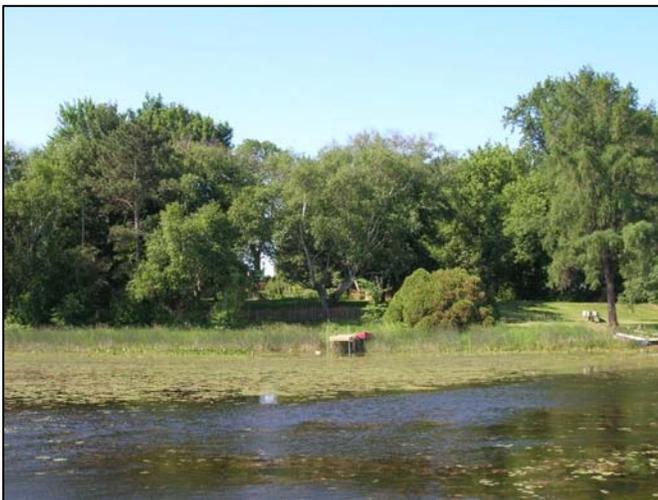
Figure 5: Example of a Birch Lake shoreline parcel. This parcel was rated as having good natural conditions.

Approximately half of the properties around Birch Lake were considered naturalized. The other properties were largely lawn all the way to the shore. There were signs of shoreline erosion on the northern and eastern sides of Birch Lake. Shoreline erosion causes soil to rush into the lake and is an indicator of the health of a lake. Nineteen of the properties that are cleared to the shore were determined to have good potential for restoration to a more natural shoreline. By creating a buffer of natural vegetation along the shoreline, there will be more filtering of chemicals from lawns and roads before it reaches the water. Homeowners on Birch Lake should be encouraged to implement these types of landscaping projects with a goal of increasing the amount of naturalized shoreline by 5% each year until 75% of the shoreline is natural. Education, grants and design assistance are available through VLAWMO and RCD to help homeowners with these projects.

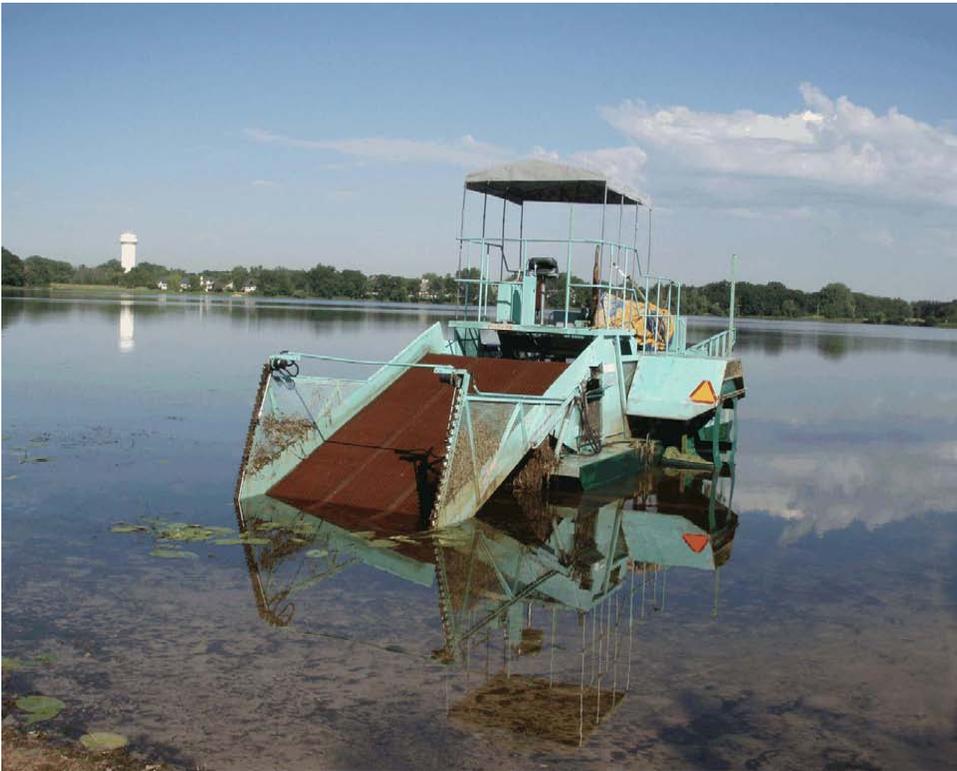
Figure 12: A mechanical harvester used in Birch Lake
