BIRCH LAKE

QUICK FACTS

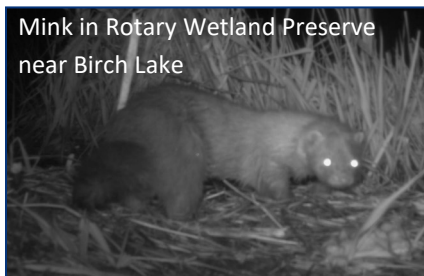
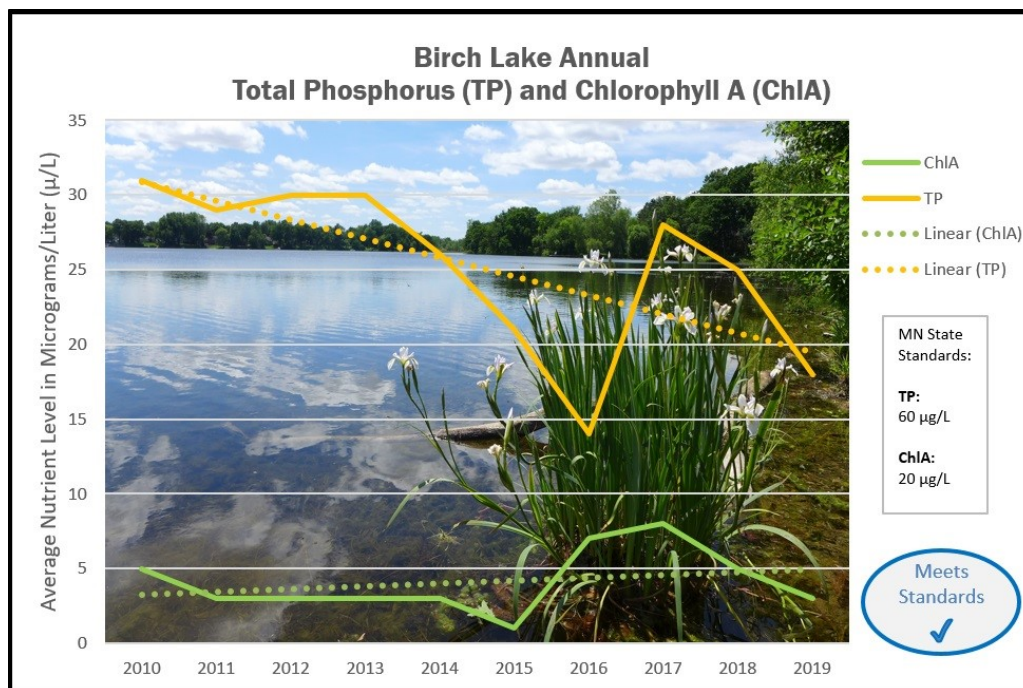
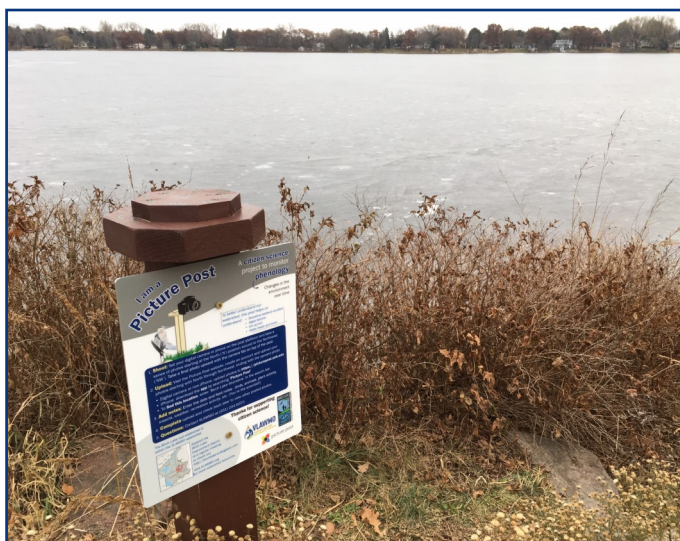
NUTRIENT SUMMARY:

Phosphorus (TP) and Chlorophyll-a (ChIA) are well below State standards and have shown a slight downward trend in the last 16 years. Financial support and volunteer time from the BLID plays an important role

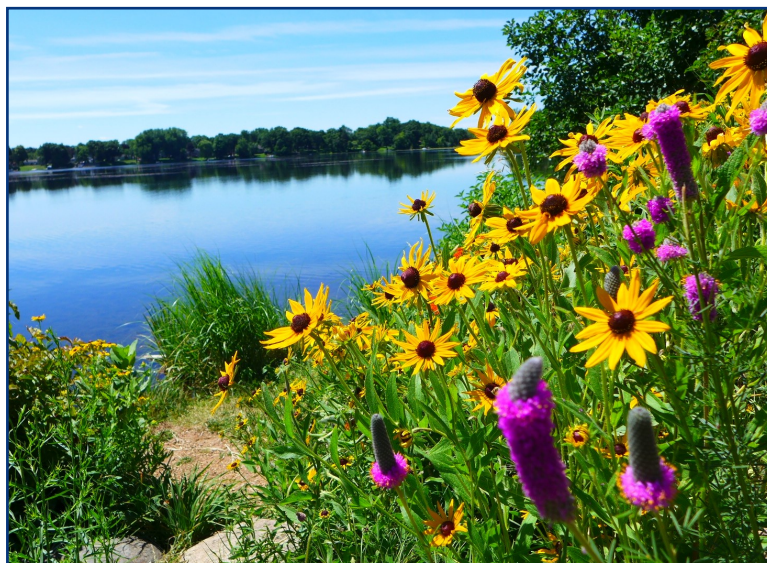
PROJECT SUCCESS:

Birch Lake has received 1 large shoreline restoration, 9 residential shore restorations, and 1 raingarden. Each project was supported by VLAWMO's cost-share program. The large restoration on the North side of the lake, spans 850 feet of shoreline. It included hundreds of native plants and an access path. A partnership between the City of White Bear Lake, the BLID, and VLAWMO supports annual maintenance and monitoring. In 2020, an iron-enhanced-sand filter was installed to reduce nutrients flowing into the lake. An adjacent habitat restoration occurred with support from MN DNR Conservation Partners Legacy funds to provide optimal filter function.
