History of WHITAKER POND

Subwatershed Size 640 acres
Average Depth 1 ft

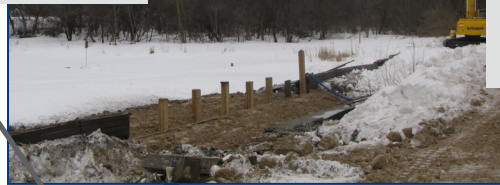
Weir #2 Install: 2010

Bags of sand/iron material were installed within a new weir. With Lambert Creek being impaired for high nutrients, this measure strived to reduce levels.

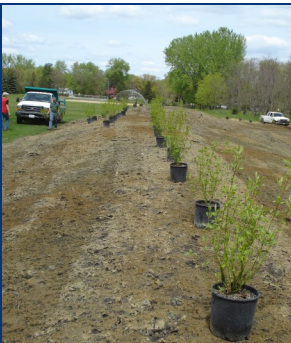
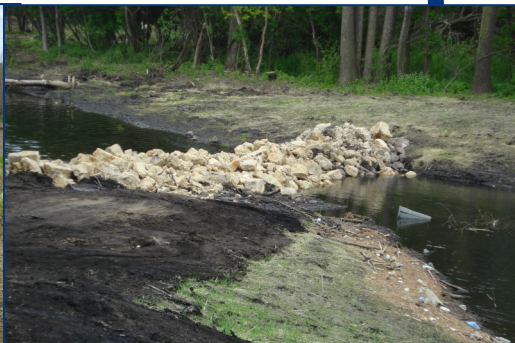
Forebay Construction: 2010

A forebay was built upstream from the main pond to provide a space for sediment to settle out. This reduces sedimentation in Lambert Creek and makes maintenance easier than in the main pond. Reinforcements were installed along the banks in 2011.

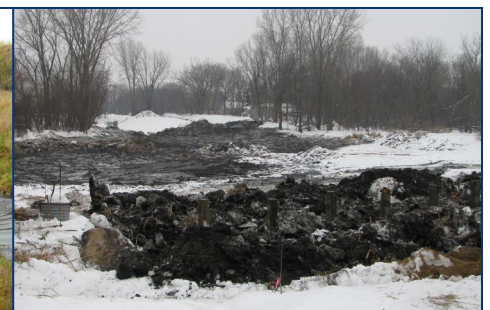
Dredging: 2015

Dredging took place in the main pond in 2010, and in the forebay in 2015. In 2015 80 cubic yards were removed, which was enough to fill 7 truck loads! The forebay is monitored each year by taking sediment core samples, and is dredged every few years to keep water storage optimal.

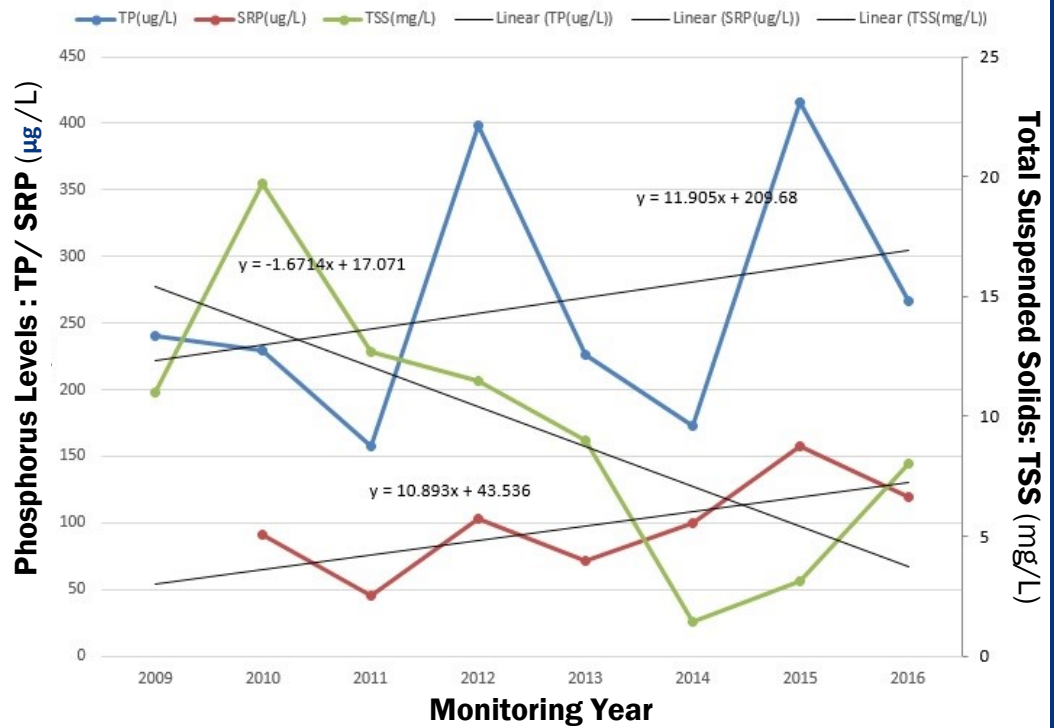
Whitaker Pond Historical Water Quality

The nature of the pond is dramatic, with high and low flashes depending on rainfall. Total Phosphorus (TP) and Soluble Reactive Phosphorus (SRP) levels show an increase. Sediment levels continually rise but drop when dredging occurs.
