**PROPERTY ACCESS AGREEMENT
VADNAIS LAKE AREA WATER MANAGEMENT ORGANIZATION**

Tamarack and Wilkinson Lakes In-Lake Treatment Feasibility Study

Prepared for
Vadnais Lake Area Water Management Organization (VLAWMO)
and Ramsey County Soil and Water Conservation Division

November, 2023

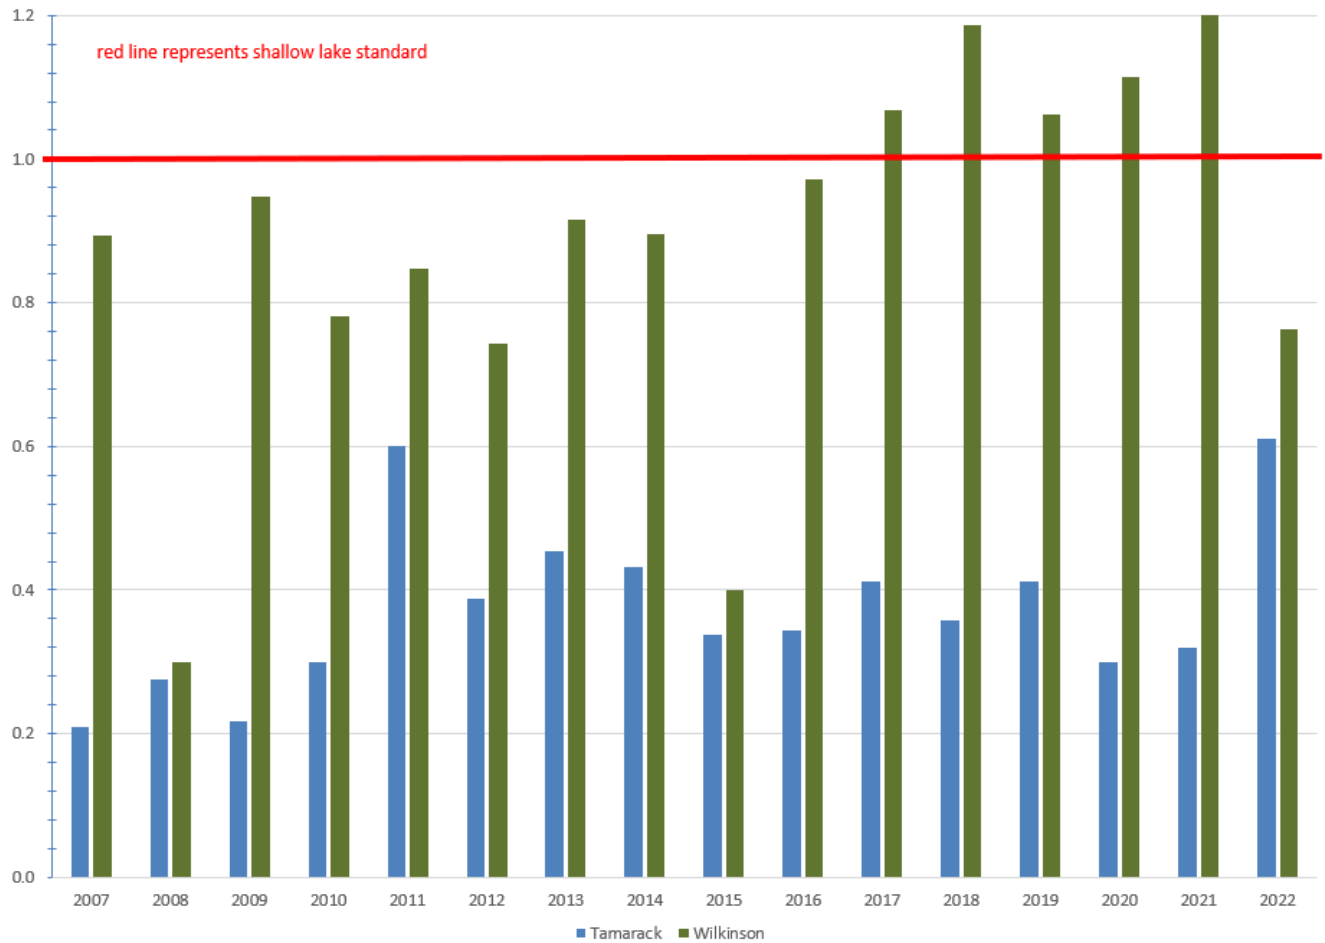
Figure 1-4 Summer Average (June-Sept.) Secchi Disc Transparency (meters) since 2007

Figure 1-4 shows that average summer Secchi disc transparency measurements were significantly worse in 2015, followed by a return to improved water quality in Wilkinson Lake between 2016 and 2021. Secchi disc transparency in Wilkinson Lake met the MPCA criteria every year between 2017 and 2021, which explains why the long-term average shown in Table 1-2 very nearly met the MPCA threshold.

While Tamarack Lake experienced its highest transparency in 2022, it remains 0.4 meters lower than MPCA threshold (see Figure 1-4) due to high algae growth and high phosphorus concentrations.

Figures 1-2, 1-3 and 1-4 show how the last ten years of average summer total phosphorus, chlorophyll-a and Secchi disc transparency, respectively, have varied for each lake. The first four years of the records shown in each figure represent the data used for the TMDL analyses of Wilkinson Lake. The monitoring data shows that both lakes have not been meeting any of the three shallow lake criteria during the period of record.

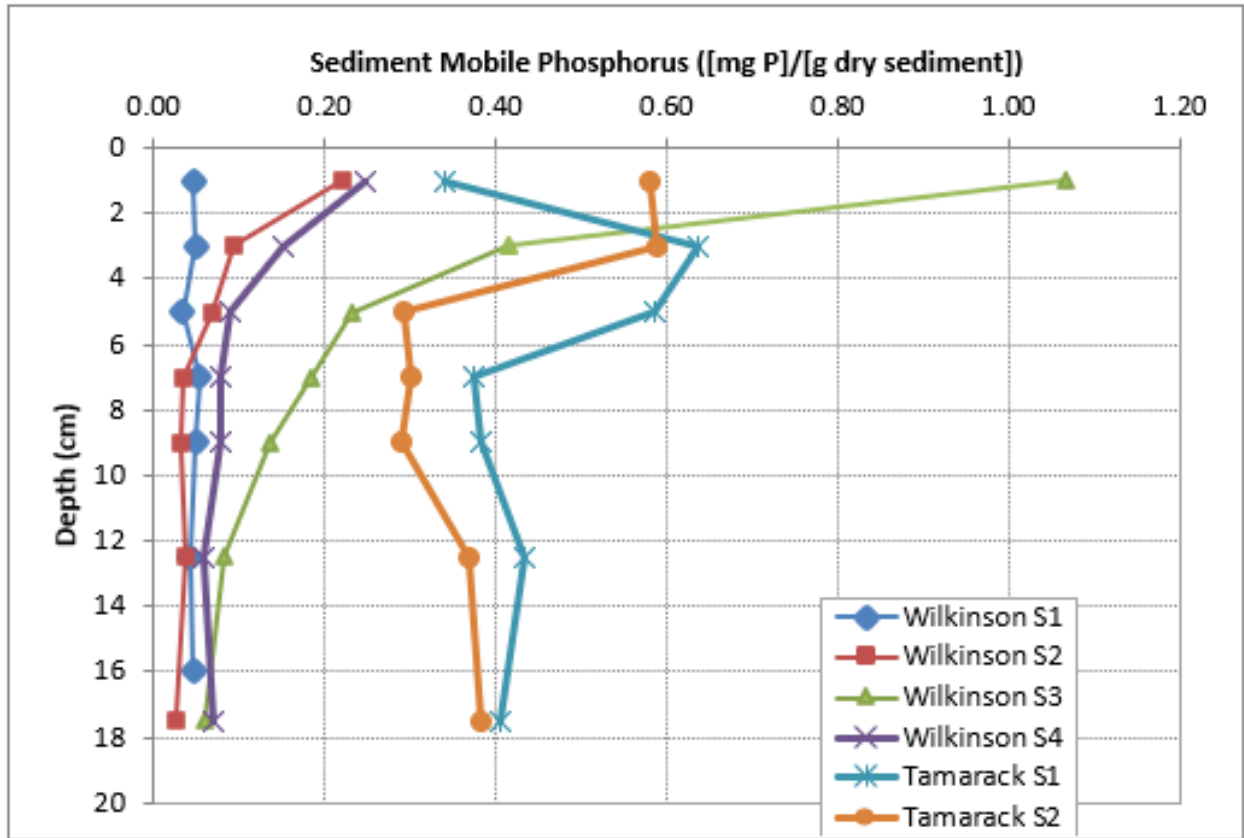
Figure 1-7 Results of Sediment Phosphorus Fractionations

In general, mobile phosphorus concentrations in the sediment of Tamarack and Wilkinson Lakes were slightly lower than the organic-P fraction, as shown in Figure 1-7, but sediment phosphorus levels were generally higher in the core section at the sediment-water interface. Phosphorus concentrations and physical characteristics were relatively similar among both cores taken from Tamarack Lake, which were elevated above the mobile phosphorus concentrations measured in the Wilkinson Lake cores. Sediment cores S1 and S2 in Wilkinson Lake were like one another, with lower mobile phosphorus concentrations (see Figure 1-7), while sediment cores S3 and S4 in Wilkinson Lake had significantly higher mobile phosphorus concentrations. Figure 1-6 shows that the locations of sediment cores S3 and S4 correspond with the slightly deeper water in Wilkinson Lake and the flow path from the south tributary to the lake outlet.

Since Wilkinson Lake sediment cores S1 and S2 had lower mobile phosphorus concentrations than sediment cores S3 and S4, and since the locations of sediment cores S3 and S4 correspond with the slightly deeper water and the flow path from the south tributary to the lake outlet, the Wilkinson Lake dosages were split into two treatment zones as shown in Figure 4-1. Table 4-1 shows the recommended alum and sodium aluminate dosages prescribed for each lake with split applications, including a breakdown of the treatment zone dosages for Wilkinson Lake.

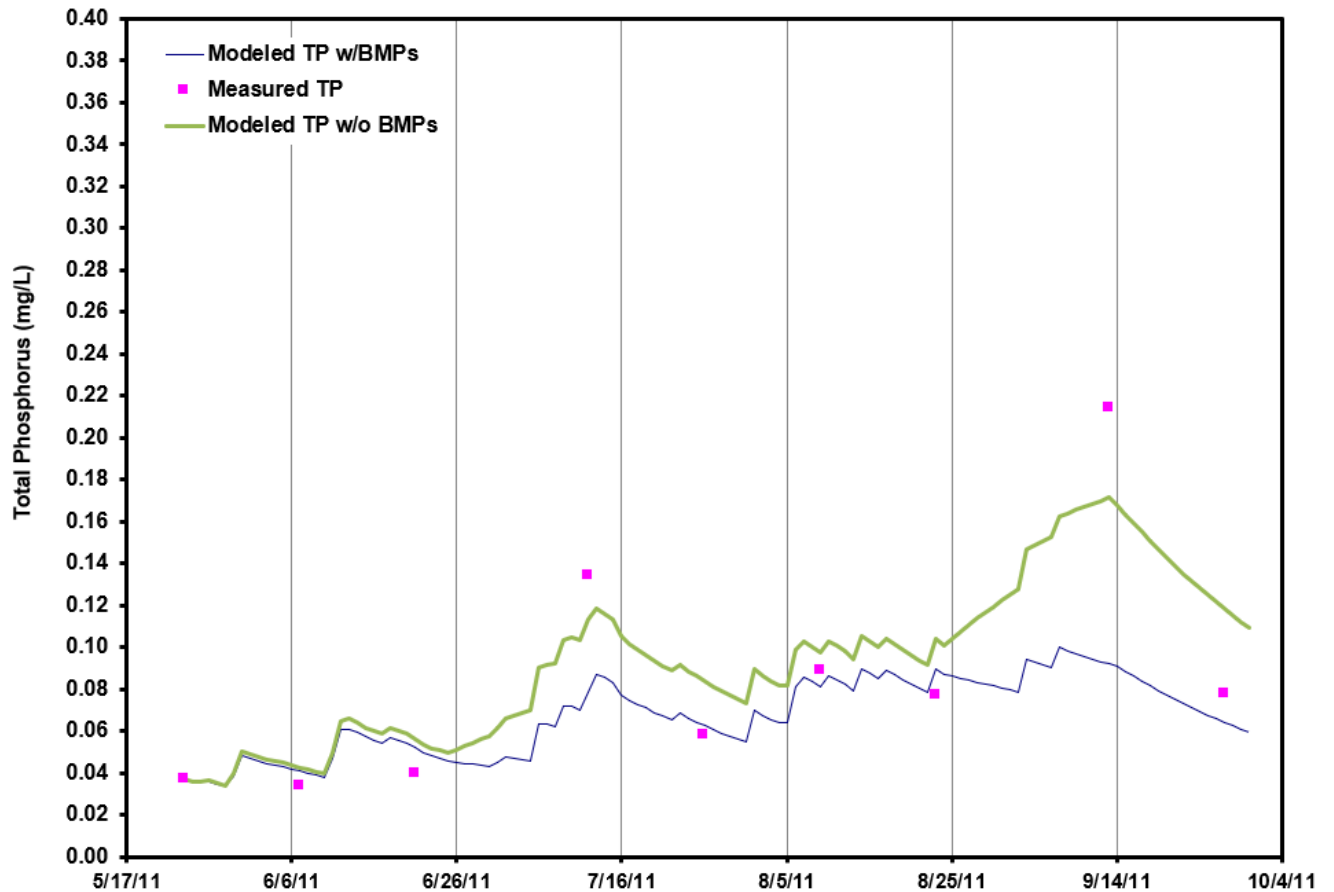
Figure 2-1 2011 Water Quality Modeling Results for Wilkinson Lake

Updated lake and watershed modeling was developed for this study and optimized to reproduce the observed water quality for each lake during the summer periods of interest. Figure 2-1 shows how the predicted and measured total phosphorus concentrations compare during the summer of 2011 for Wilkinson Lake without BMP implementation. Approximately 200 pounds of the overall phosphorus load was attributed to sediment phosphorus release during this time. The in-lake water quality modeling was used to show how implementation of the deep-water wetland restoration project (that is expected to remove 32.5 pounds of total phosphorus per year from the south tributary to Wilkinson Lake) and in-lake alum treatment would improve water quality during 2011. Figure 2-1 shows that the predicted phosphorus concentration in Wilkinson Lake would respond well to the implementation of the watershed BMP and an 80 percent reduction in internal load (like what would be expected following an in-lake alum treatment), or approximately 160 pounds per year of phosphorus.

The modeled summer average TP following BMP implementation shown in Figure 2-1 is 67 ug/L, but it should be noted that the results of these analyses are based on the same starting phosphorus concentration at the beginning of the summer. Over time, following full-scale BMP implementation or in-lake alum treatment, it is expected that the starting concentrations would be lower than what is shown at

the beginning of each summer season. Based on the results shown in Figure 2-1, this in turn, should ensure that an in-lake alum treatment combined with implementation of the deep-water wetland restoration project would maintain lake water quality at levels that are very close to the shallow lake standards.
