**VADNAISS LAKE AREA WATER MANAGEMENT ORGANIZATION  
Sustainable Lake Management Plan  
Birch Lake, Ramsey County, MN**

**Prepared by Dawn Tanner and Tyler Thompson  
March 2020**

## SUSTAINABLE LAKE MANAGEMENT PLAN – BIRCH LAKE

### MARCH 2020

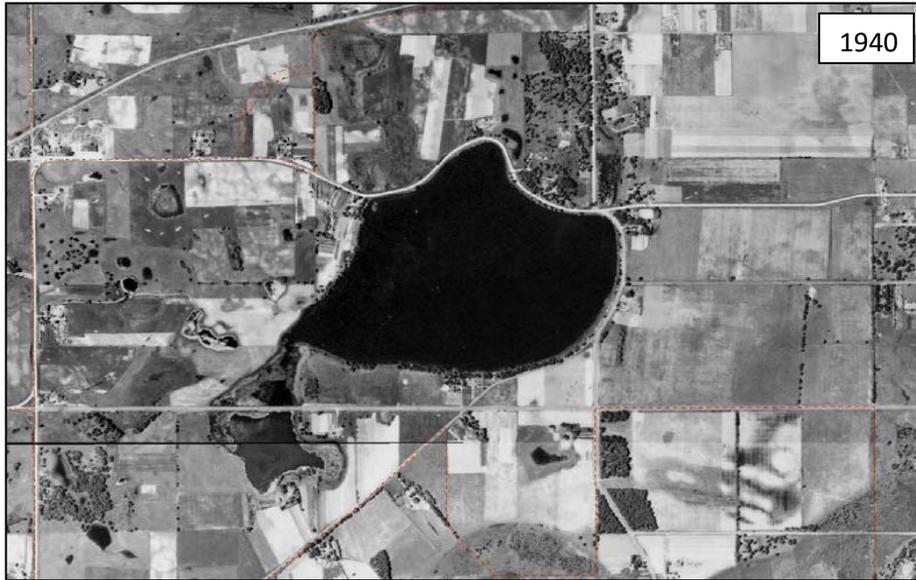
Figure 3: 1940 aerial photo of Birch Lake

In 1940, aerial photos from Ramsey County show that the land surrounding Birch Lake was largely agricultural, and the road that is now Highway 96 was in place to the south of Birch Lake.

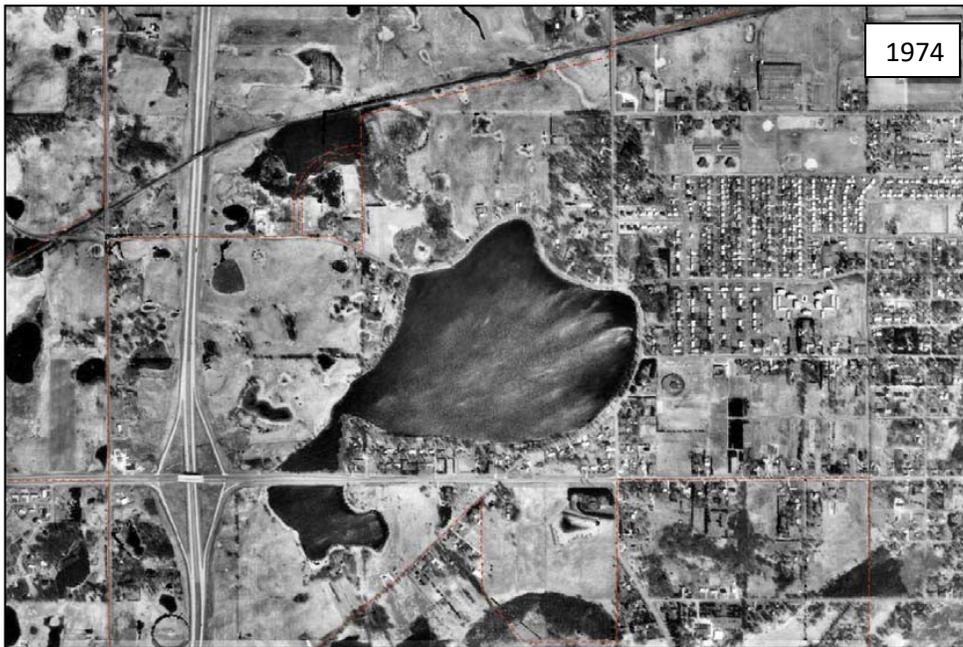
Figure 5: 1974 aerial photo of Birch Lake

By 1974, Interstate 35E is in place, and development east of Birch Lake has increased.

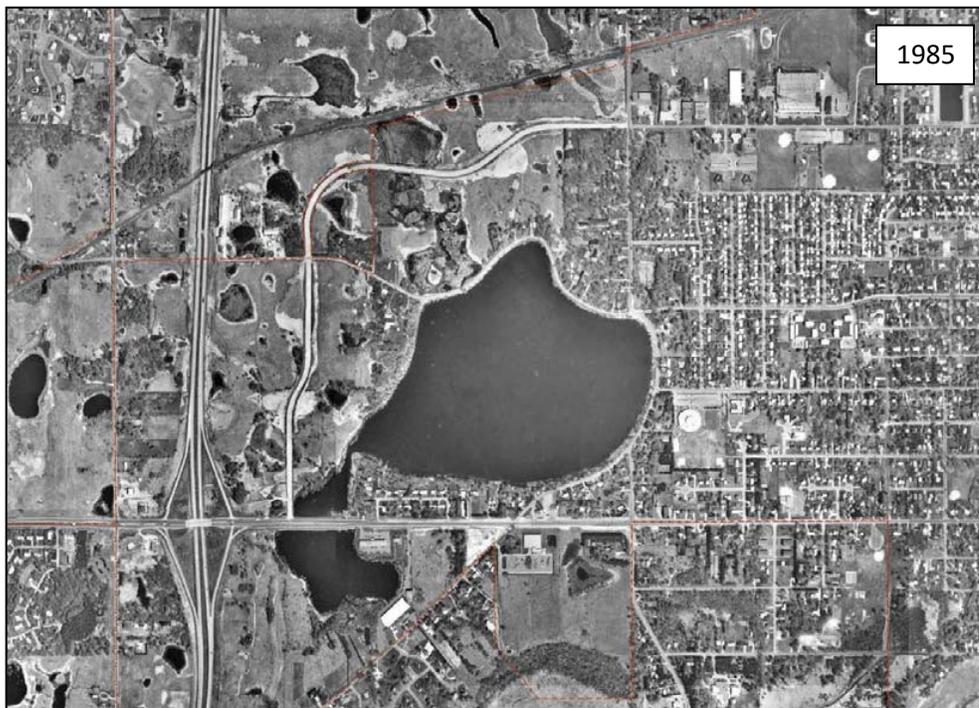
Figure 6: 1985 aerial photo of Birch Lake

By 1985, White Bear Parkway is constructed, and residential development has continued to grow east of Birch Lake as well as commercial development on the south.

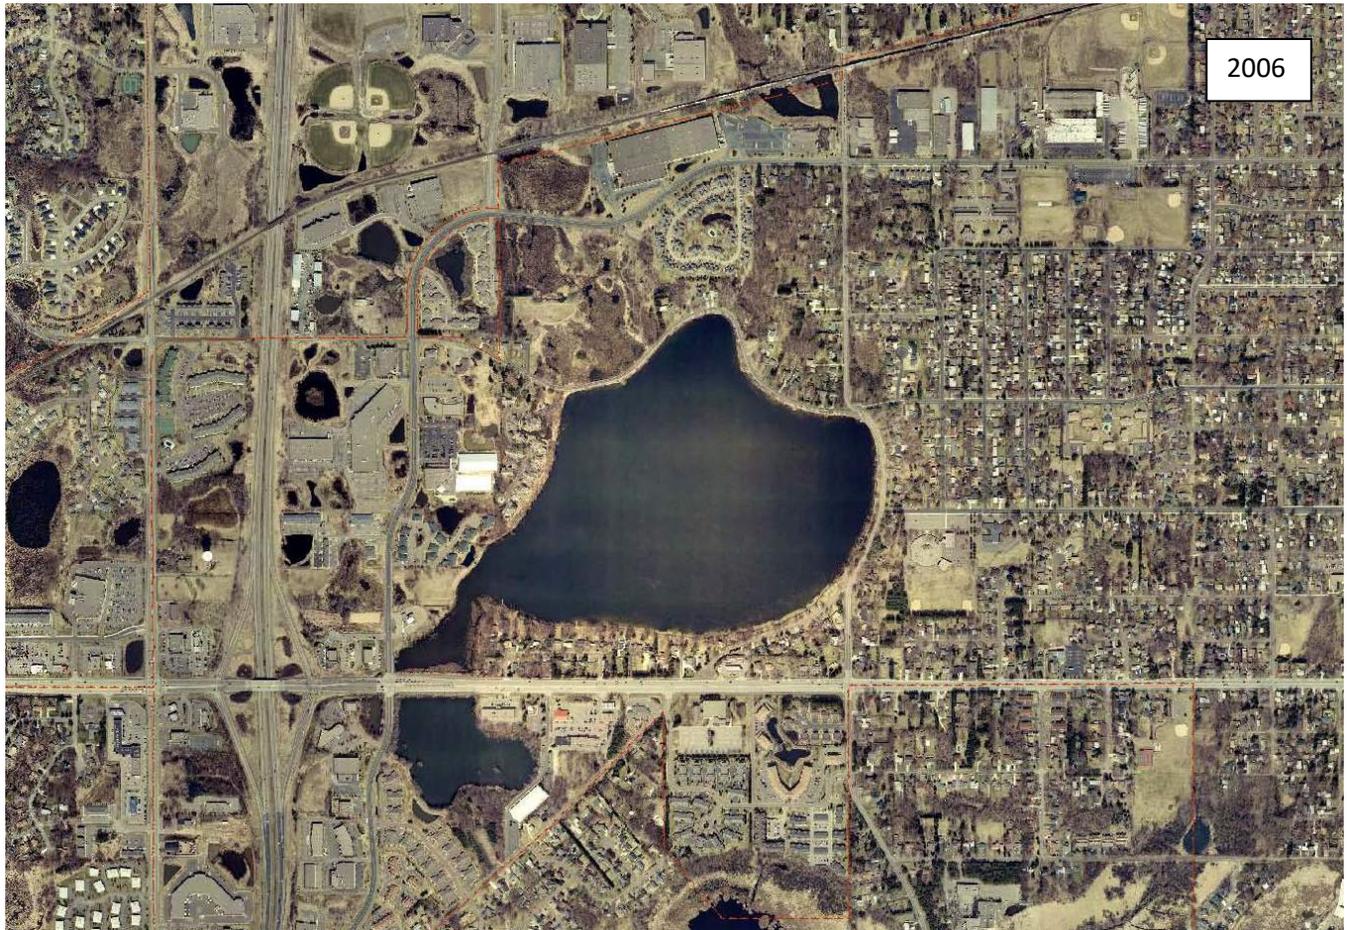
Figure 7: 2006 aerial photo of Birch Lake

The 2006 aerial photo shows that commercial development has been built west and south of the lake along with townhome developments on the sides to the west and north. White Bear Parkway has been extended to cross Highway 96. It cuts through a portion of the southern basin of Birch Lake (colloquially known as Little Birch).

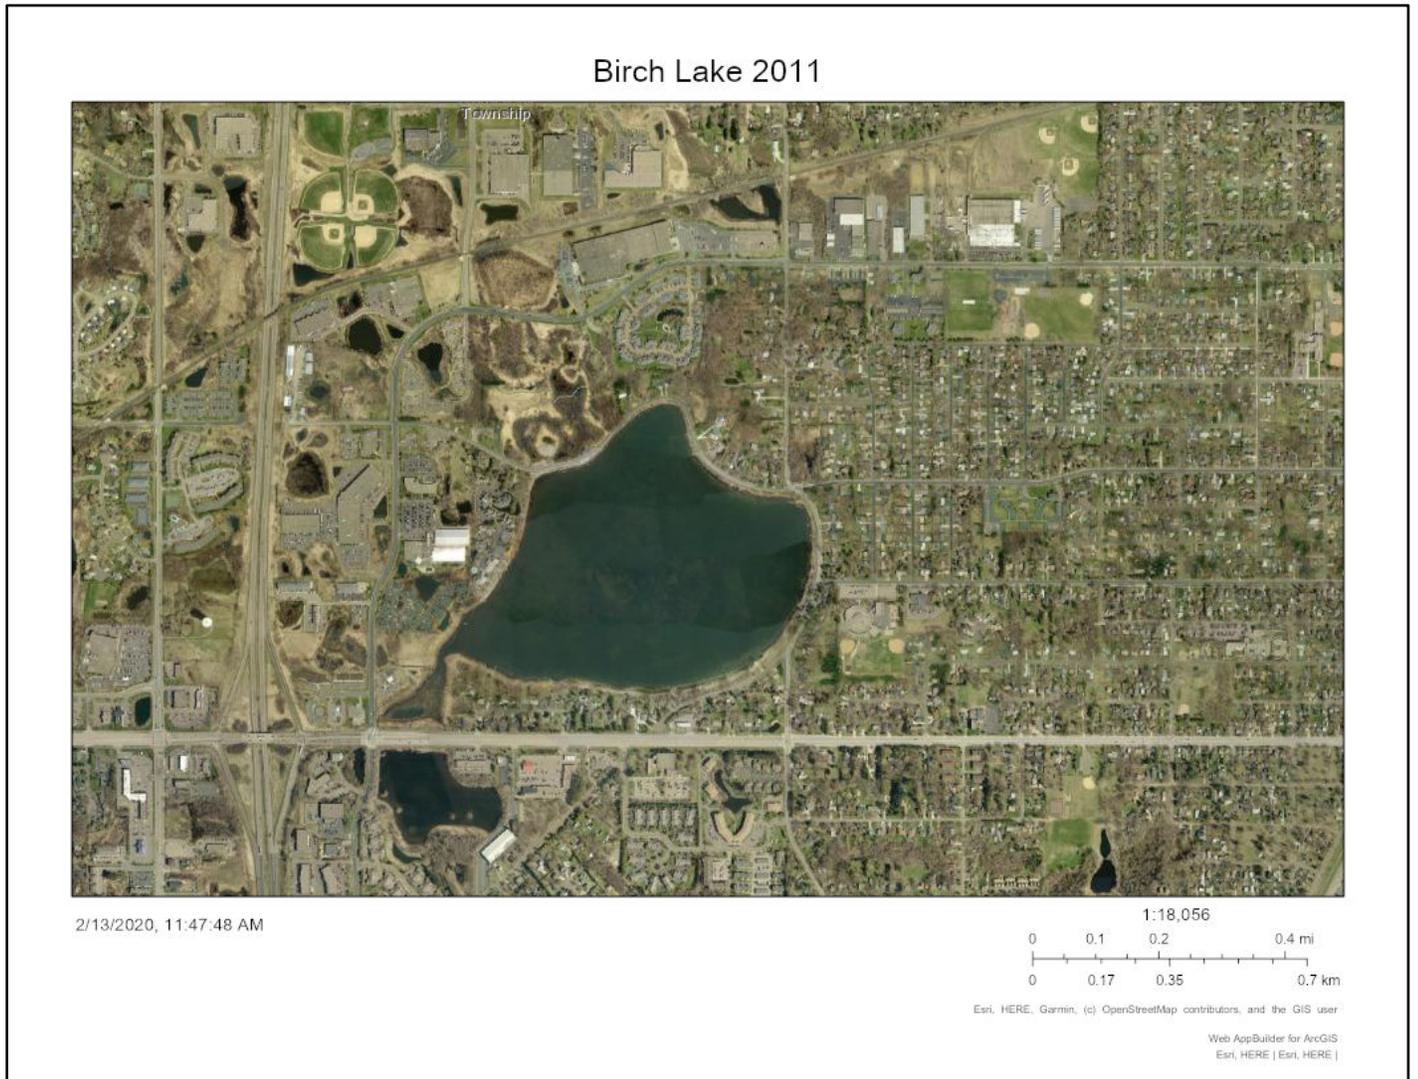
Figure 1: 2011 aerial photo of Birch Lake

In 2011, little has changed since 2006 at this scale.

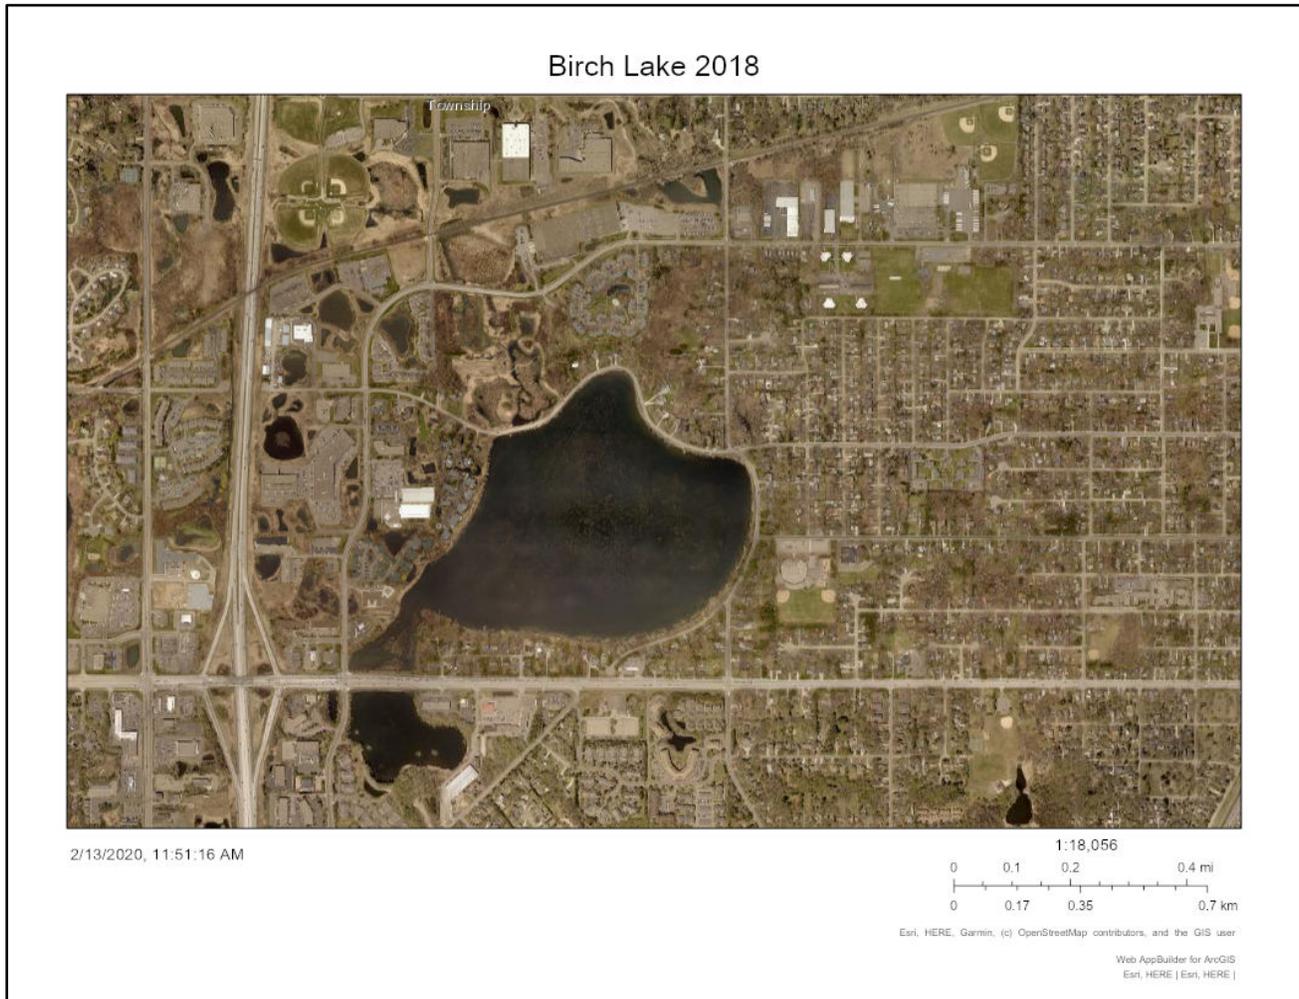
Figure 2: 2018 aerial photo of Birch Lake

In 2018, little has changed since 2011, though several small residential lots have been developed near the Lake in recent years. An iron-enhanced sand filter will be constructed on the northeast corner of the Lake in 2020 to treat roughly 50 acres of stormwater input into Birch Lake. Note that additional years of aerials are available on the VLAWMO GIS Map, linked on the website under Resources.

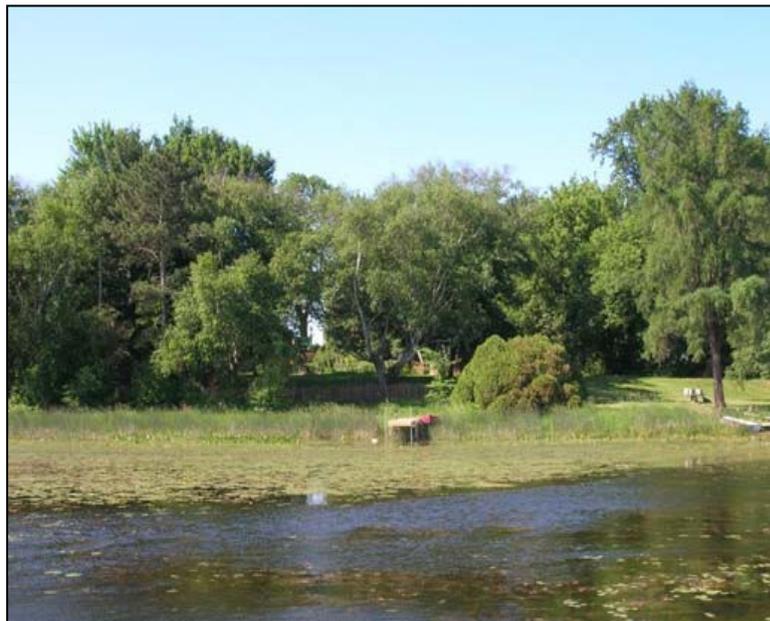
Figure 18: Example of a Birch Lake shoreline parcel. This parcel was rated as having good natural conditions.

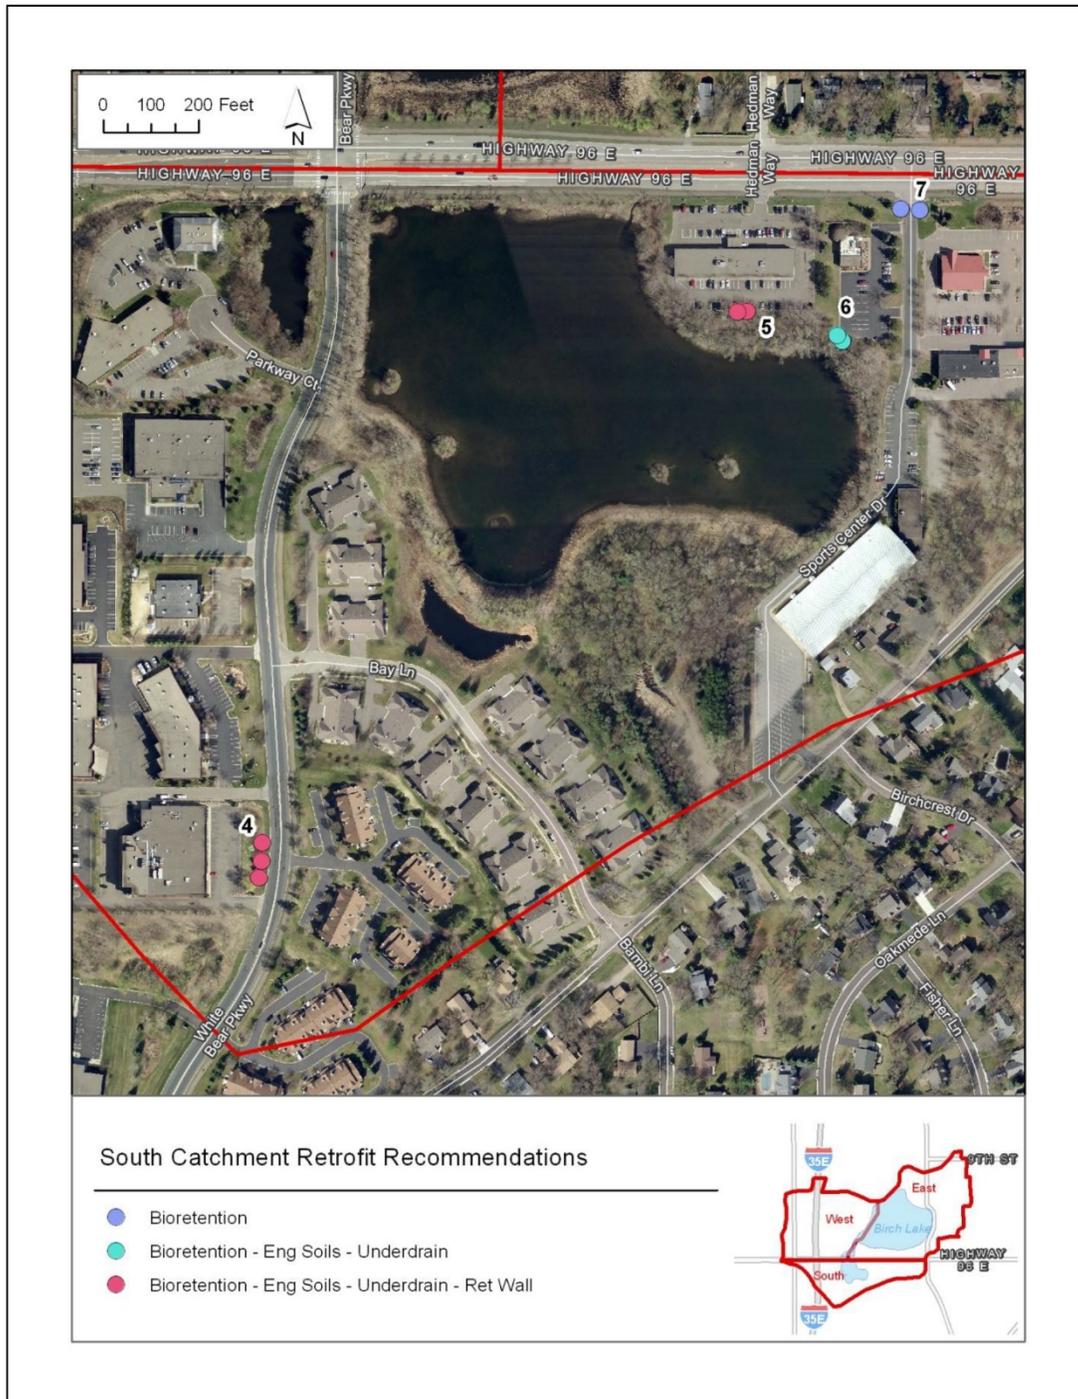
Figure 34: Retrofits identified for the south side of Birch Lake. Nine locations were identified for this side of the lake.
