Lambert Creek Bacterial Source Identification Study Final Report

Lambert Creek Bacterial Source Identification Study
Project No. 78186

August 21, 2020

**Vadnais Lake Area Water Management
Organization
Vadnais Heights, MN**

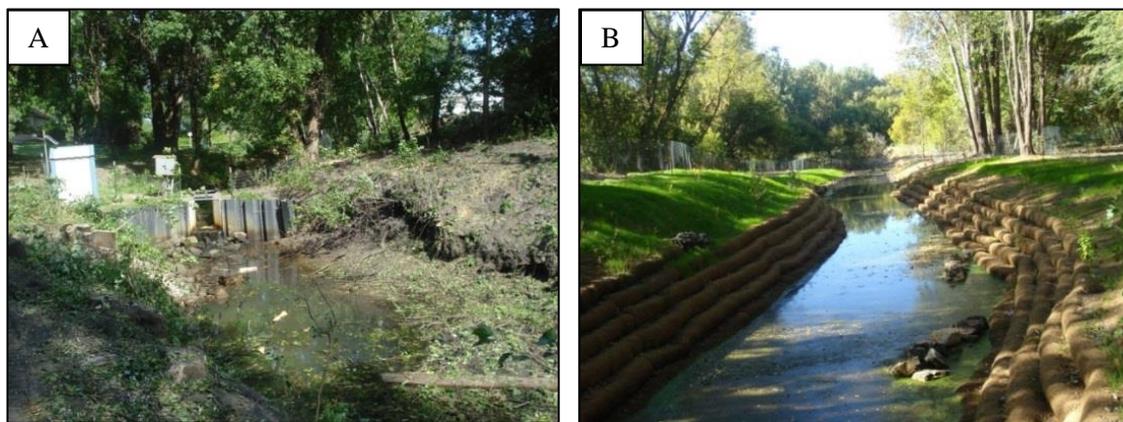
Figure 4-2: Lambert Creek at Oakmede Monitoring Site Before (A) and After (B) Restoration

The reach of Lambert Creek between the Rice Lake Weir (Site Oak-C1) to just downstream of Oak-P was restored in 2013. Prior to restoration, stream bank erosion was apparent on both sides of the reach, there was extensive riparian overgrowth, and large amounts of wood debris, detritus, and sediment had accumulated in the stream (Figure 4-2). Over the course of the restoration project, riparian cover was thinned, debris was removed from the stream channel, and the banks were stabilized.

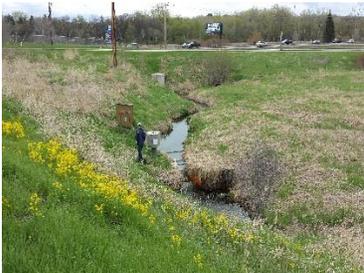
| Site ID | Site Name / Sample Location | Site Drainage Description | Photos |
|---|--|---|---|
| CRF-P | Primary Monitoring Site / Weir at Base of County Road F Drainage at County Road F and Centerville Road | The entire County Road F Drainage | |

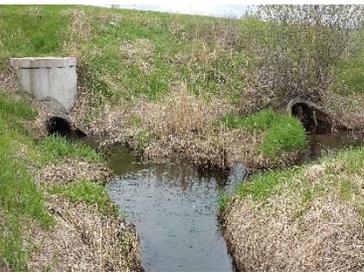
| Site ID | Site Name / Sample Location | Site Drainage Description | Photos |
|---|--|---|---|
| CRF-A1 | Centerville Road / At the storm drain outfall that drains the Centerville Road from Pondview Court to County Road F (outfall to the left in the photograph) | Centerville Road north of County Road F | |

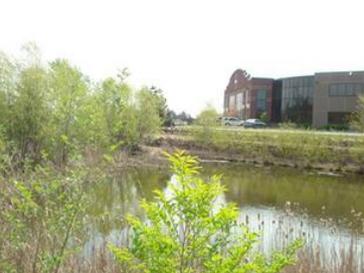
| Site ID | Site Name / Sample Location | Site Drainage Description | Photos |
|---|--|---|---|
| CRF-A2 | Retention Pond / At the grated storm drain outlet on the southwest corner of the pond | Small business park area at the top of Centerville Road | |

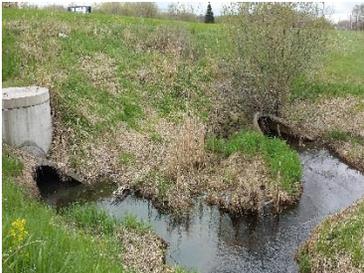
| Site ID | Site Name / Sample Location | Site Drainage Description | Photos |
|---|--|---|---|
| CRF-B1 | I-35E Outfall / At the storm drain outfall on the mainstem on the west side of I-35E (outfall to the right in the photograph) | Reach under I-35E between the wetland and outfall on west side of I-35E | |

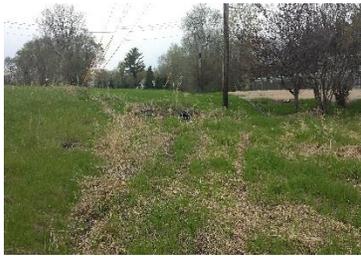
| Site ID | Site Name / Sample Location | Site Drainage Description | Photos |
|---|---|--|--|
| CRF-C1 | South Centerville Road / West of Centerville Road and south of outfalls CRF-A1 and CRF-B1 | Small area to south of CRF-P adjacent to Centerville Road | |

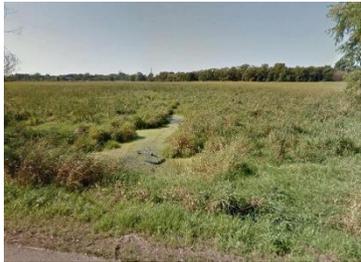
| Site ID | Site Name / Sample Location | Site Drainage Description | Photos |
|---|---|--|--|
| CRF-D2 | White Bear Parkway / West (downstream) side of White Bear Parkway where mainstem of Lambert Creek crosses under road | Entire drainage upstream of White Bear Parkway, including Whitaker, Goose, and Oakmede drainages | |

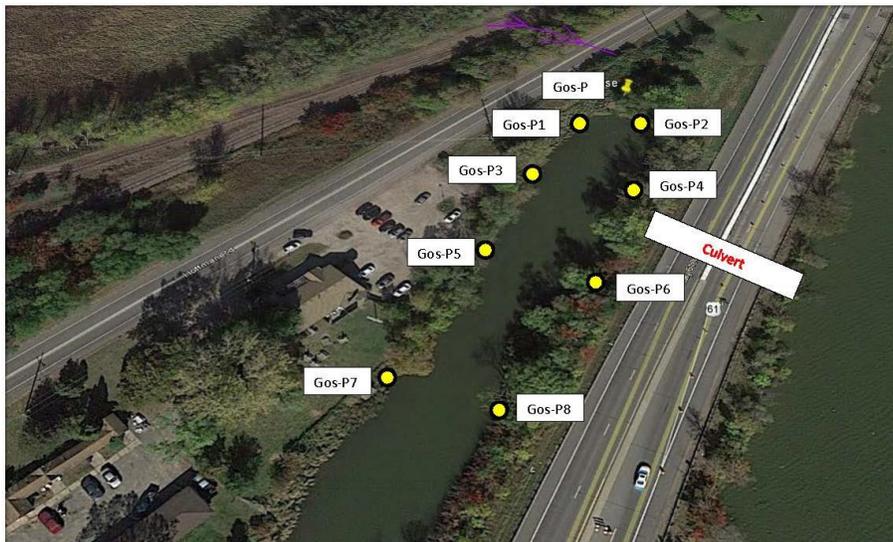
Figure 4-13: Map of Goose Drainage Monitoring Sites Samples in the Goose Special Study

In order to further assess potential sources of *E. coli* associated with the large number of geese near the primary monitoring site, a small Special Study was conducted in the Goose Drainage. Several sites close to the primary monitoring site (Gos-P1) were monitored for *E. coli* over a period of three days from August 26 through September 1, 2015, as shown on Figure 4-13.
