Connections to the water network

Goose Lake - Headwaters of Lambert Creek w/wt

East Goose: Weighing options

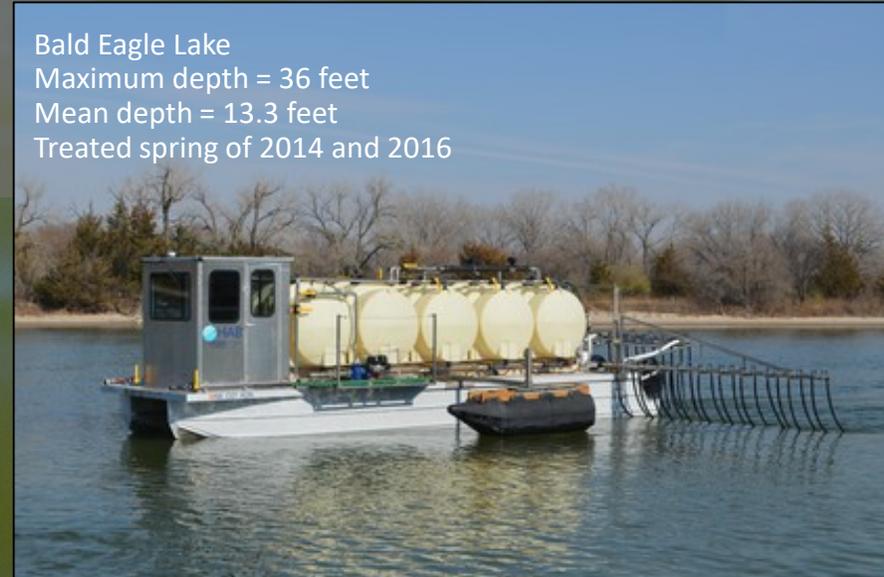
Bald Eagle Lake
Maximum depth = 36 feet
Mean depth = 13.3 feet
Treated spring of 2014 and 2016
