**VADNAIS LAKE AREA WATER MANAGEMENT ORGANIZATION
Sustainable Lake Management Report
West Vadnais Lake, Ramsey County, MN**

**Prepared by Dawn Tanner and Tyler Thompson
October 2021**

VLAWMO SUSTAINABLE LAKE MANAGEMENT REPORT (SLMR): WEST VADNAIS LAKE, OCTOBER 2021

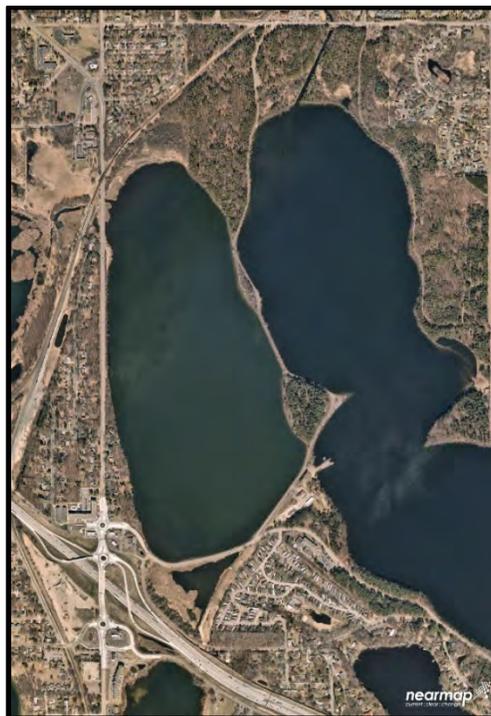
Figure 1: West Vadnais Lake Image from NearMap (April 1, 2021). Even early in the growing season, West Vadnais shows a darker green appearance compared to East Vadnais (to the east and separated by a created land bridge; the 2 lakes are not hydrologically connected). The green color in West Vadnais Lake comes from abundant algae and is an indicator of poor water quality. Major roads that bound the area are County Road F to the north, Rice Street to the west, and West Vadnais Blvd to the south. 694 is the larger freeway on the southern edge of the image.

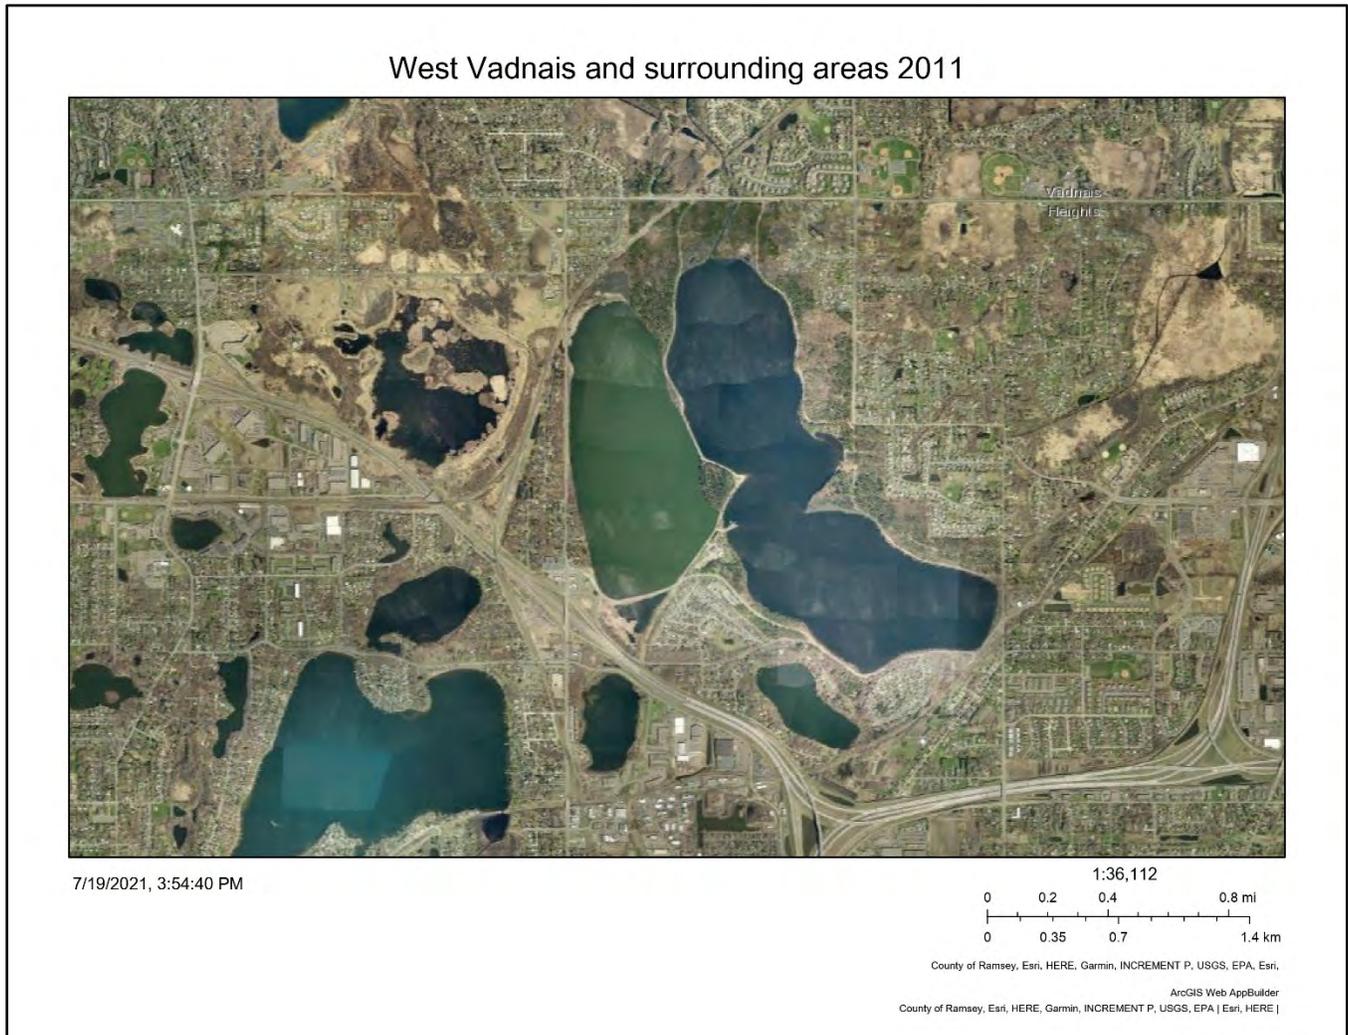
Figure 7: 2011 aerial photo of West Vadnais Lake

In 2011, the green hue of algae is clearly visible indicating poor water quality. Lambert stormwater pond (built in 2004) is present on this map, as is the ditch system discharging from the pond and flowing into East Vadnais Lake.

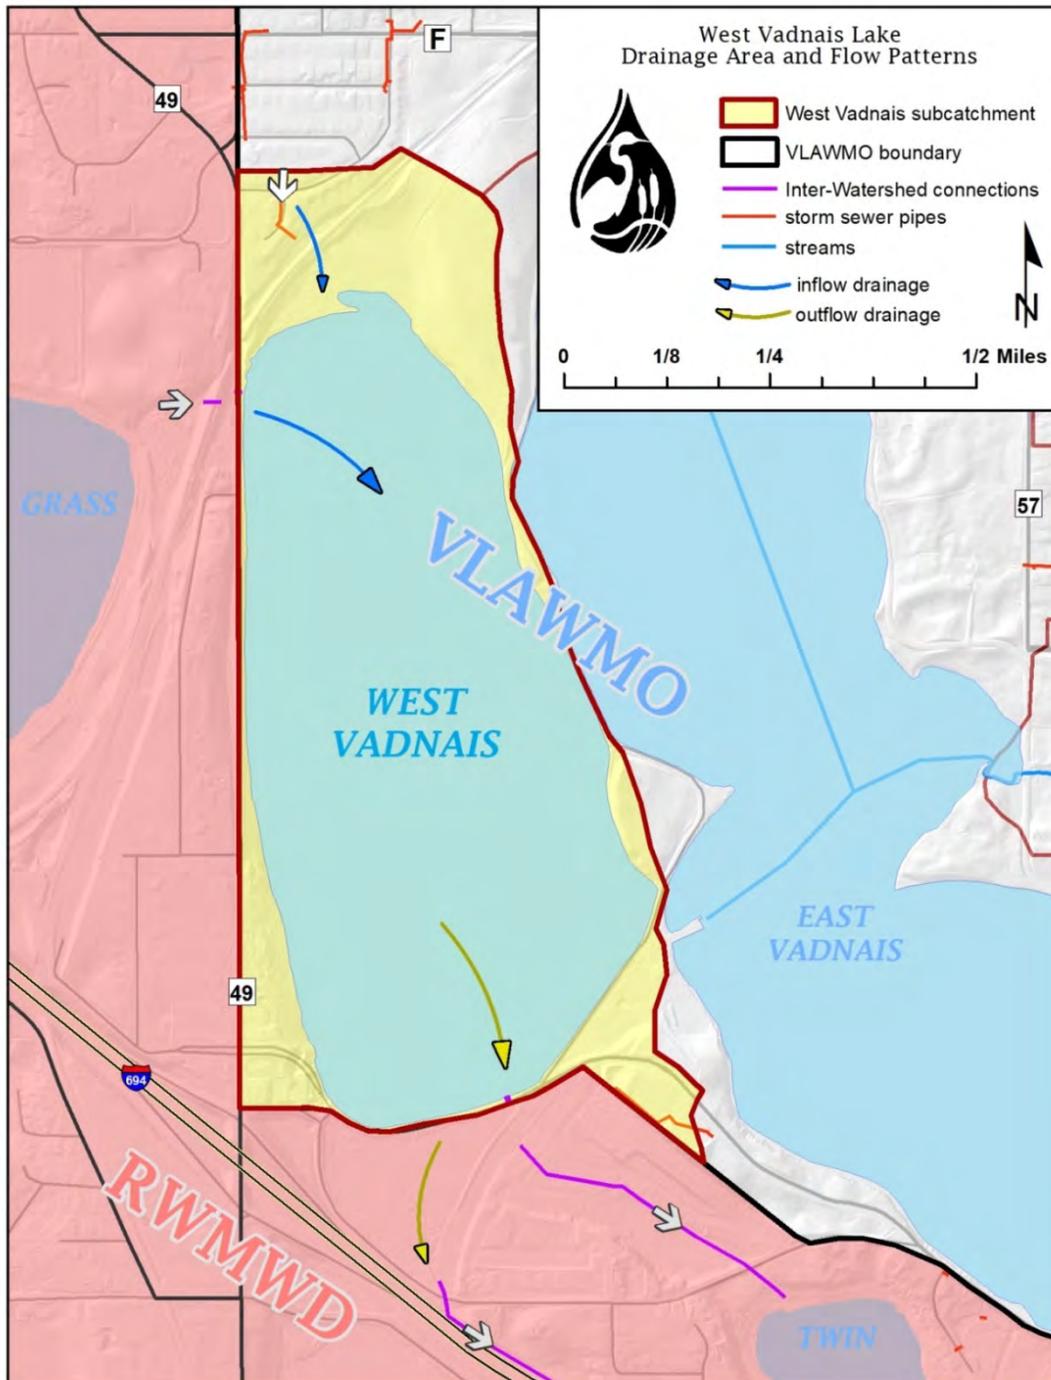
Figure 9: West Vadnais Lake Drainage Area and Flow Patterns

The subcatchment area (shaded area in Figure 9) of West Vadnais Lake is approximately 301 acres, and the surface area of West Vadnais Lake is 221 acres. West Vadnais Lake's basin footprint comprises nearly 75% of the subcatchment area, leaving only 80 areas of terrestrial land area that drains to the lake, and is a relatively small drainage area to a lake. Though lakes with a small drainage area (less than 10:1 ratio) tend to have better water quality, West Vadnais Lake is impaired and was added to the Minnesota Impaired Waters List for nutrients affecting aquatic vegetation in 2014.

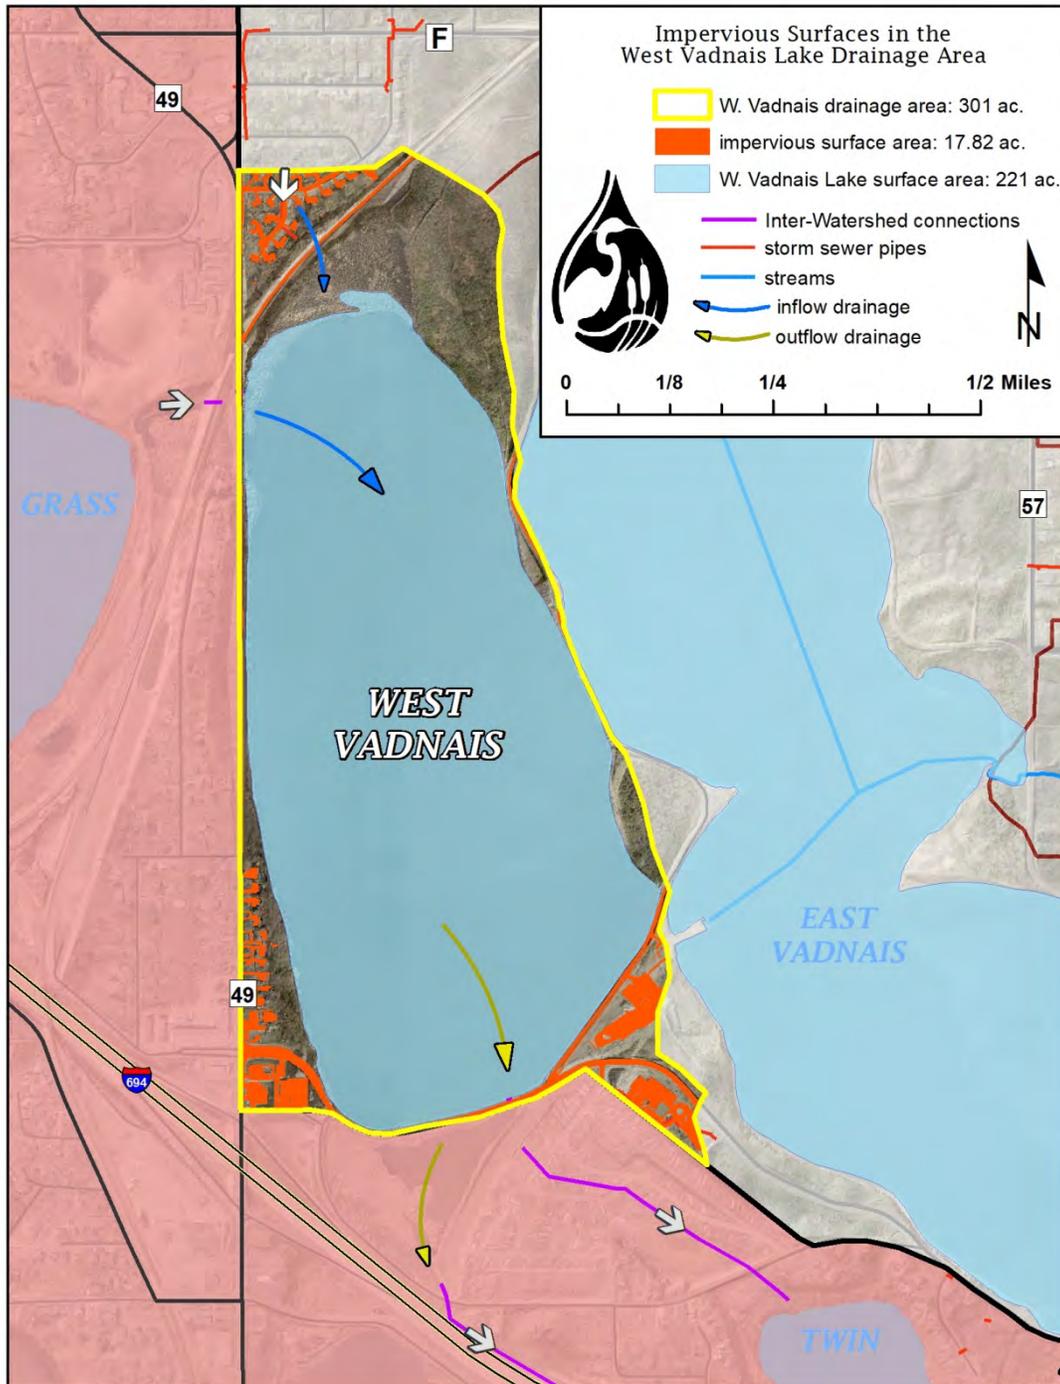
Figure 10 shows that a modest amount of land cover in the West Vadnais Lake area is developed. Impervious surfaces make up 17.8 acres or of total land area or 5.9% within the subcatchment area, including water surface area and terrestrial surface area. Not including West Vadnais Lake's surface water area, impervious surface area comprises of 21% of the 80 acres of terrestrial land cover. The majority of precipitation that falls on those surfaces moves rapidly into downstream lakes, wetlands, and streams.

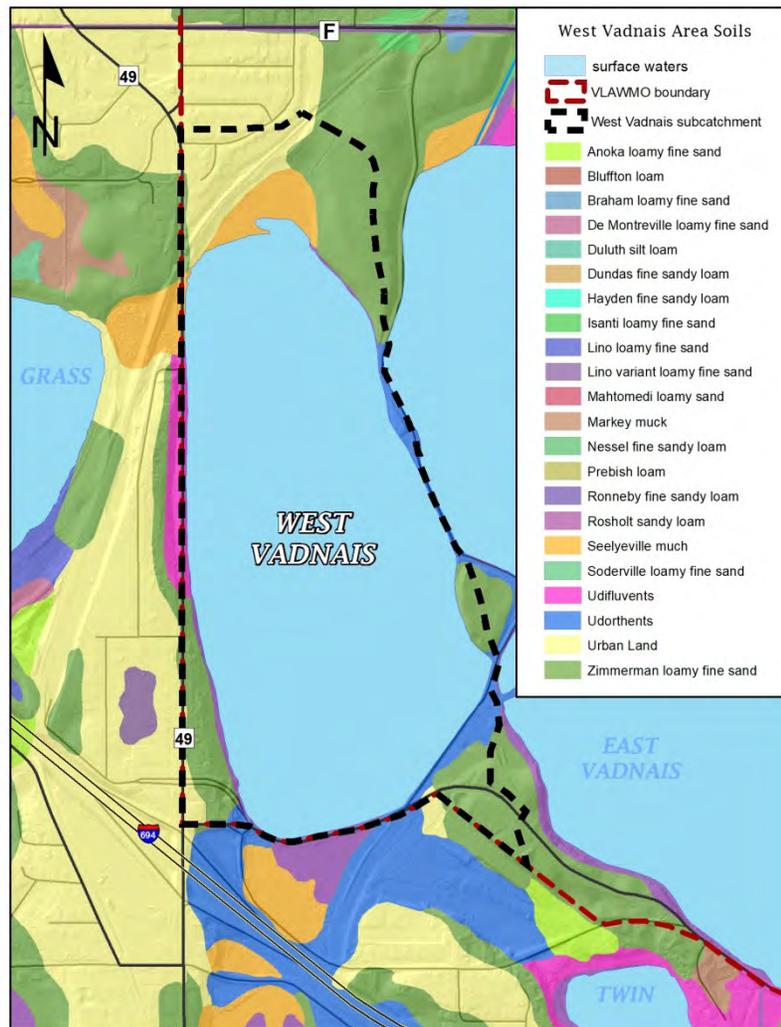
Figure 11: West Vadnais Lake Area Soils

Soils in the West Vadnais Lake subcatchment drainage area are mainly comprised of Zimmerman loamy fine sand, Seelyeville muck, urban land, udifluvents and udorthents. Zimmerman loamy fine sand is moderately well drained, allowing water to infiltrate. With urban soils associated land development, much of the soils have been compacted, moved, and paved over, and are often heterogeneous. Retrofit Best Management Practices (BMPs), such as rain gardens, infiltration basins, and filtration basins, are designed with these differing soil types in-mind.

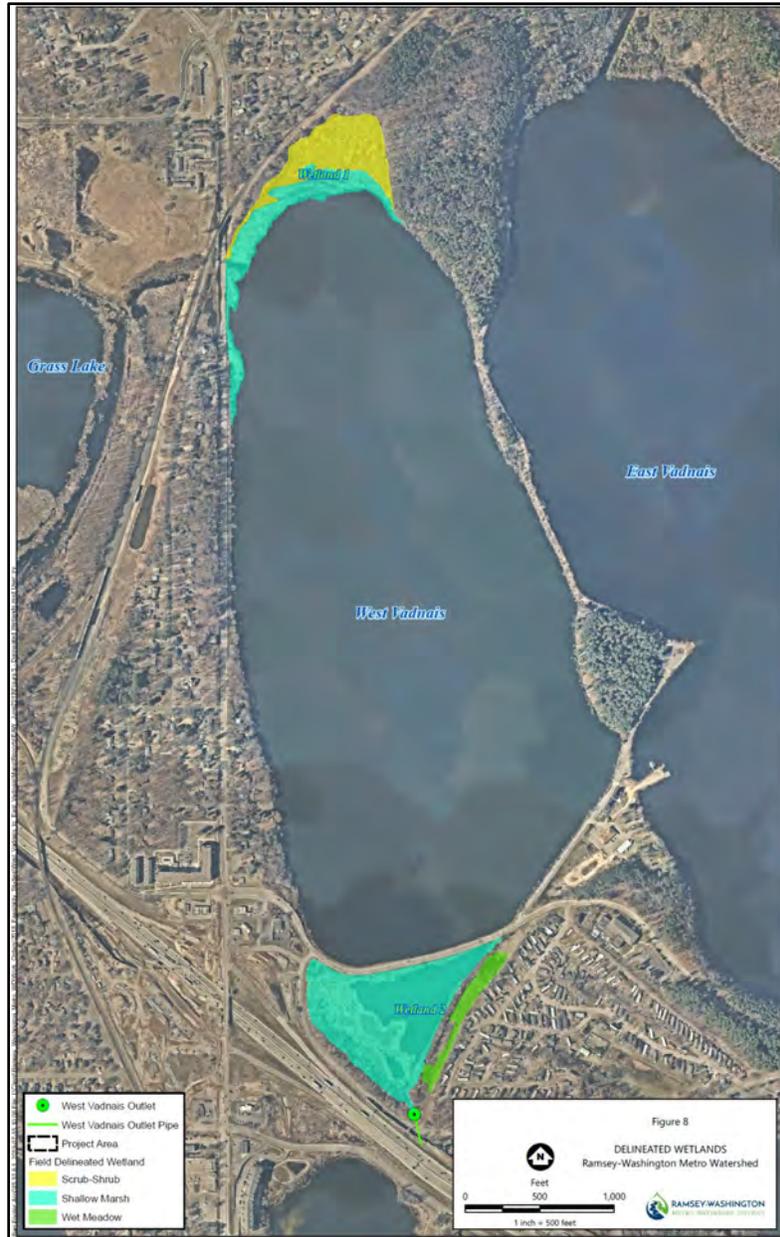
Figure 12: Wetland areas delineated for the RWMWD EAW

From the RWMWD 2019 EAW: A field wetland delineation was conducted on June 17, 2019 and July 3, 2019. Two wetlands collectively totaling 28.9 acres were delineated as part of the culvert modification project. Wetland one, encompassing approximately 12.1 acres, was delineated on the north end of the proposed Project area (Figure 5). This wetland consists of two primary vegetation types, a scrub-shrub area

Based on the Minnesota Routine Assessment Method (MnRAM), both wetlands were classified as preserve wetlands. Shallow-water bathymetric data was also collected in June 2019 in where the littoral zone and wetland area on the north side of the Lake intersect (Figure 3). Surface water depths are primarily less than 0.5 feet, but do get as deep as 3 feet within the delineated wetland area. Bathymetric data collection across the entire delineated wetland area was impeded by accessibility; however, it does indicate the presence of standing water across the entire area.

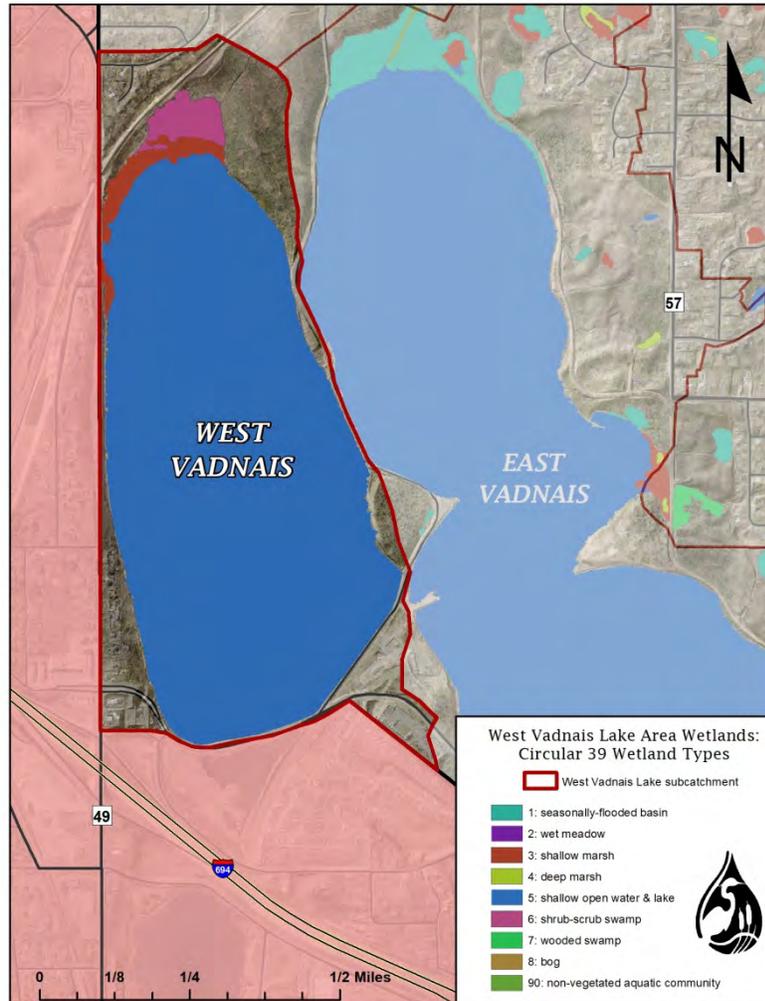
Figure 13: West Vadnais Lake Circular 39 Wetland

As Classified by the Circular 39 wetland classification system, the north end of West Vadnais Lake is classified as forested shrub/scrub further away from the shore, and adjacent to the shore is listed as freshwater emergent wetland, in the shallows. While the greater area of West Vadnais Lake is classified as shallow open water or lake, as the majority of the lake's perimeter is surrounded by emergent wetland vegetation. The north of the Lake exhibits the most shallow wetland characteristics with predominantly emergent vegetation, and the south and southwestern shore has the most developed or altered shoreline habitat, though it is light.

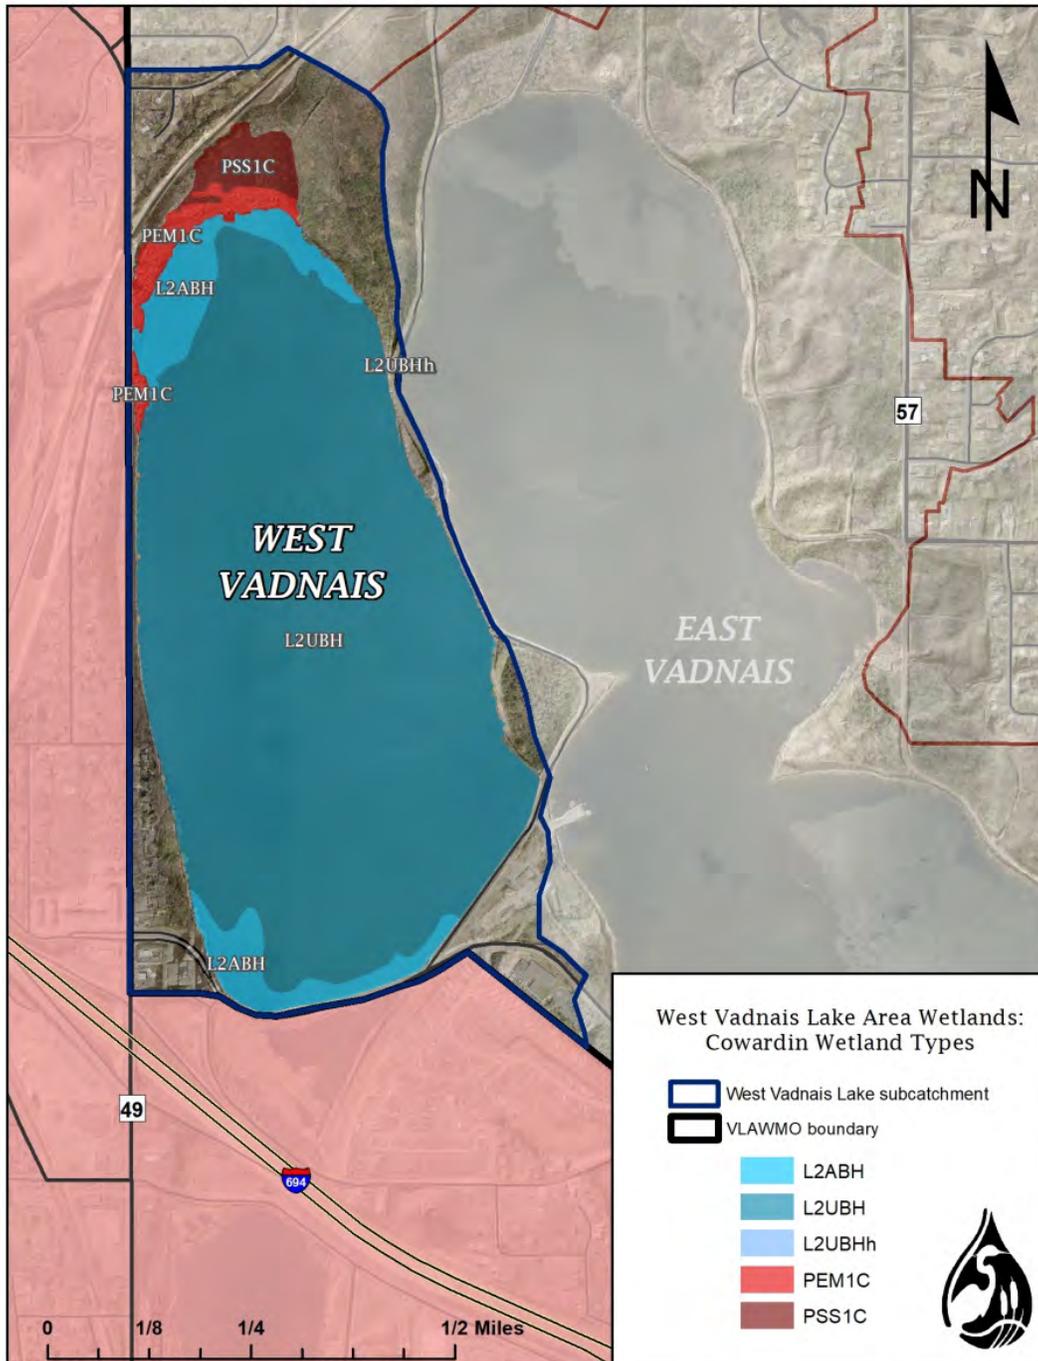
Figure 14: West Vadnais Lake Cowardin Wetland

Within the US Fish & Wildlife Service's National Wetland Inventory (Cowardin Classification System), there are four predominant classifications around and within West Vadnais Lake: PSS1C, PEM1C, L2ABH, and L2UBH which correspond to shrub, shallow marsh, and freshwater lake descriptions (Figure 14). PEM1C refers to palustrine, emergent, persistent marshes that are seasonally flooded (1C), whereas PSS1C is identified as a palustrine, scrub-shrub, and seasonally flooded. PEM1C and PSS1C both occur in the north shore area of the lake, with PSS1C occupying periodically-flooded areas. L2ABH is identified as a shallow open water lake community, and covers the north and south shores, while L2UBH is identified as a non-vegetated lake community and covers the deeper areas and majority of West Vadnais Lake.

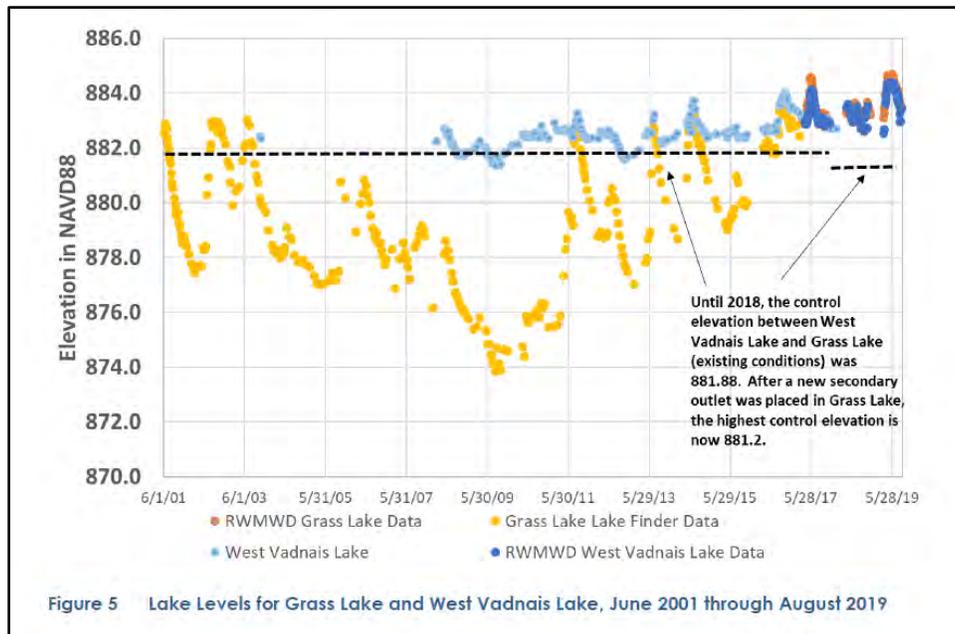
Figure 15: 10-year Hydrograph of West Vadnais Lake from the RWMWD EAW

From the RWMWD 2019 EAW: *West Vadnais Lake has a surface area of 213 acres. Based on bathymetric data collected in early summer 2019 as part of the culvert modification Project, the Lake has an average depth of about 8 feet and a maximum depth of 11 feet. Water levels within the Lake have steadily increased over the years and have led to the flooding of the surrounding areas including Grass Lake located on the west side of Rice Street, as well as overtopping Rice Street itself.*

Water levels began being recorded in West Vadnais Lake in the 2000s, though regular monitoring began in 2008 by the Ramsey-Washington Metro Watershed District. Water levels were within a consistent range, until continued, extreme precipitation events occurred between 2015–2019 throughout the region. This brought the highest lake level recordings that had been seen on West Vadnais Lake and presented localized flooding issues. As these issues persisted, the RWMWD pursued a project to lower the southern outlet of the lake by 0.8 feet to reduce peak lake levels and flooding during extended high-precipitation periods. This project was completed in 2020.

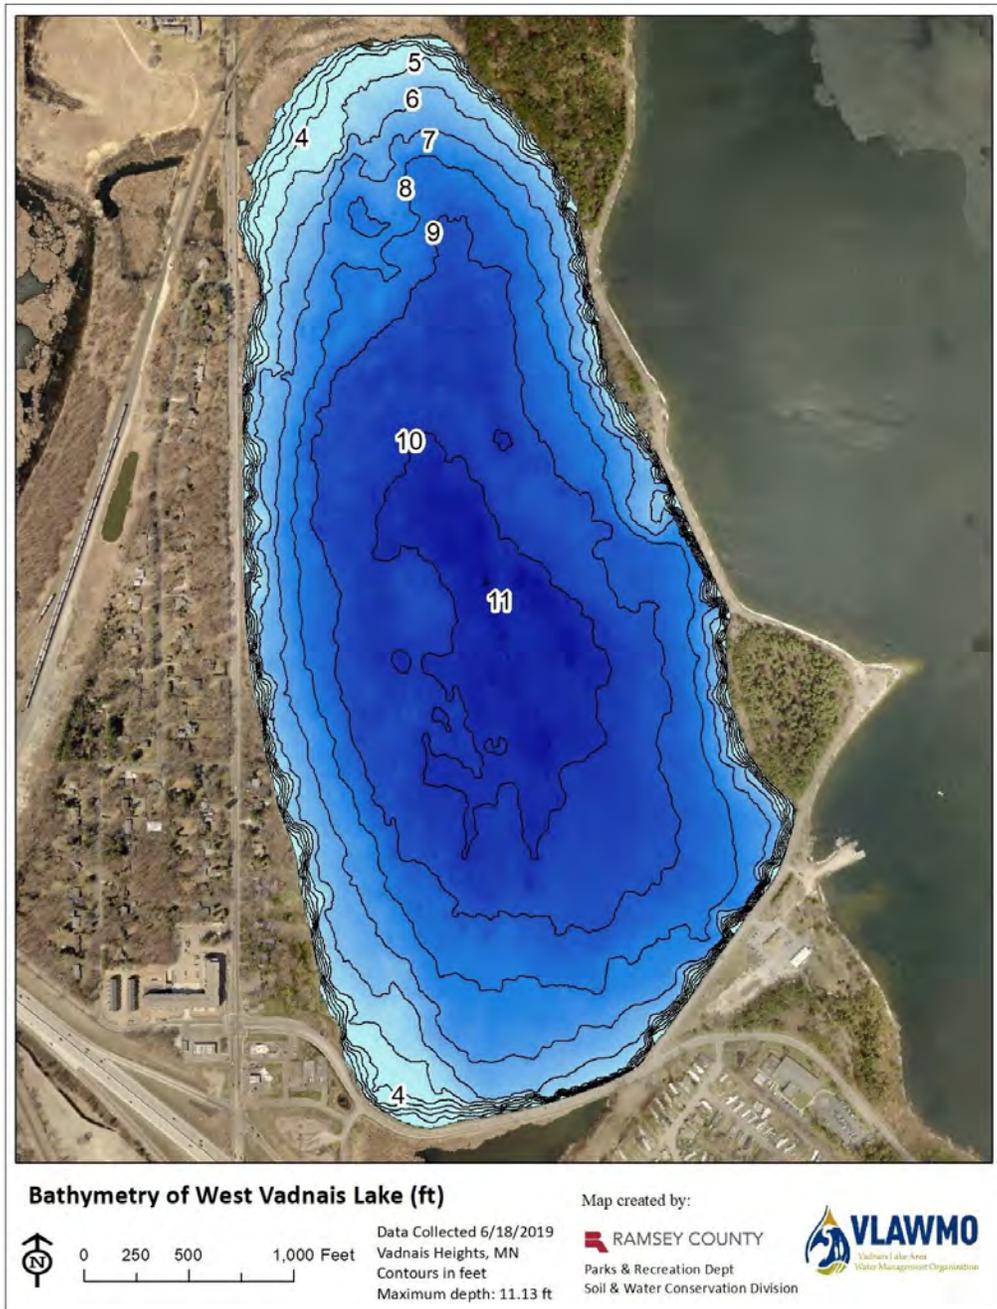
Figure 16: West Vadnais Lake Depth with 1-foot Contours

A bathymetry survey was completed by Ramsey County Soil and Water Conservation Division (RCSWCD) on June 18, 2019, to develop a map of the bottom of West Vadnais Lake and determine depths. The deepest point measured with a rod was 10.05 ft (not at the deepest location in the lake). The deepest location detected by sonar was 11.13 ft. The average lake depth is between 7-8 ft.

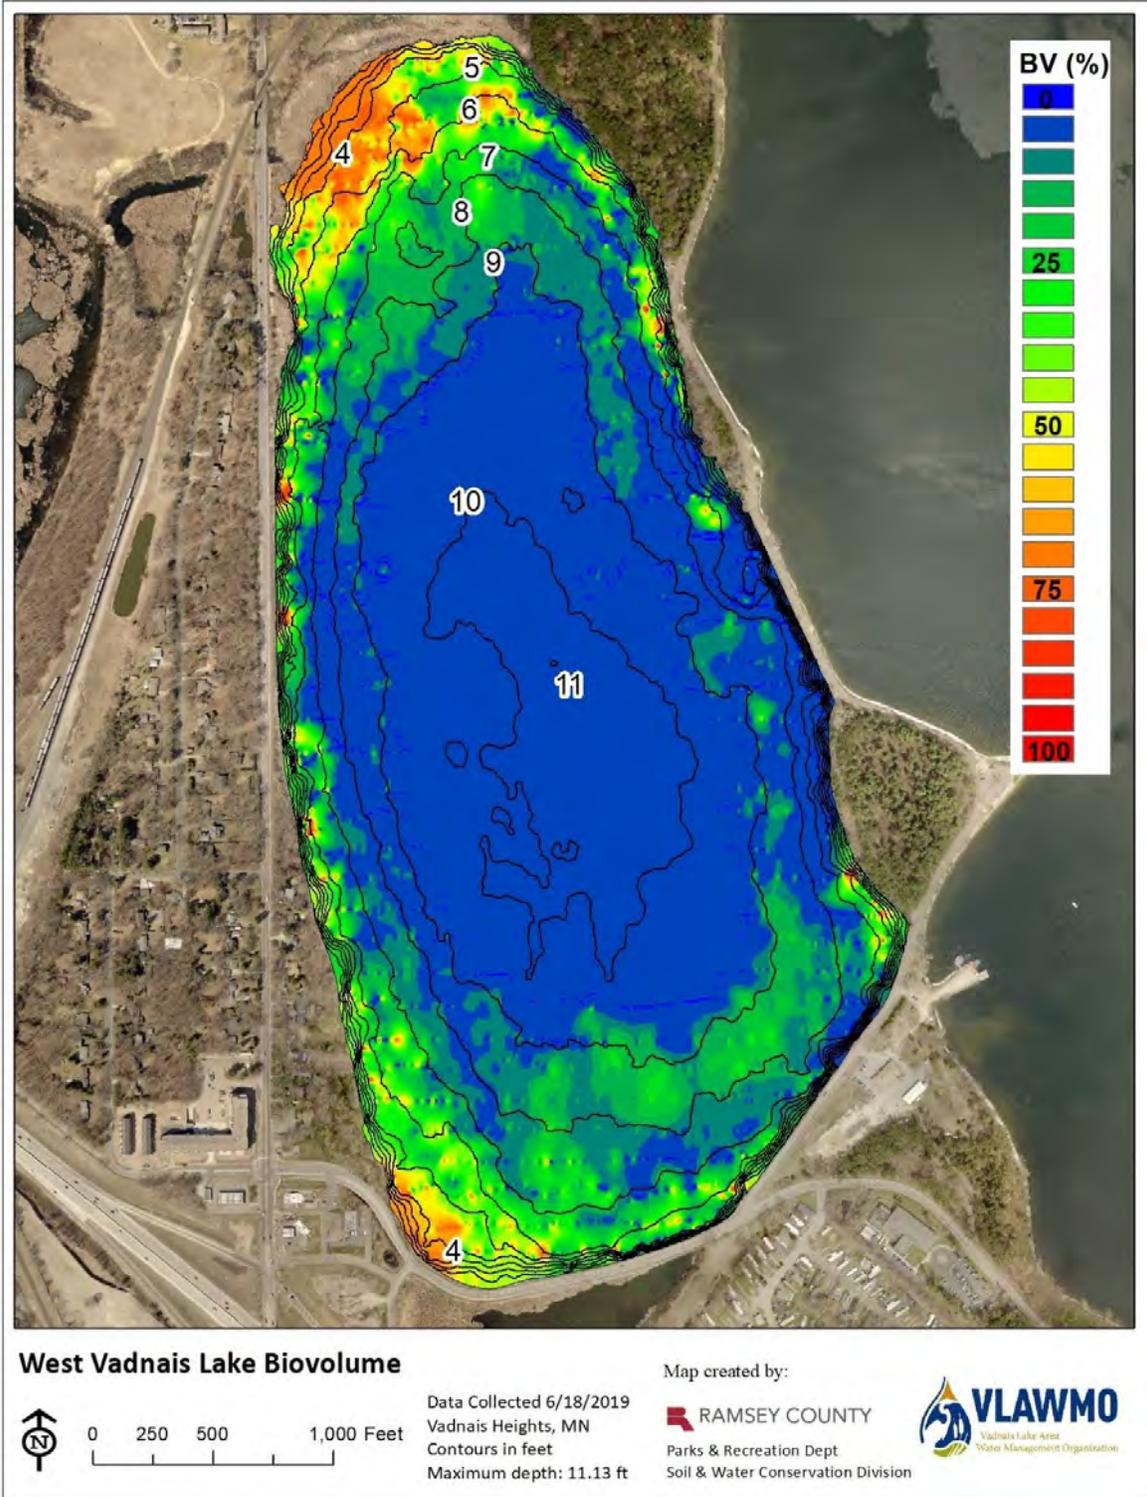
Figure 17: West Vadnais Lake

Ramsey Soil and Water Conservation Division (RCSWCD) conducted a biovolume and aquatic vegetation survey on June 18, 2019. Biovolume measures the density of plant life within the lake. Blue signifies 0% plant life, and red signifies 100% plant life. At depths greater than 4-6 feet, there is commonly no plant life in Minnesota lakes. Plant growth is limited because the sun does not penetrate the water column below those depths enough to allow photosynthesis to occur. West Vadnais Lake has abundant plant life in the littoral areas and no vegetation in the deeper portions of the lake. (Figure 17).

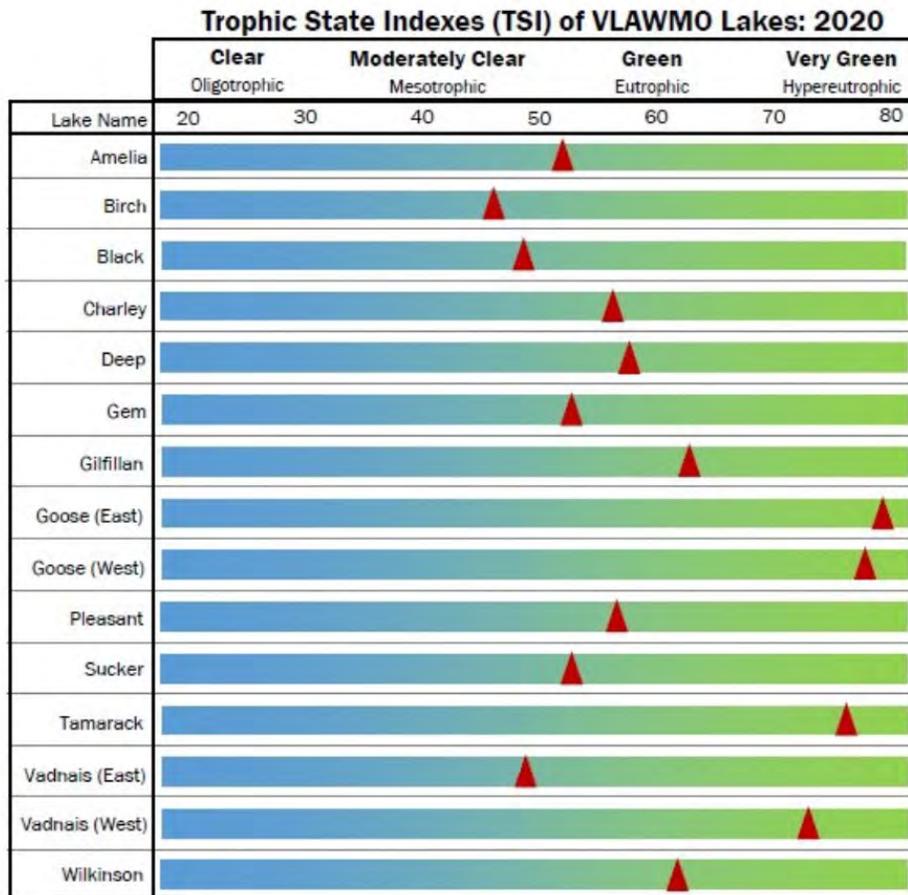
Figure 19: TSI Scores for VLAWMO Lakes

West Vадnais Lake is one of the lakes in the watershed that is impaired for nutrients. It has poor water quality as shown by its Trophic State Index (TSI) score of 73 as determined by the Minnesota Pollution Control Agency (MPCA). The lake is characterized as “very green” or hypereutrophic. More information can be found in the annual VLAWMO Monitoring Report.

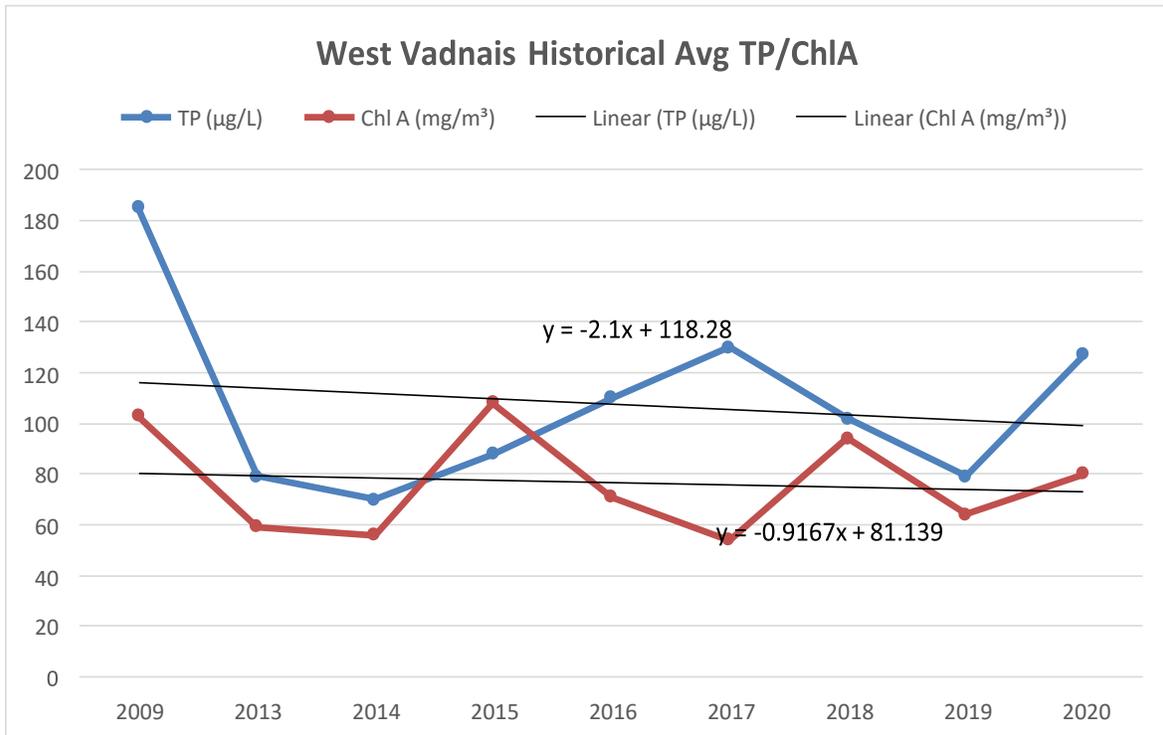
Figure 20: Historical Water Quality Averages in West Vadnais Lake 2013-2020

Figure 20: The graph shows results of TP/Chl-a with a linear trend through time. TP levels were more than double the State Standard (60 µg/L) in 2020. Chl-a is also consistently high, indicating high amounts of algae in the water column.

West Vadnais Historical Avg TP/Chl A/SDT			
Year	TP (µg/L)	Chl A (mg/m ³)	Secchi (m)
2009	185	103	0.4
2013	79	59	0.4
2014	70	56	0.5
2015	88	108	0.3
2016	110	71	0.3
2017	130	54	0.4
2018	102	94	0.4
2019	79	64	0.5
2020	127	80	0.5

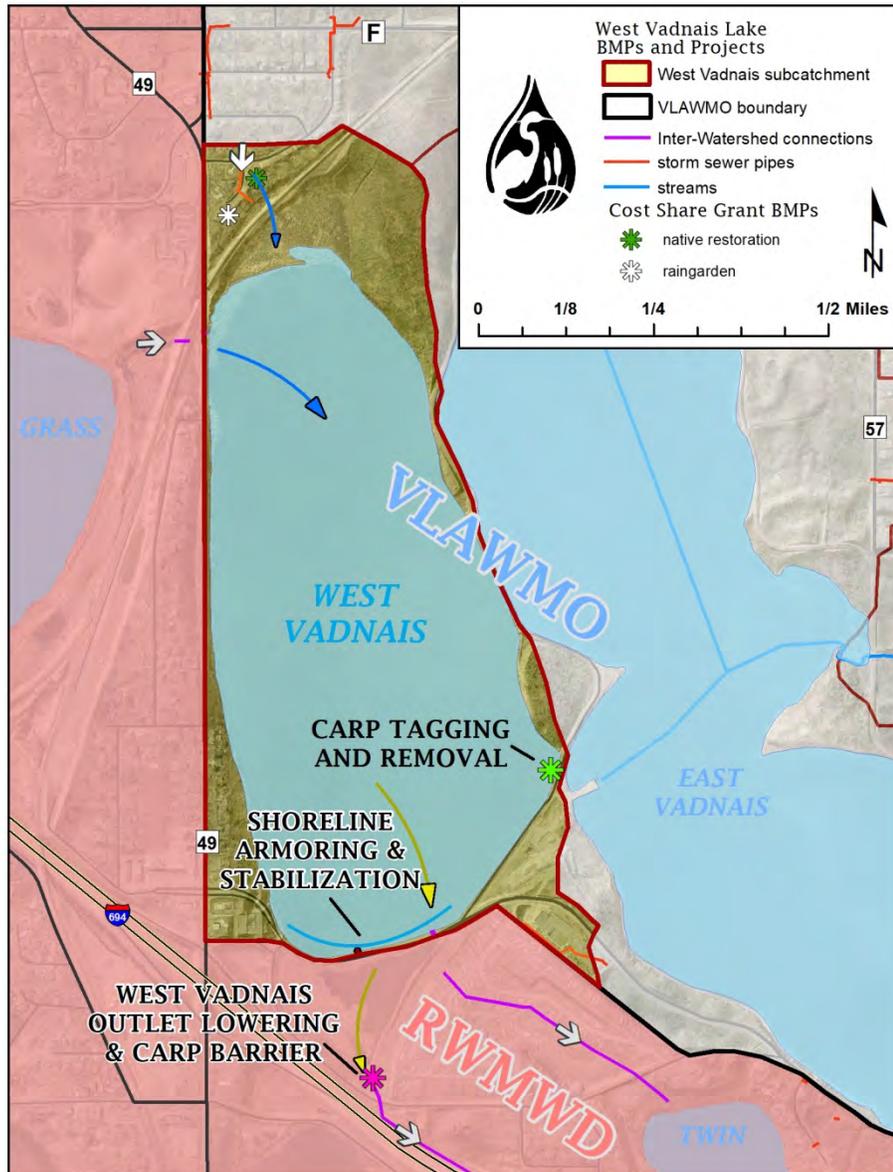
Figure 21: West Vadnais Lake Subwatershed Implemented projects and BMPs

- South shoreline armoring for lake shore stabilization, completed in 2019 by the RWMWD.
- 2020 West Vadnais Lake outlet lowering, completed by the RWMWD.
- 2 VLAWMO Cost Share grant BMPs: 1 native restoration and 1 residential rain garden within the Suzanne neighborhood, tributary to West Vadnais Lake storm sewer drainage.
- Carp management efforts are underway and ongoing, as described below.

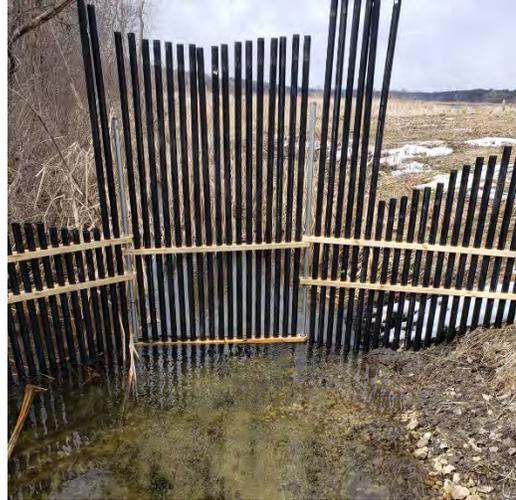
Temporary barrier in place for 2019 when COVID complications negated a plan for an electrified barrier

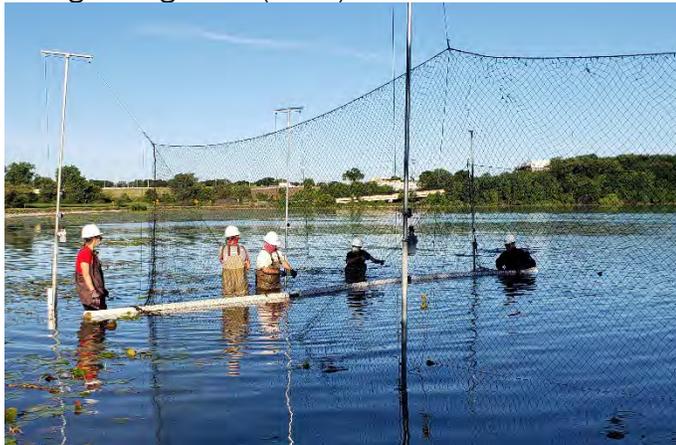
Baited netting effort. Nets were baited with corn and remotely triggered to capture carp feeding at the site during the nighttime (2019)

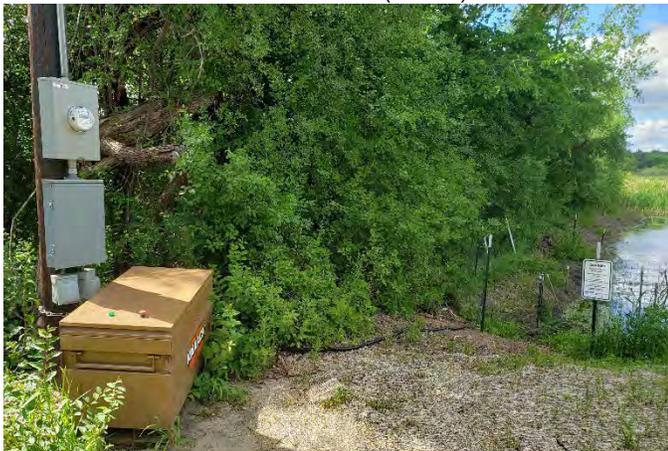
Power run for electrified barrier (2020)

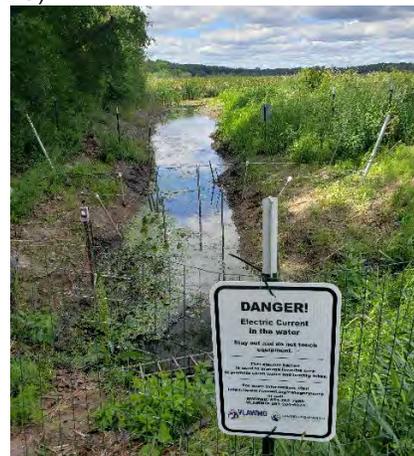
Electrified barrier on southern wetland at modified culvert (2020)

Before the start of the 2020 season, the carp management plan for West Vadnais was to install an electric barrier in the outlet channel of the lake, mark 100 carp with Passive Integrated Transponder (PIT) tags in the lake, place a PIT antenna near the barrier, and conduct carp removals at the barrier in the spring. The combination of marking carp with PIT tags and removing carp at the barrier while checking for PIT tags would allow for a mark-recapture population estimate to be calculated. Additionally, the PIT antenna at the outlet and potentially at other locations on connected water bodies would show carp seasonal migration patterns, potentially leading to the construction of other barriers and spring removal at those barriers. Unfortunately, the COVID-19 pandemic forced a change in those plans. The electric barrier system became unavailable, so a simple ABS pipe physical barrier was installed instead. The installation of PIT antennas was postponed, with the possibility of continuing the effort in 2021. As the lake warmed up and the carp became active in the shallows of the lake, 3 electrofishing surveys were conducted in late April to mark carp. A total of 120 carp were caught in these surveys. Because one of them in a later survey was a recapture from a previous survey, only 119 carp were marked with a PIT tag and released. No significant aggregation of carp was seen at the barrier throughout the spring, so no migration removal was attempted. Instead, it was decided to use 2 box nets to examine the feasibility of removing carp using the box net method while also fulfilling the objective of obtaining a robust carp population and biomass density estimate. Over the course of 7 removal attempts between 7/30/20 and 10/8/20, 356 carp were removed. A total of 21 marked carp were recaptured during these removals. Based on these recaptures, 18% of the carp population in West Vadnais was removed. The population is estimated to be around 1,950 carp, with a corresponding biomass density of 26 kg/ha.
