VADNAIS LAKE AREA WATER MANAGEMENT ORGANIZATION
Sustainable Lake Management Report
Sucker and East Vadnais Lakes, Ramsey County, MN

Prepared by Dawn Tanner and Tyler Thompson
March 2022

VLAWMO SUSTAINABLE LAKE MANAGEMENT REPORT (SLMR): SUCKER AND EAST VADNAIS LAKES, MARCH 2022

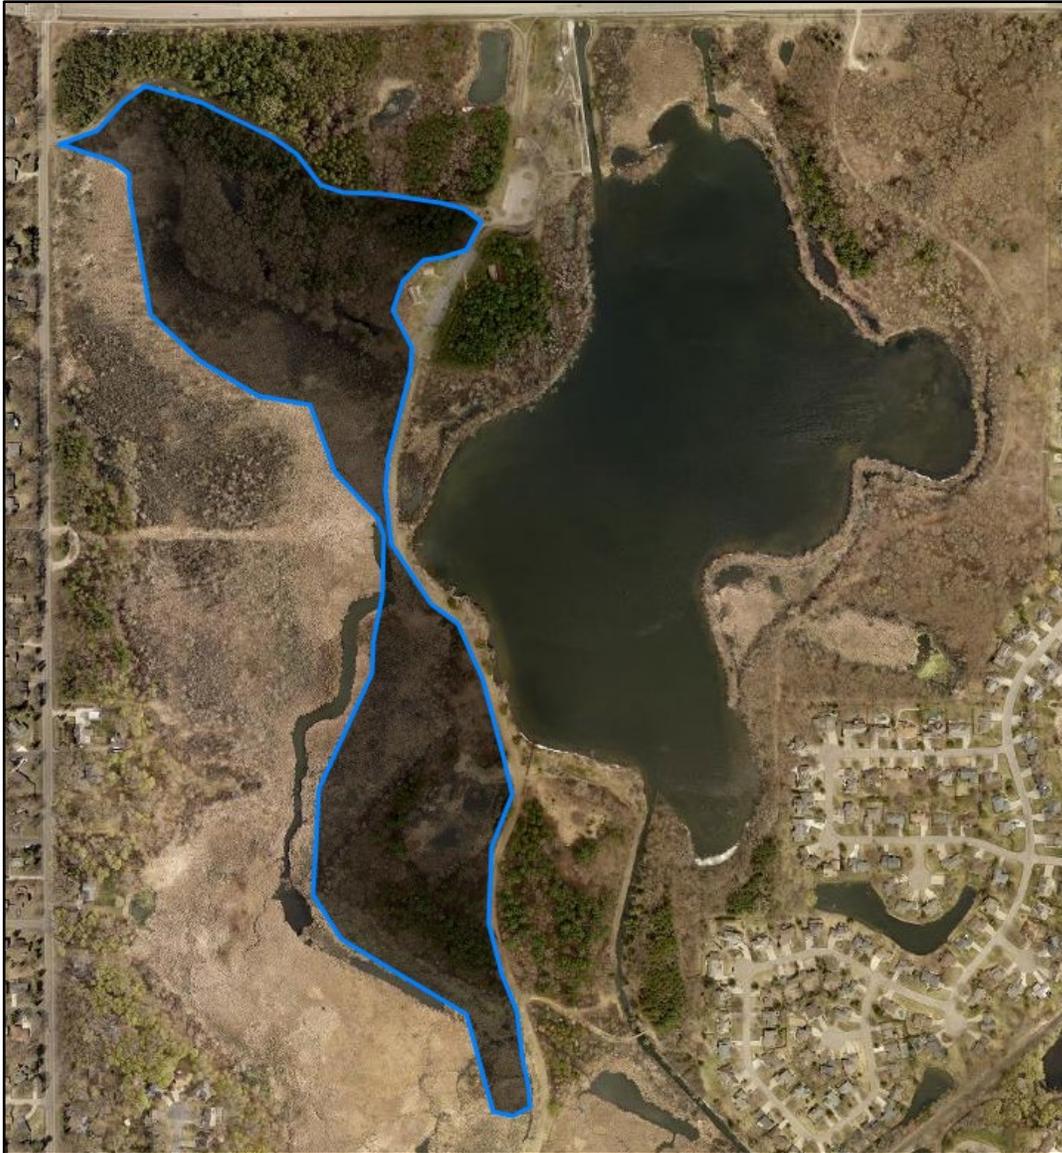
Figure 16: Upcoming Restoration in Vadnais-Sucker Lake Regional Park with Great River Greening, Ramsey County Parks, and SPRWS, shown here for context and relationship to wetland areas

During 2019, VLAWMO submitted a letter of interest to Great River Greening for inclusion in their suite of restoration projects for the upcoming round of restoration-focused grant-based projects. Great River Greening included VLAWMO in their proposal to the Environment and Natural Resources Trust Fund (ENRTF) and Outdoor Heritage Fund. During 2020, the Legislature failed to vote on ENRTF projects. During 2021, VLAWMO was notified by Great River Greening that the Vadnais-Sucker Lake Regional Park, 45-acre restoration was approved in the suite of projects submitted for Outdoor Heritage funding. VLAWMO staff worked with SPRWS and Ramsey County to establish a landowner agreement between Great River Greening and SPRWS for the restoration. A maintenance agreement was also outlined and is in progress at the time of this report preparation. Great River Greening will be managing the restoration project. VLAWMO, Ramsey County Parks, and SPRWS will partner in maintenance following completion of the project.

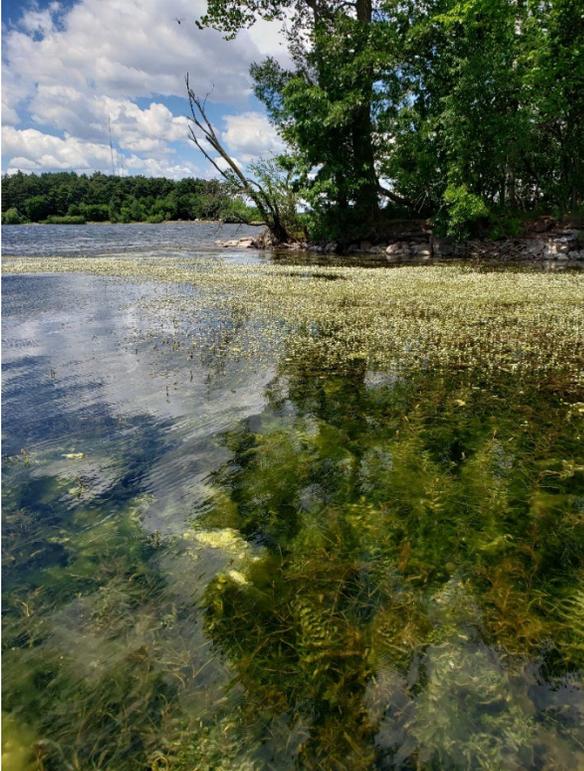
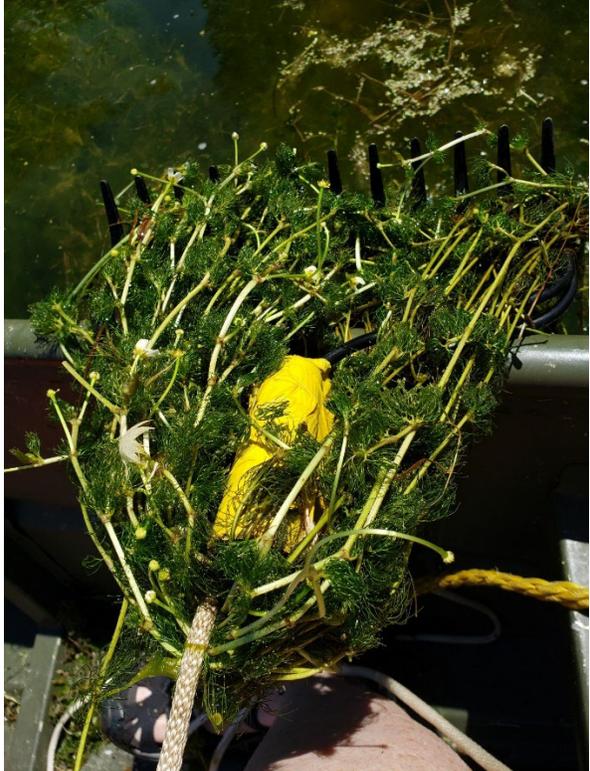
Figure 24: Photos of Aquatic Vegetation in East Vadnais Lake

<p>East Vadnais Lake has a healthy community of aquatic plants, with some invasive species</p>	<p>A sample of plants collected on the rake</p>

For the aquatic macrophyte survey, 45 points were surveyed on Sucker Lake, and 120 points were surveyed on East Vadnais Lake using the metal portion of a rake/tines tied to a rope. Aquatic macrophytes were found at 42 of 45 points surveyed in Sucker Lake and 63 of 120 points surveyed in East Vadnais. The 3 most common species detected in Sucker Lake were Coontail (*Ceratophyllum demersum*), Greater Duckweed (*Spirodela polyrhiza*), and Lesser Duckweed (*Lemna minor*). Other moderately common species observed included Flat-stem Pondweed (*Potamogeton zosteriformis*) and Star Duckweed (*Lemna trisulca*). In East Vadnais Lake, the most common species observed (62% occurrence) was Greater Duckweed (*Spirodela polyrhiza*). Other relatively common species observed included Coontail (*Ceratophyllum demersum*), **Curly-leaf Pondweed (*Potamogeton crispus*)**, **Eurasian Watermilfoil (*Myriophyllum spicatum*)**, Flat-stem Pondweed (*Potamogeton zosteriformis*), and Star Duckweed (*Lemna trisulca*).

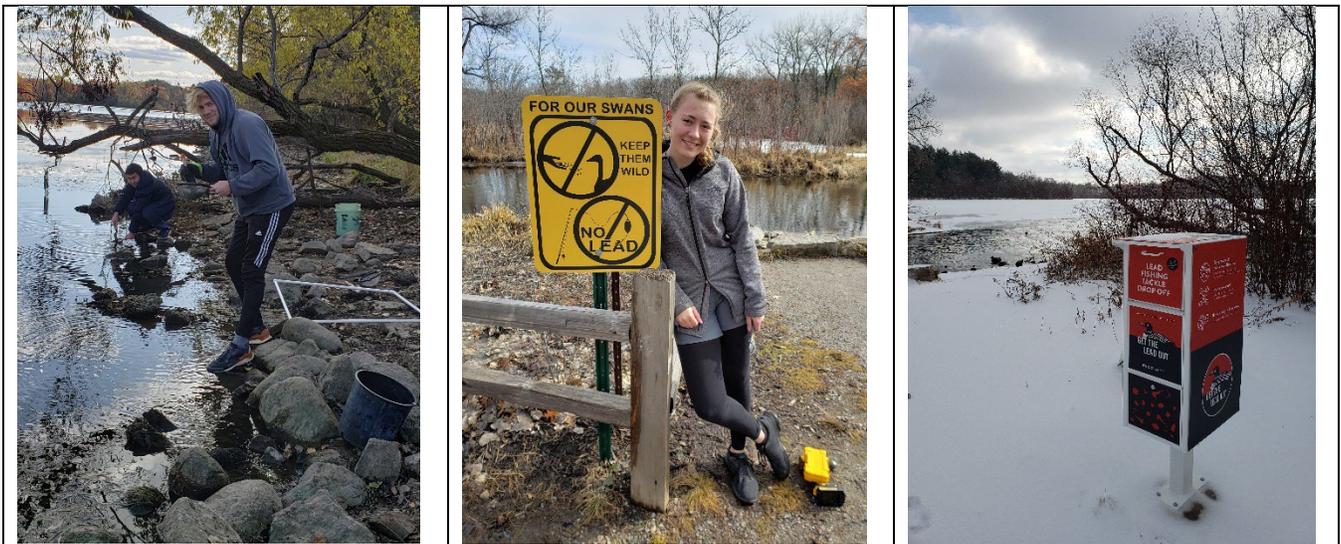
Figure 28: Photos of 1) sediment sampling for lead sinkers, 2) VLAWMO-installed signage, 3) MPCA lead dropbox

The location where the swans have died corresponds to a high-use fishing area. Lead sinkers and tackle are commonly found at this location. A small sediment sampling effort was undertaken by VLAWMO staff with UMN community-engaged learning students in 2019. Because of the limestone lining in the channel, it was difficult to obtain lake sediment uniformly. The easiest way to locate lead sinkers was to follow tangled fishing line to find the sinkers attached. Signage was installed by VLAWMO staff in 2020. In partnership with Ramsey County Parks and MPCA, a lead dropbox with educational materials was installed in 2021.

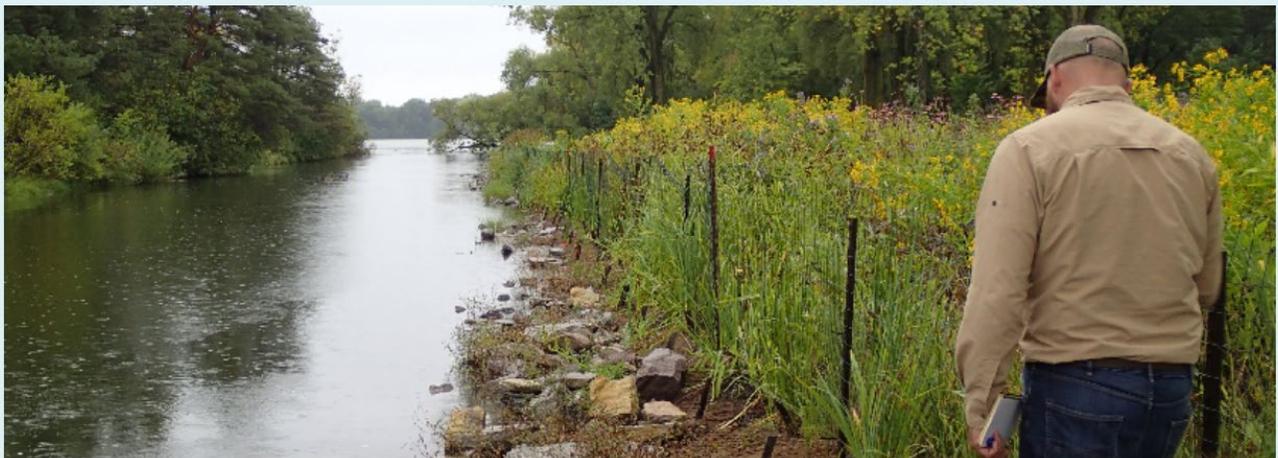
– Ramsey County – Restoring Sucker Channel

The shoreline of the Sucker Channel in northern Ramsey County is a heavily used fishing area. After decades of wear, the paved paths that lined the banks of the Channel were falling into the water and rainfall was washing pollutants into the Channel that serves as the City of St. Paul's drinking water supply. Ramsey County Parks Soil and Water Conservation Division worked with the Vadnais Lakes Area Watershed Management Organization to stabilize the shoreline, provide a vegetated buffer for rainwater, and create pollinator habitat with flowering native plants. Ongoing monitoring and maintenance will ensure the continued success of this project's multiple benefits.

A restoration was completed in 2018 to upgrade and stabilize Sucker Channel at Sucker Lake. The project was a joint restoration effort between VLAWMO, Ramsey County Parks, Ramsey Soil and Water Conservation Division, and SPRWS. The channel between Pleasant and Sucker Lakes, south of Co. Hwy. 96 is highly visible and in a well-used section of the Vadnais-Sucker Regional Park. It was in poor condition and in need of restoration.

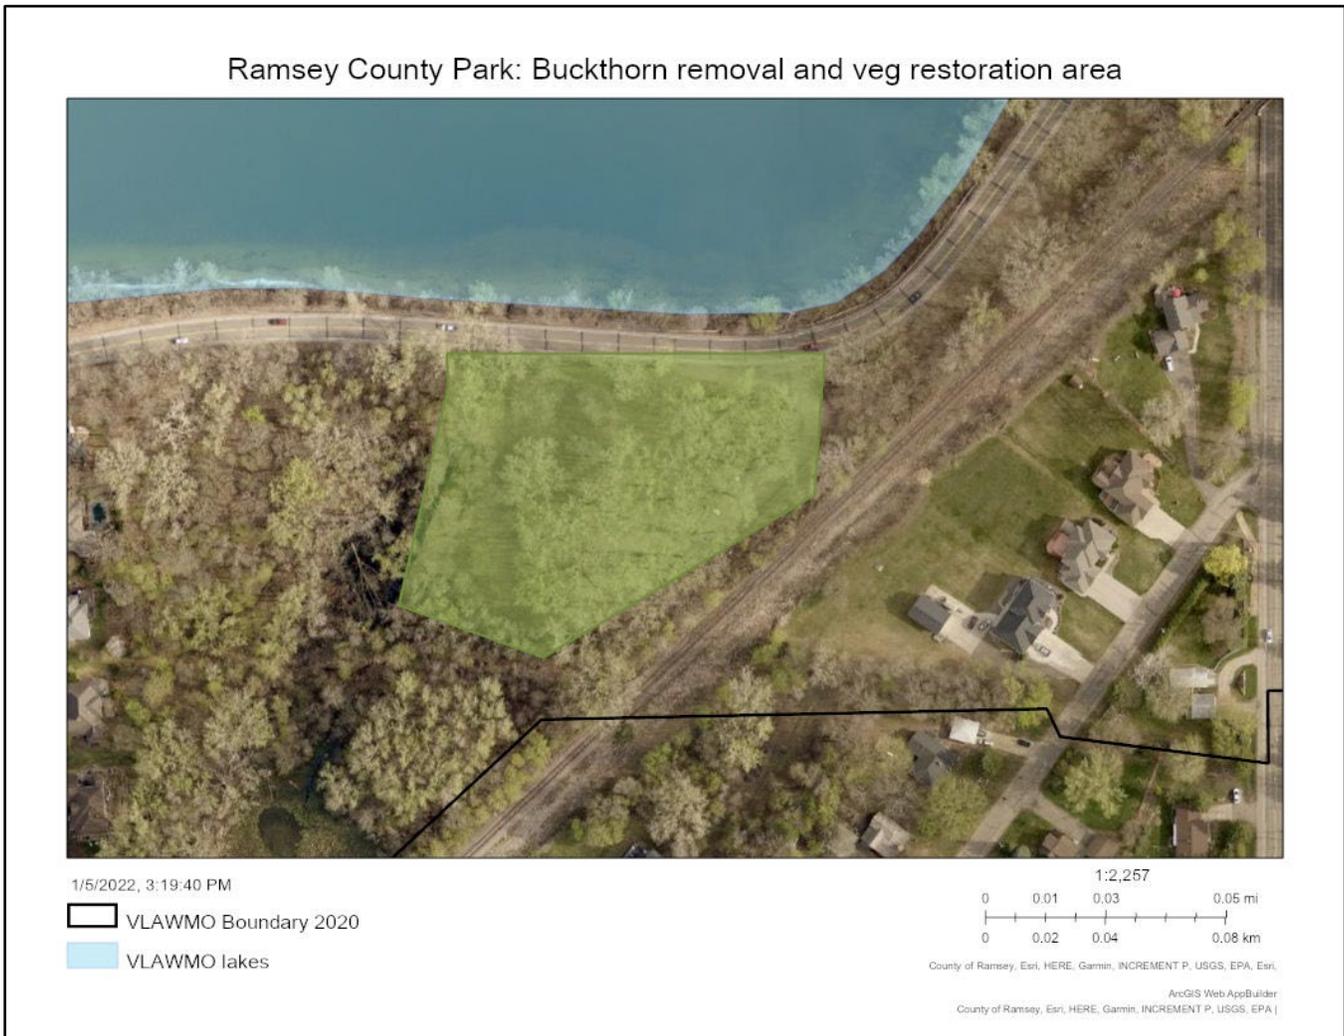
Figure 39: Restoration area in Vadnais Park to the south of East Vadnais Lake in Vadnais Heights. Photos of the restoration process included below.

A smaller restoration project (~2 acres) was begun in 2020 at the south end of East Vadnais Lake at Vadnais Park (Ramsey County Park/parking area and green space) due to the initiative of a local resident. VLAWMO has been working with volunteers and the UMN community-engaged learning students in partnership with Ramsey County Parks on this smaller buckthorn removal and vegetation restoration.
