**VLAWMO**

**VADNAISS LAKE AREA WATER MANAGEMENT ORGANIZATION  
Sustainable Lake Management Report  
Gem Lake, Ramsey County, MN**

**Updated by Dawn Tanner and Lauren Sampedro, 2023  
Originally prepared by Kristine Jensen, 2015**

## VLAWMO SUSTAINABLE LAKE MANAGEMENT REPORT (SLMR): GEM LAKE

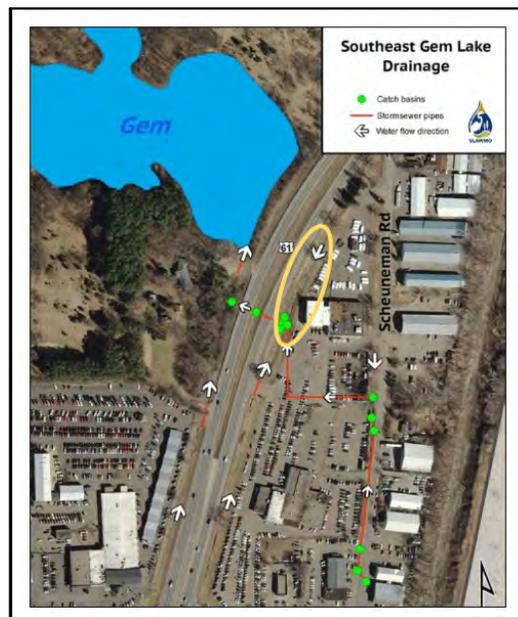
**Figure 1:** Stormwater swale and catch basins treating stormwater from Hwy 61. This was included in the VLAWMO press release in 2018 announcing the delisting of Gem Lake.

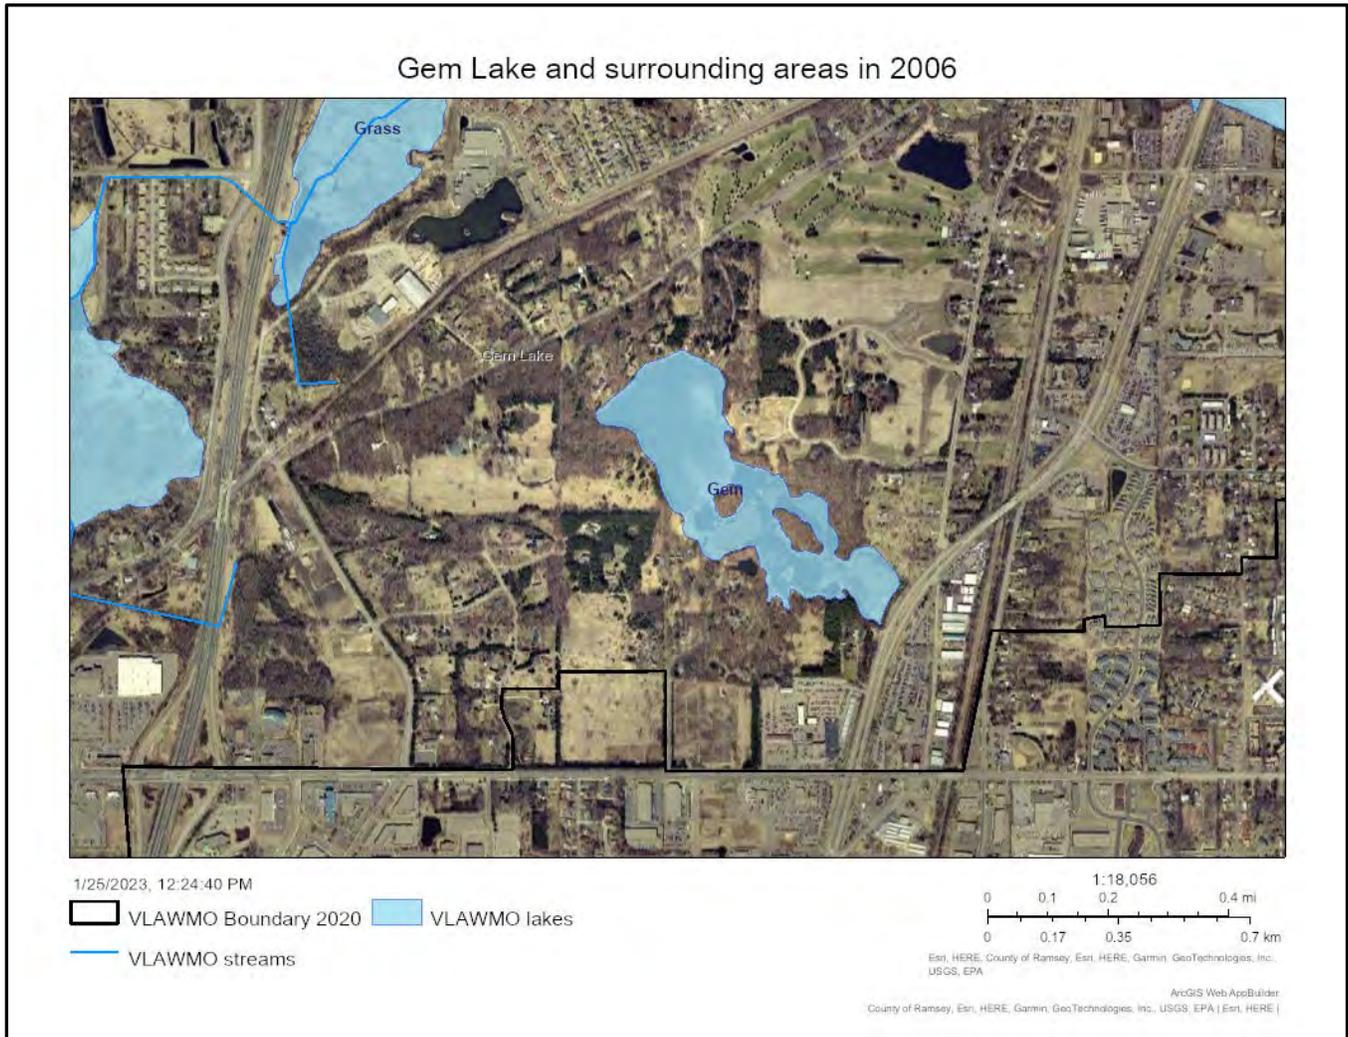
Figure 7: 2006 aerial photo of Gem Lake

In 2006, the Hillary Farm residential area construction had begun, and the Gem Lake Golf Club had been built.

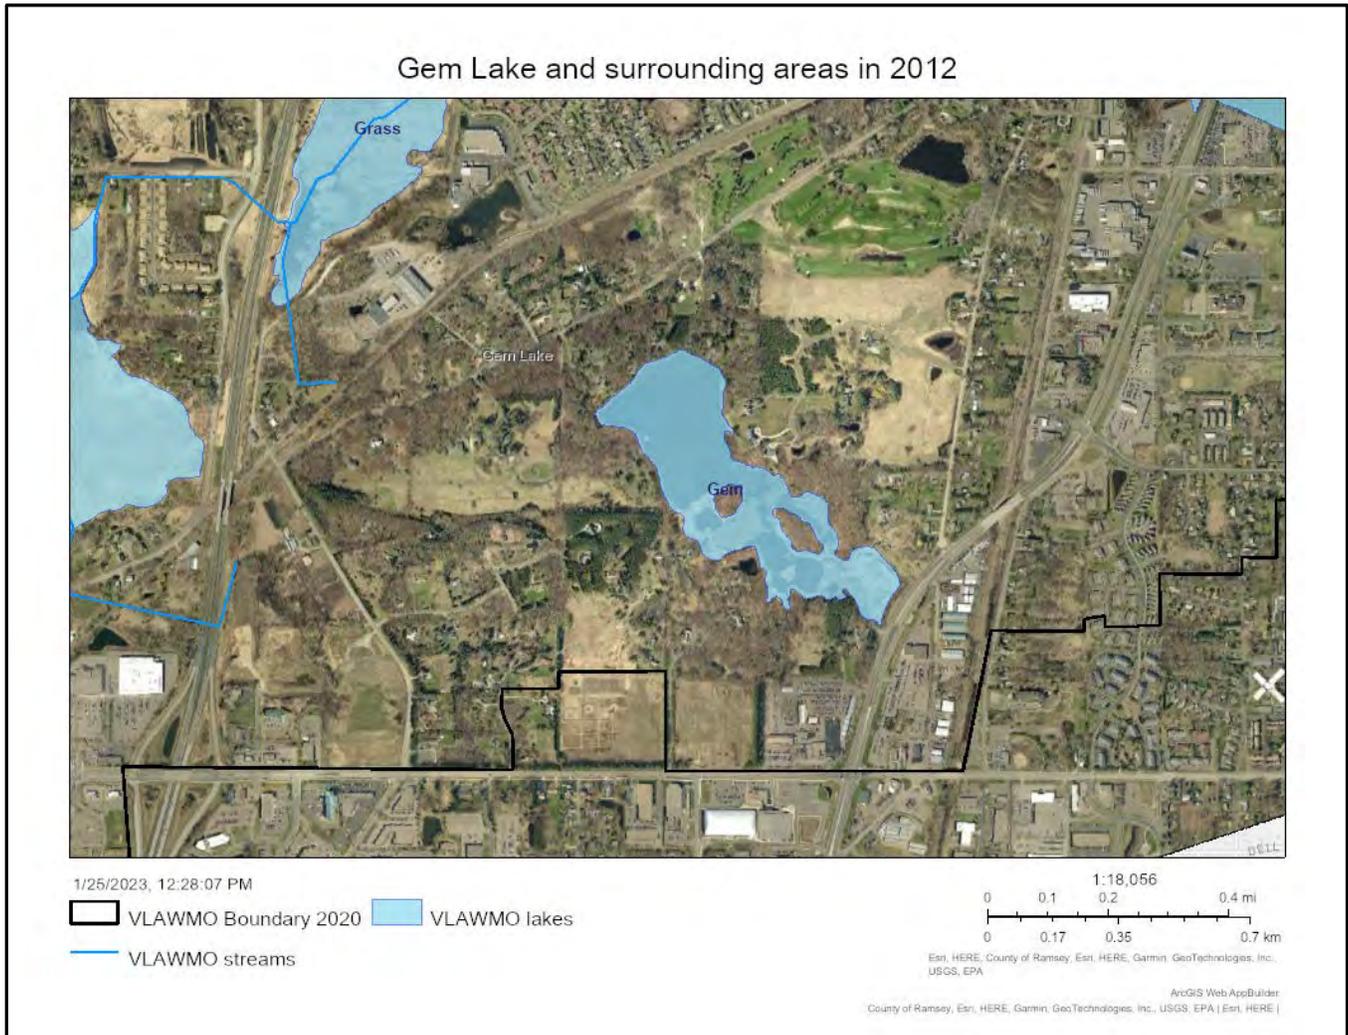
Figure 8: 2012 aerial photo of Gem Lake

By 2012, more homes were built in the Hillary Farm area. More homes were also planned for the Hillary Farm development.

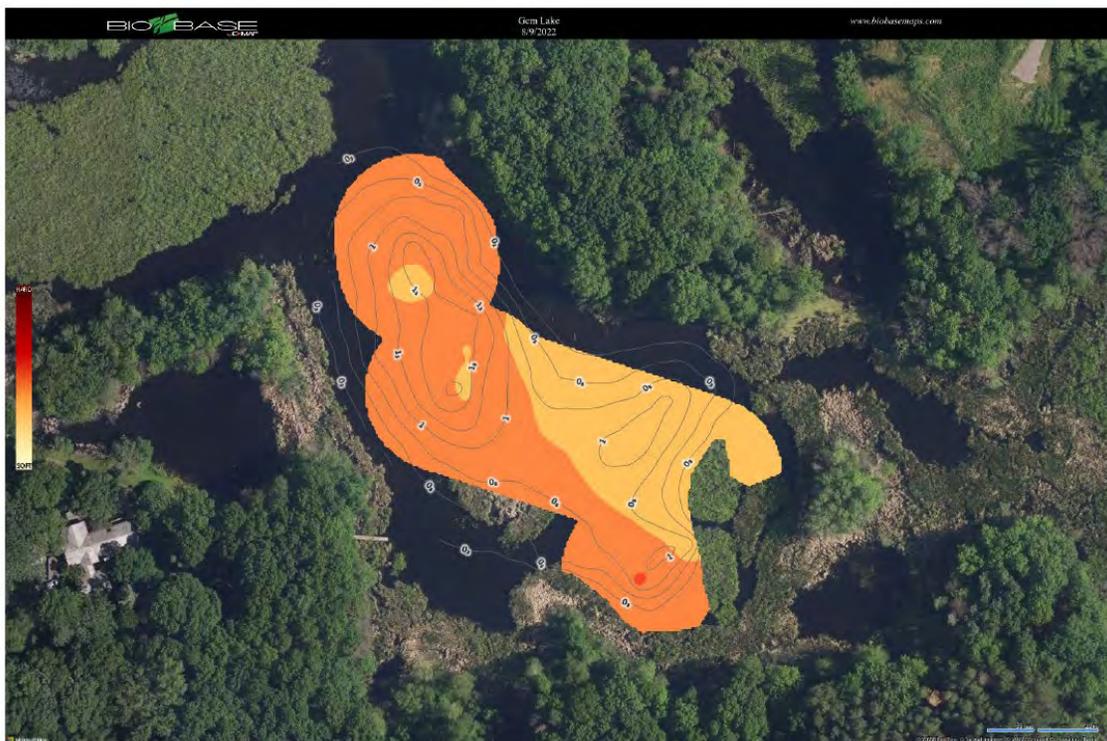
Figure 10. South Gem Lake bottom composition values with 0.3-m contours taken on August 9, 2022.

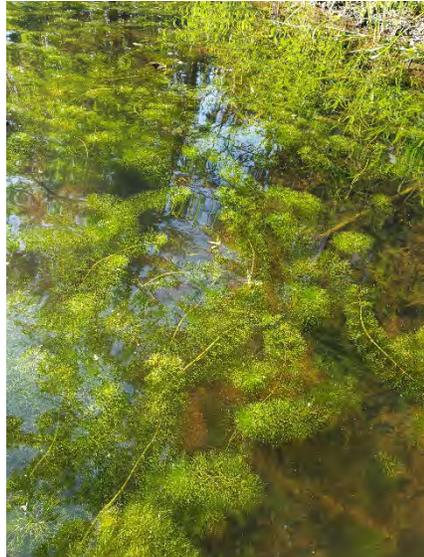
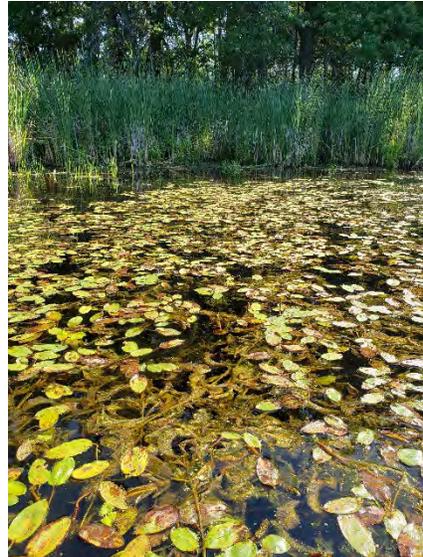
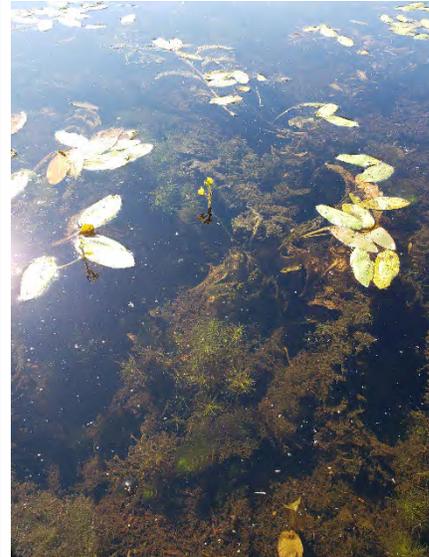
**Figure 16:** Macrophyte sampling with RCSWCD and VLAWMO staff.

For the aquatic macrophyte survey, 65 evenly spaced (50 m) georeferenced points were surveyed using the metal portion of a rake/tines tied to a rope. Aquatic macrophytes were found at 25 of 65 points surveyed. A total of 13 species were detected. Species included: Coontail (*Ceratophyllum demersum*), Naiad (*Najas* spp.), Large leaf pondweed (*Potamogeton amplifolius*), Leafy pondweed (*Potamogeton foliosus*), Robbin’s pondweed (*Potamogeton robbinsii*), Flatstem pondweed (*Potamogeton zosteriformis*), Bladderwort (*Utricularia macrorhiza*), Hornwort (*Ceratophyllum echinatum*), White waterlily (*Nymphaea odorata*), Wild Celery (*Vallisneria americana*), Duckweed (*Lemna* major and minor), Filamentous algae (*Spirogyra/Cladophora* spp.). The three most common species found on Gem Lake were Large leaf pondweed (*Potamogeton amplifolius*), Hornwort (*Ceratophyllum echinatum*), and Coontail (*Ceratophyllum demersum*). The Naiad species appeared to be Southern naiad (*Najas guadalupensis*), but further verification is needed. Spatterdock (*Nuphar variegatum*) was visible near point 33 but was not detected on the rake. Due to low water levels points 1-5, 37-38, 40-48, 51-53, and 66-75 were inaccessible and not able to be surveyed. No aquatic invasive plant species were detected.

Hornwort at Gem Lake	Large-leaf pondweed at Gem Lake	Native plants (Large-leaf pondweed and Naiad shown here) help support clear water by using nutrients in the water column for growth

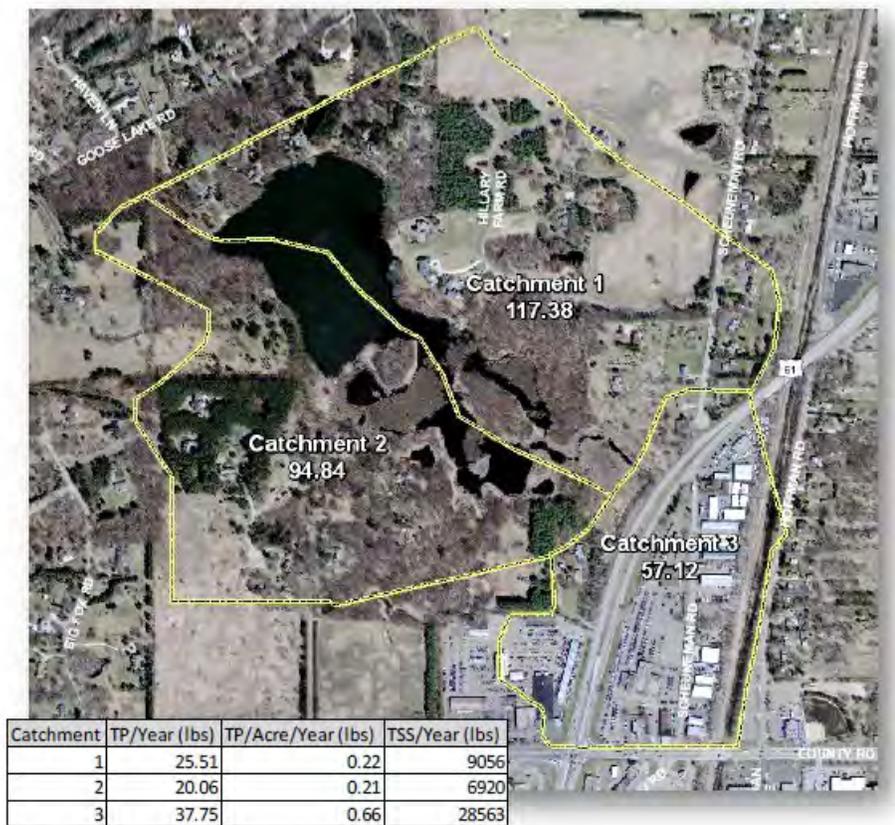
In 2012, the Ramsey Conservation District (RCD), now RCSWCD, completed a Retrofit Report for Gem Lake. This was part of a larger effort to assess the full watershed and subwatershed scales and identify optimal locations for BMPs.

Figure 22: Gem Lake Subwatershed: 3 subcatchments focused upon for recommended retrofits
