APPENDIX B: INVENTORY & ASSESSMENT

COMPREHENSIVE WATERSHED MANAGEMENT PLAN 2017-2026

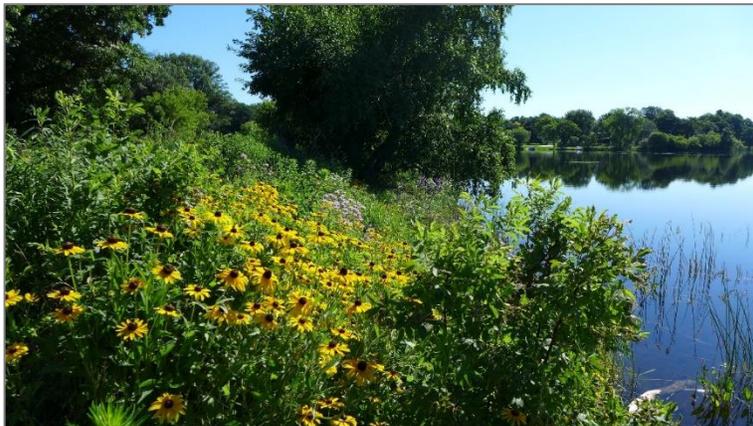
VLAWMO partnered with the BLID and the City of White Bear Lake to restore an area on the northwest shoreline of Birch Lake that had visible erosion issues due to the public trying to access the lake as well as many weeds and non-native plants. From 2010 - 2012, 850 feet of shoreline was restored, which included the installation of hundreds of native plants and an access path with large stones for fishing platforms as well as a bench for viewing.

Snags were left in the water to provide habitat for turtles and fish. The partnership provides funds each year for maintenance activities. This project received grant funding from the Ramsey Conservation District and the MN Department of Natural Resources.

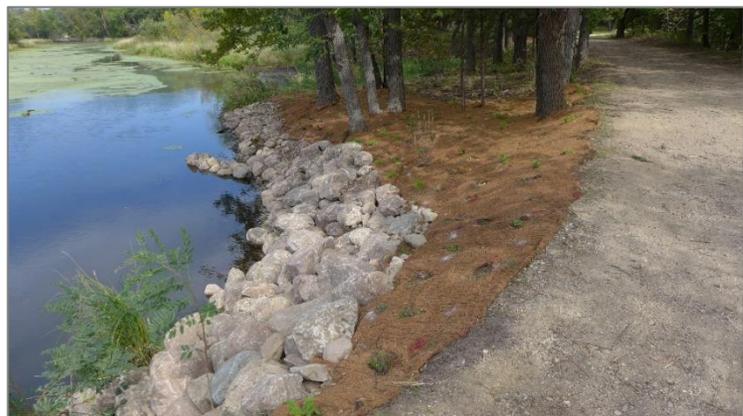
In fall 2015, VLAWMO worked with the Ramsey Conservation District and the North Oaks Homeowners Association to restore a portion of the channel between Deep and Pleasant Lake. The banks of the channel showed signs of erosion and a combination of rip rap and native vegetation was used to secure the bank and prevent further erosion. A crew from the Conservation Corps of Minnesota and Iowa performed much of the labor and North Oaks volunteers have been providing maintenance.

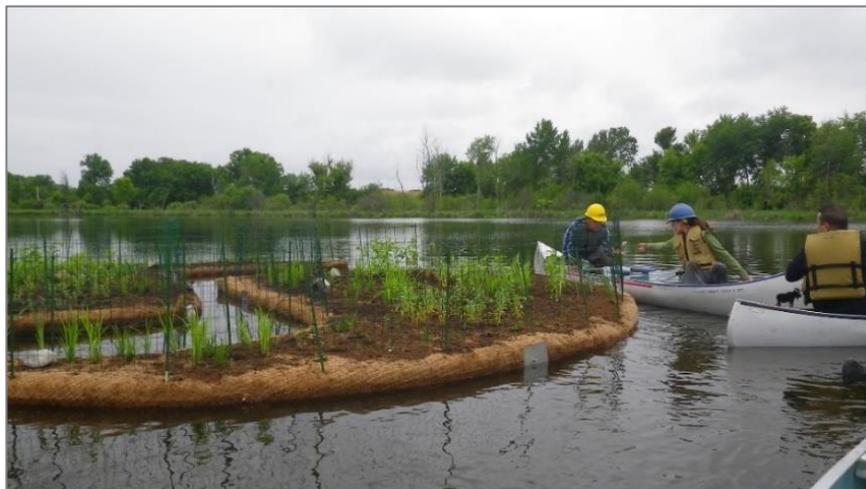
VLAWMO installed a floating island on Tamarack Lake in 2014 to be used as an educational tool as well as help water quality. Studies have shown that floating islands can absorb nutrients from the water which can lower TP levels. The island is planted with native vegetation and provides habitat for the birds and wildlife at the nature center. VLAWMO also participates in educational programs at Tamarack Nature Center, most recently with the successful Dragonfly Monitoring program for both kids and adults.

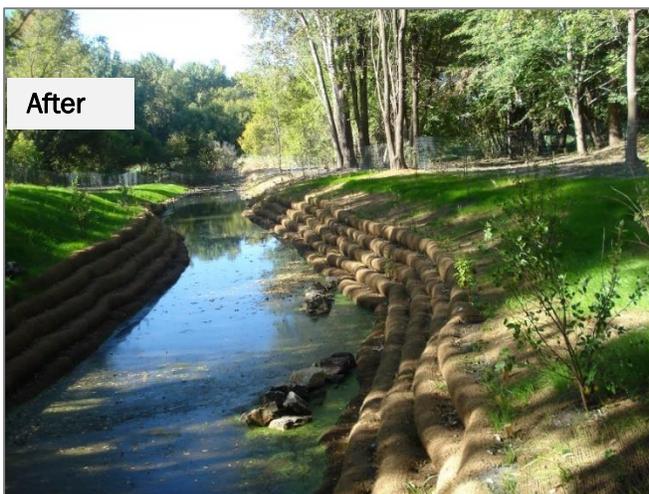
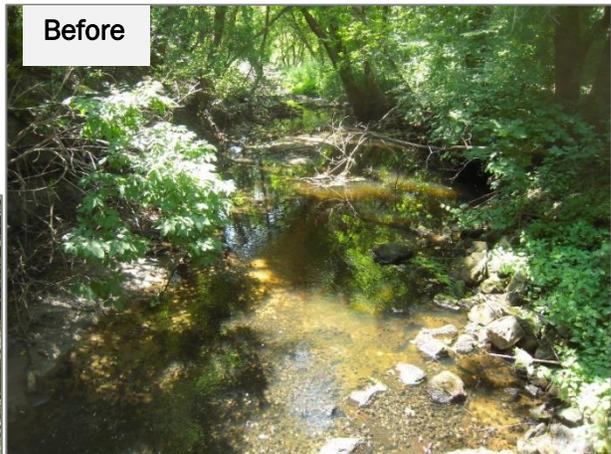
VLAWMO restored the banks of Lambert Creek at the Oakmede site in 2012-2014. The site was overgrown with trees and weeds and the banks were eroding. The site was cleared of invasive and excess vegetation and

soil lifts were installed to stabilize the banks. Native shrubs, trees and perennials were installed. Water quality levels were better in 2015 at this site and staff hopes to see that trend continue. Funding support for this project came from a Clean Water Legacy
