Pleasant Lake Shoreline Evaluation

North Oaks Homeowner Association

July 2009

The North Oaks Home Owners Association (NOHOA) owns the entire buffer area surrounding the lake, an approximately 50-feet strip up from the Ordinary High Water Line (OHWL). Funded by NOHOA, this report outlines the findings and recommendations stemming from the shoreline assessment that was performed by Great River Greening in June and July of 2009.

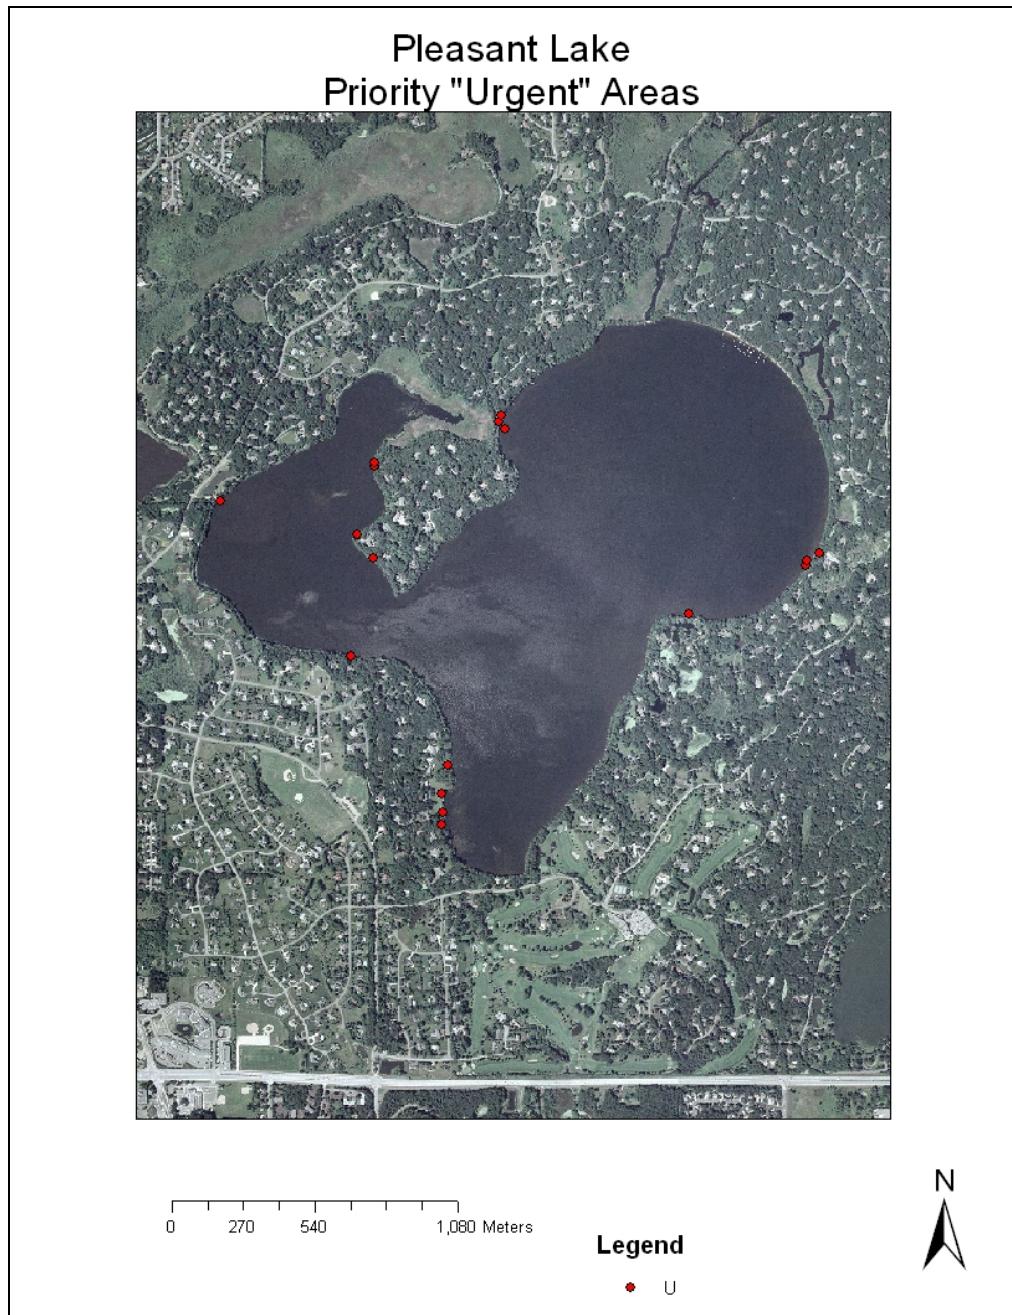
Figure 6. Map of Urgent Priority areas.

"Urgent Priority" areas are shown in Figure 6. These are problem sites where active erosion is occurring very close to a trail or a road, etc. It is recommended that action be taken to stabilize the shoreline within the next 1 to 3 years to slow/halt degradation of the shoreline before it undermines trails or roads, etc. NOTE: Bank re-shaping may not be an option for most of these sites, since there is no space to grade back to (trail or road is too close), so other stabilization options will be needed, like building up the bank with vegetated or soft-armor wall (for example Bio-D-Blocks, Enviro-Lok or Delta-Lok systems) at a higher than 1:4 slope ratio.

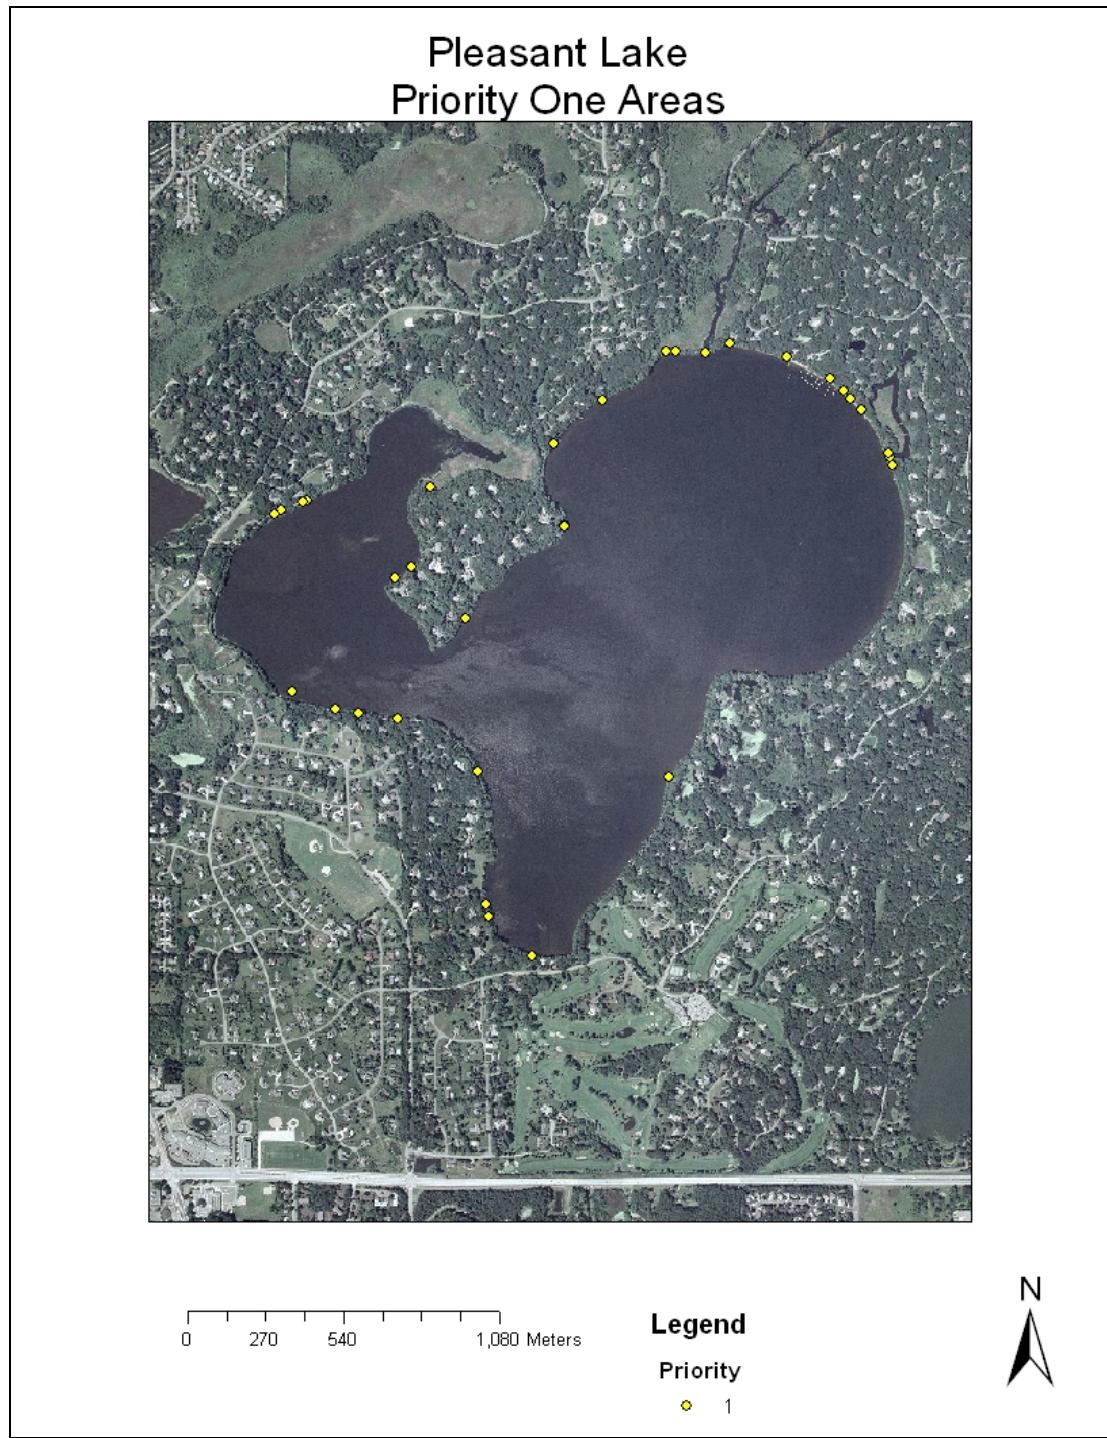
Figure 7. Map of Priority 1 areas.

- *High Priority Areas (“Priority 1”)*: it is recommended that action be taken to stabilize the shoreline within the next 5 years to slow/halt degradation of the shoreline before it undermines trails or roads. NOTE: for most of these sites, there is still adequate space to perform bank re-shaping, if needed, but if stabilization activities are delayed too long, this opportunity will be lost.

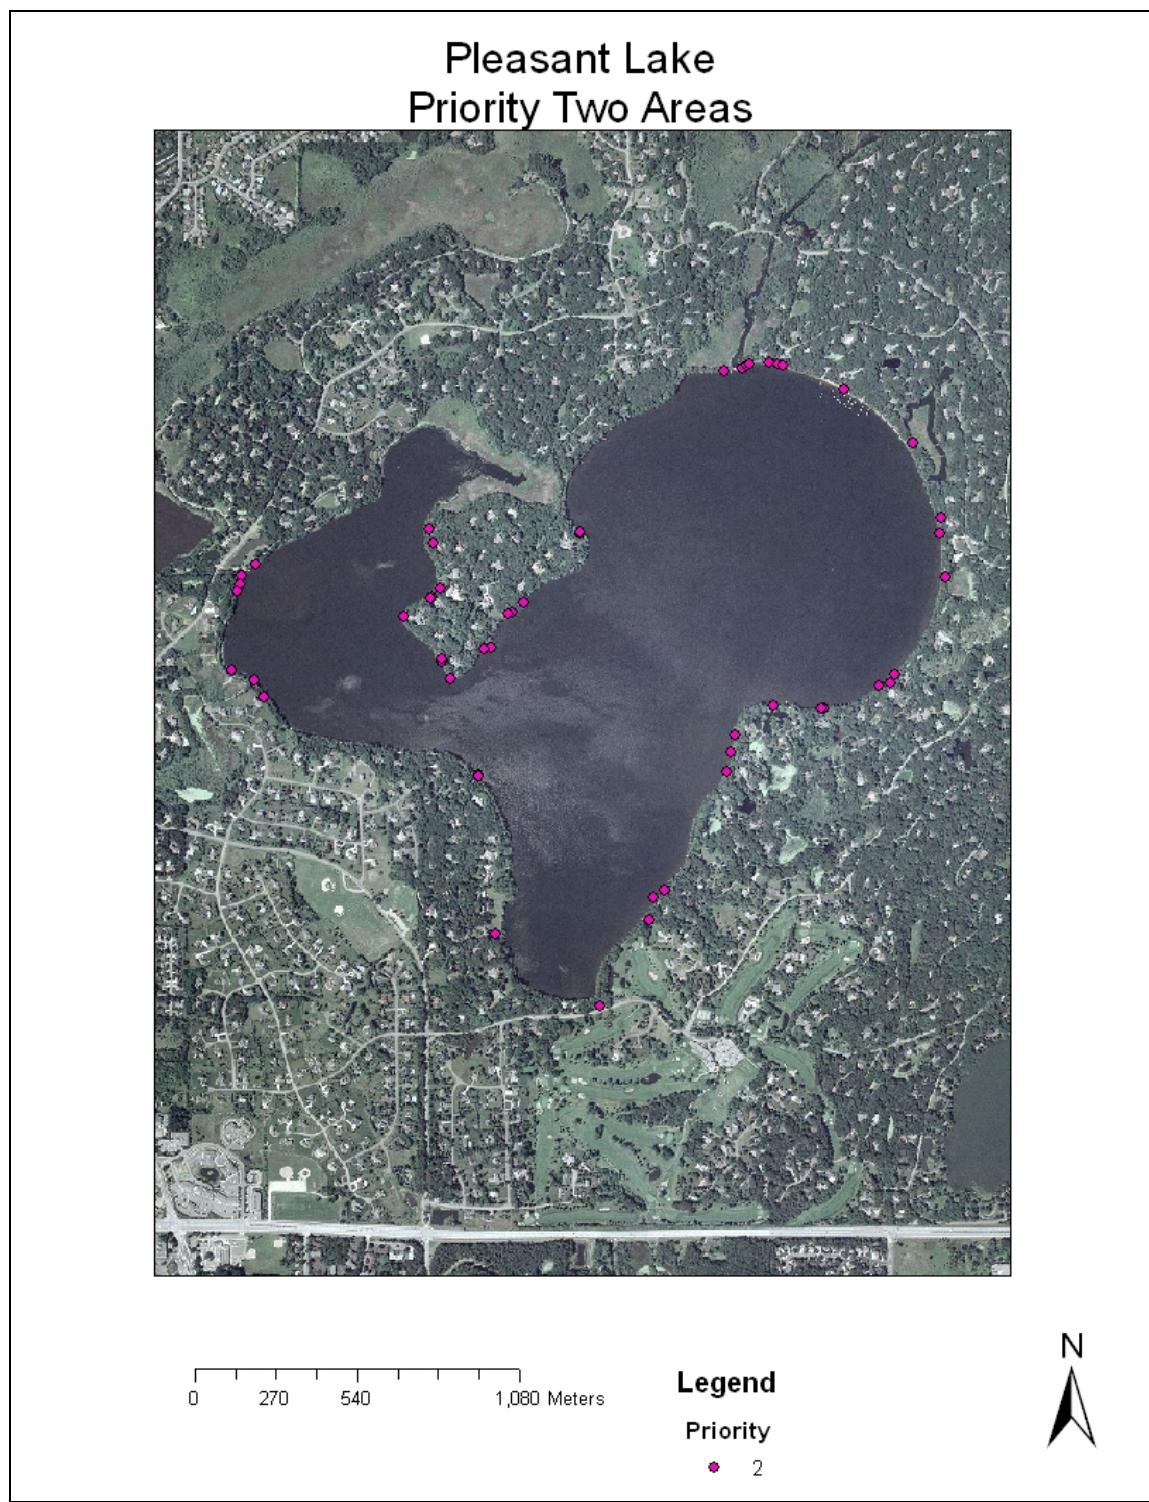
Figure 8. Map of Priority 2 areas.

- *Medium priority areas (Priority 2):* it is recommended that action be taken to stabilize the shoreline within the next 10 years to slow/halt degradation of the shoreline or upland bank. NOTE: for most of these sites, there is still plenty of space and time to perform bank re-shaping, if needed.

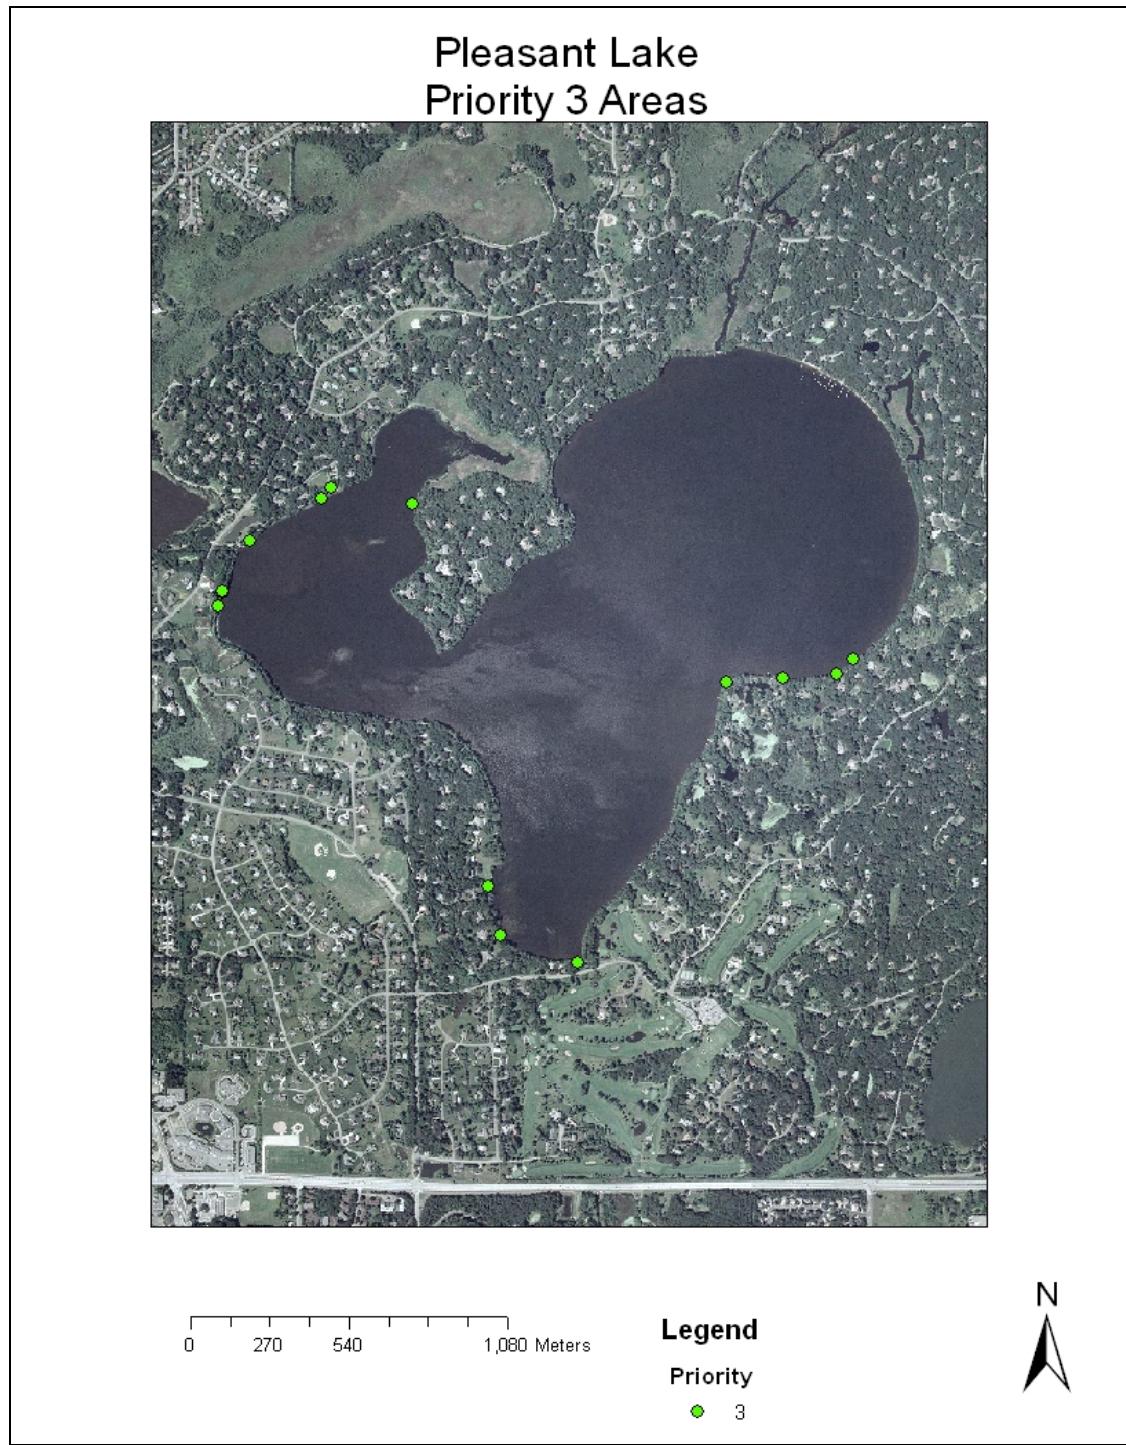
Figure 9. Map of Priority 3 areas.

- *Low priority areas (Priority Area 3):* it is recommended that action be taken to stabilize the shoreline within the next 10 to 20 years to slow/halt degradation of the shoreline or upland bank. Even though labeled “low” priority, these are still problem areas that require attention. NOTE: for most of these sites, there is still plenty of space and time to perform bank re-shaping, if needed.

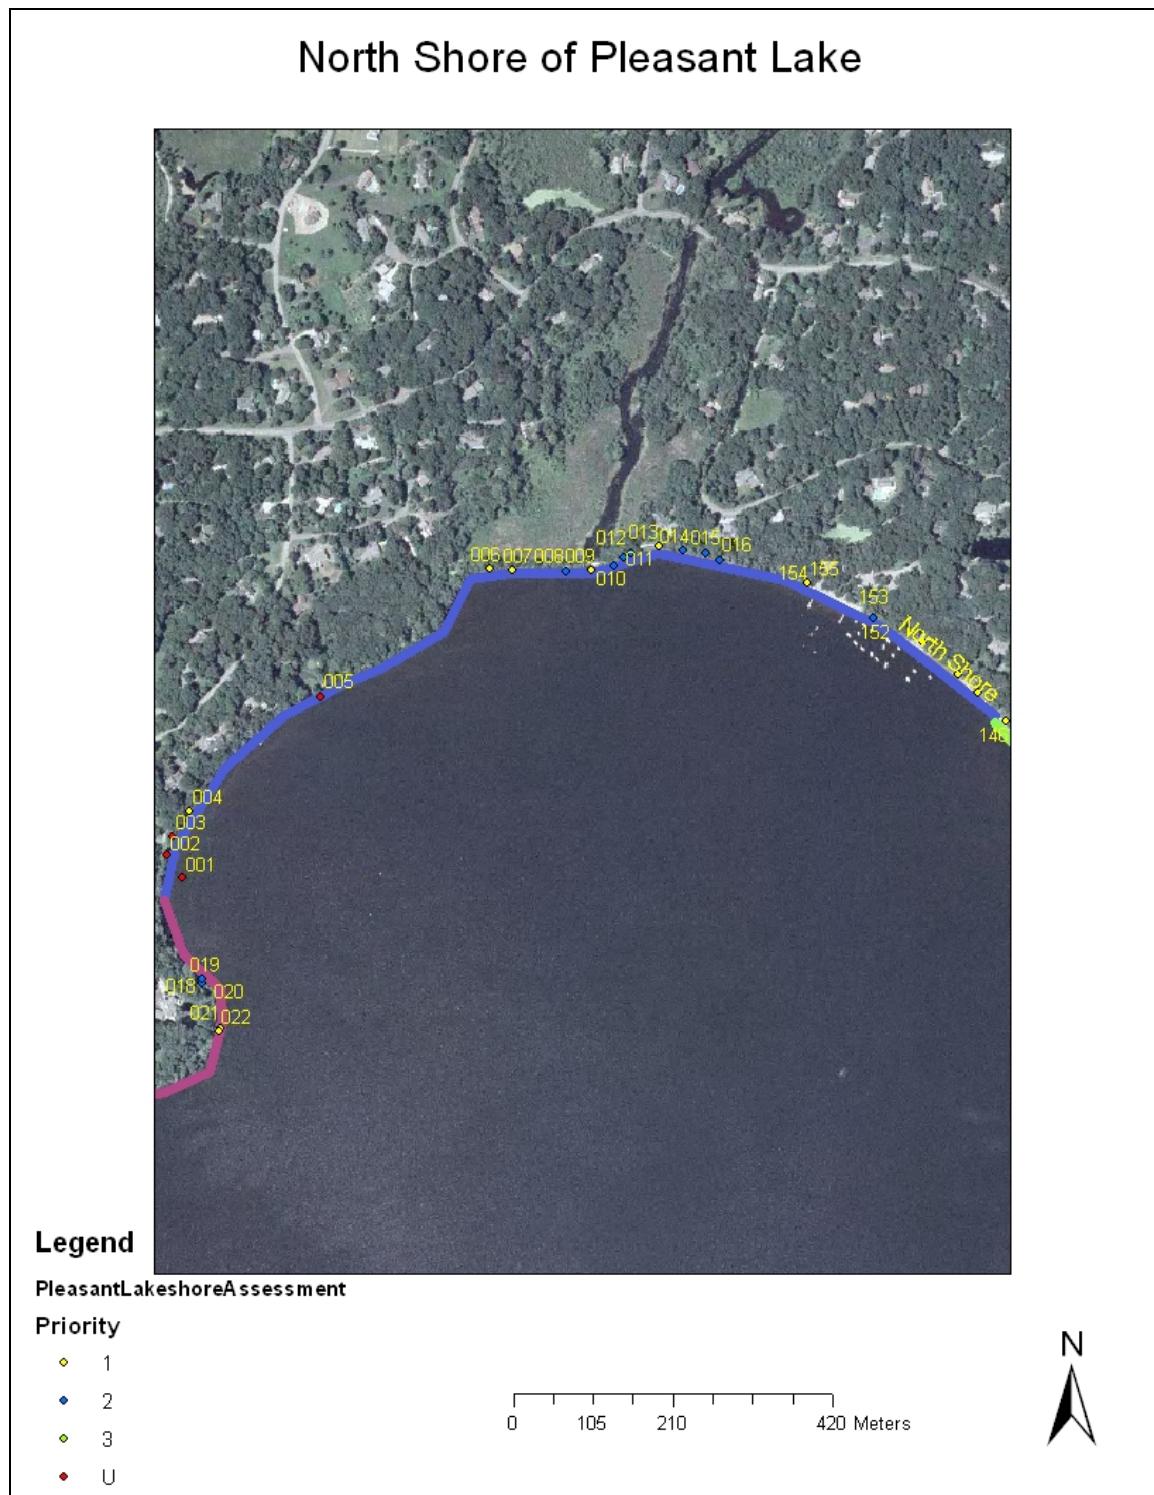
The shoreline that extends from south of the Swimming Beach westward around the north side of the lake to the start of the Island Peninsula (approximately 4500 feet long) (Figure 11) is referred to in this report as the *North Shore of Pleasant Lake*. The banks of this stretch were moderate in height and consisted mostly of mineral soil, except for the canal area that connects to Deep Lake, which are organic soils. Along the north side and the Island Peninsula were observed many boulders on the toe of the bank. Most of this shoreline was classified as a *low-bank, high energy* shoreline.

Figure 11. Map of North Shore of Pleasant Lake, showing priority areas. Note that “urgent” priority areas are marked with a red dot.

For the canoe storage area, by the swimming beach, it is recommended that it be re-designed so that the following criteria are met:

- Build racks for the canoes to get them off the ground and contained to one area.
- Install the racks on the upland side of the path so people are more reluctant to drag them to the water and have to portage them to the water's edge.
- Thicker vegetation, fencing or both to direct people to the launch area to put the canoes in and protect the bank.

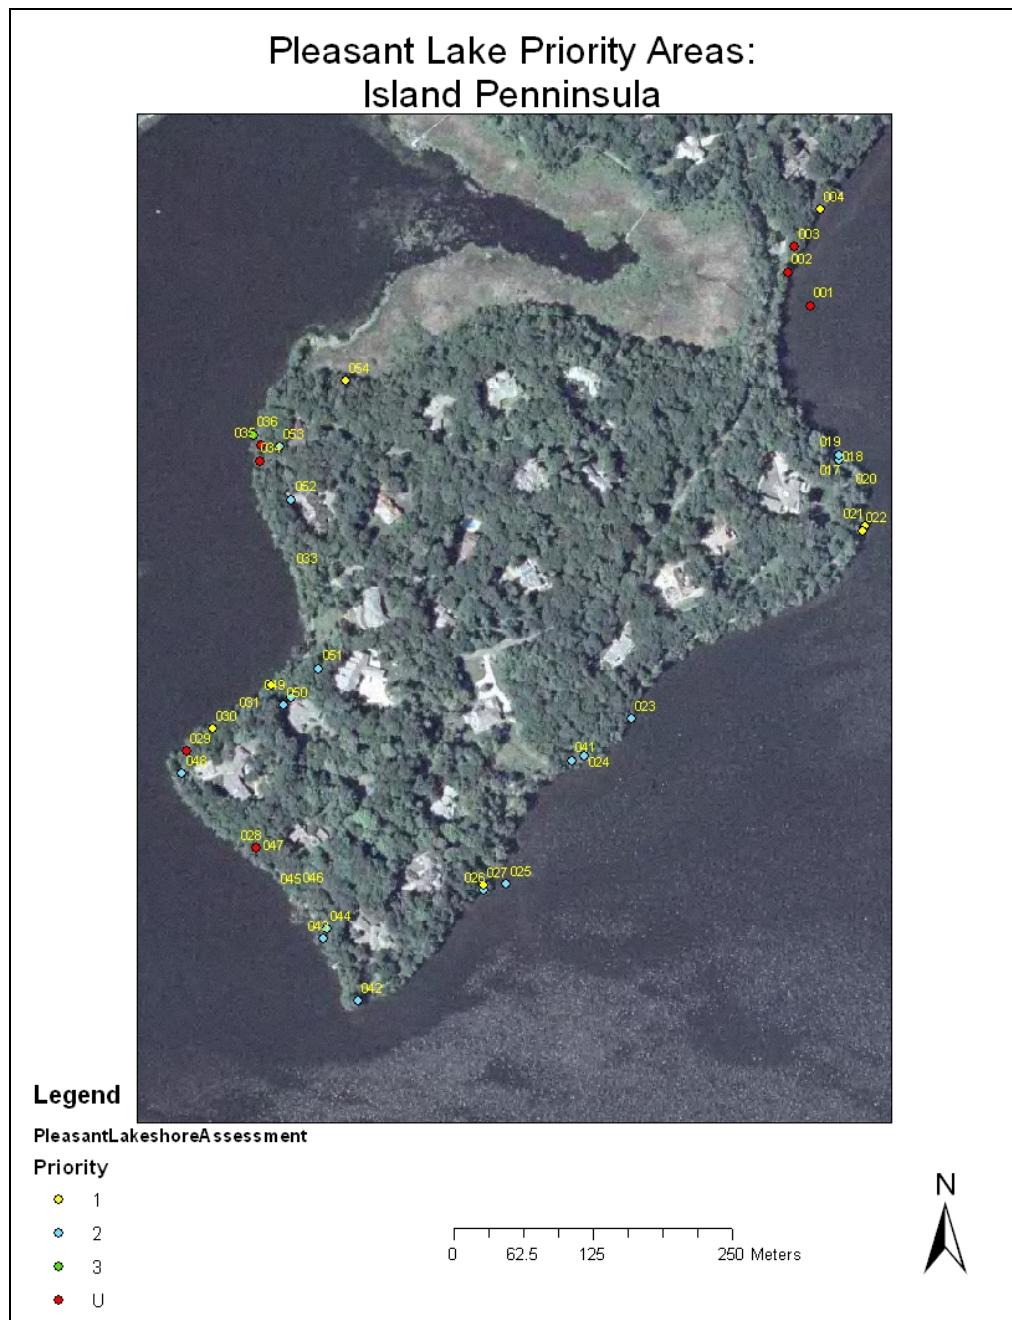
The shoreline that extends from the beginning of the Island Peninsula, or “the Island”, (where the trail starts up again from Island Road), all the way around the peninsula to the start of the Cattail Marsh, approximately 5200 feet long (Figure 13). The majority of this shoreline was classified as *low bank, high energy*. This stretch had several urgent high priority areas (see Table 2), including the area where Island Rd approaches the water’s edge, and most of the stretch of west- and southwest-facing shoreline on the west side of the peninsula.

Figure 13. Map of Island Peninsula of Pleasant Lake, showing priority areas. Note that “urgent” priority areas are marked with a red dot.

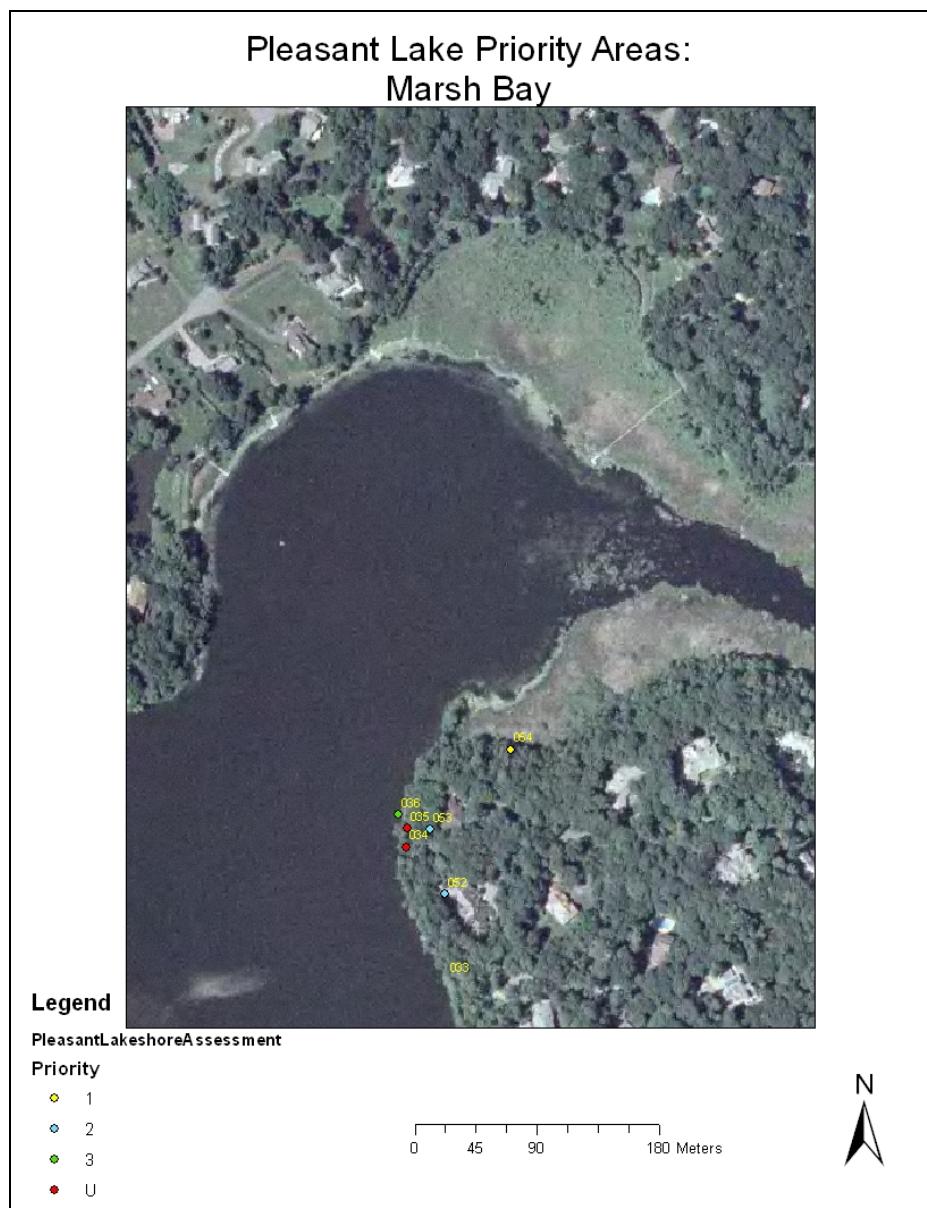
The approximately 2700 foot long stretch of shoreline on this marshy bay, located northwest of the Island Peninsula consisted almost exclusively of cattail marsh plant community species (Figure 15). This shoreline was classified as *low bank, low energy*. Here, hybrid cattail, reed canary grass, Canada blue joint, dominate, but many other species such as tussock sedge, lake sedge, bottle brush sedge, marsh fern, and other marsh species live in this mucky soil. See Appendix 6 for a list plant species encountered during this evaluation. The main priority of this stretch would be to identify and remove exotic yellow iris. Currently, yellow iris is in the early stages of invasion here, and it would be relatively easy to snuff it out before it gets a stronghold on the marsh. The best time to identify it is in early to mid June, when it is in flower (Figure 16). Blue flag iris, the native blue-flowering iris, should be left alone (Figure 17).

Figure 15. Map of Marsh Bay of Pleasant Lake, showing priority areas.

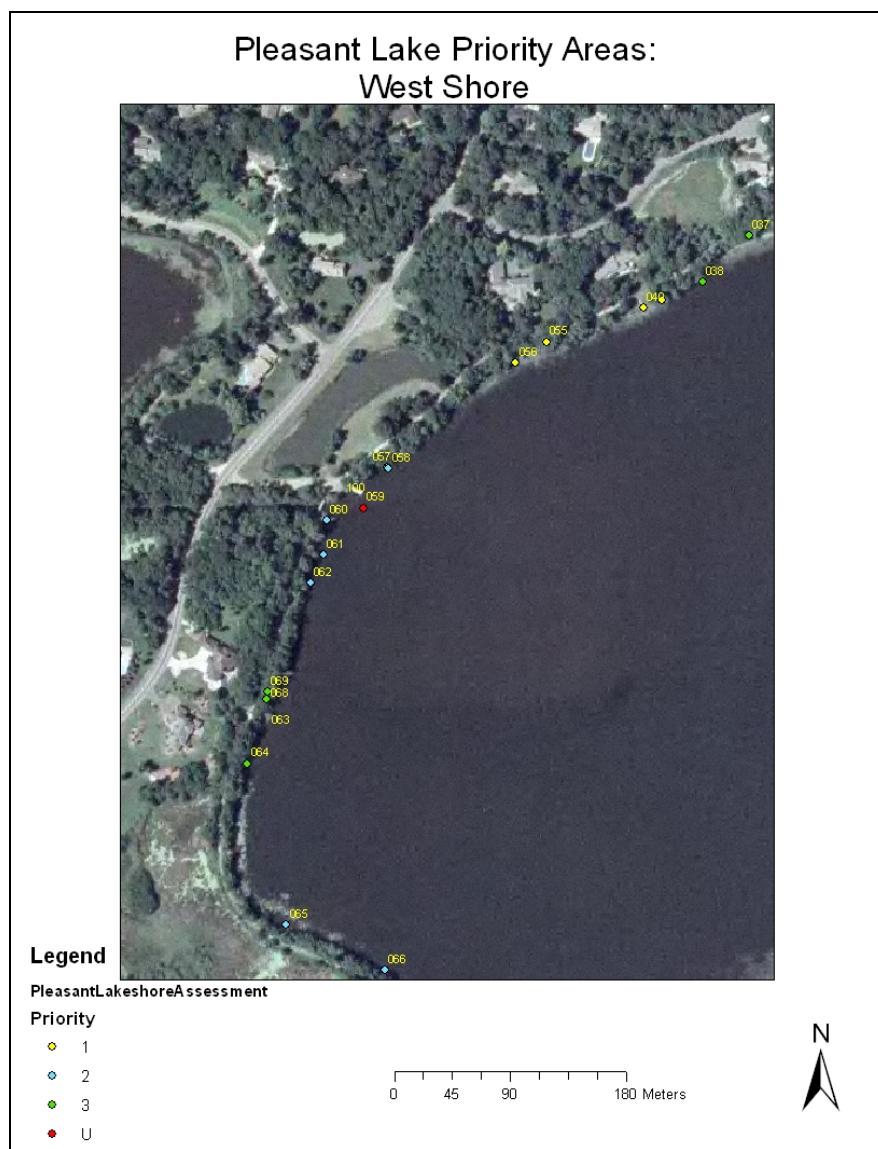
The West Shore is approximately 2700 feet long (Figure 18). Mineral soils resume on the west side of the lake (at approximately the location of 1 or 2 Ironwood Lane), and the plant communities, reflecting the soils, contain larger trees (silver maple, green ash, oak, etc.). Not as many rocks were evident on this part of the shoreline, extending down to the boat landing at Charlie Lake inlet. The majority of this shoreline was classified as *low bank, high energy*.

There are several priority areas here; including the large Urgent Priority area associated with the Charlie Lake Inlet canal (Figures 19-20), which is very eroded at the point, and potentially eroding the footings of the bridge. Included are plan and sections drawings of recommended practices for the Charlie Lake Inlet Canal area. A full, vegetated restoration of the point area is recommended, and rock vanes for the canal (see Appendices 5 and 7). Rock vanes are a practice that redirects the channel (the “thalweg”) away from the shoreline and towards the middle of the canal.

Figure 18. Map of West Shore of Pleasant Lake, showing priority areas. Note that one “urgent” priority area is marked with a red dot.

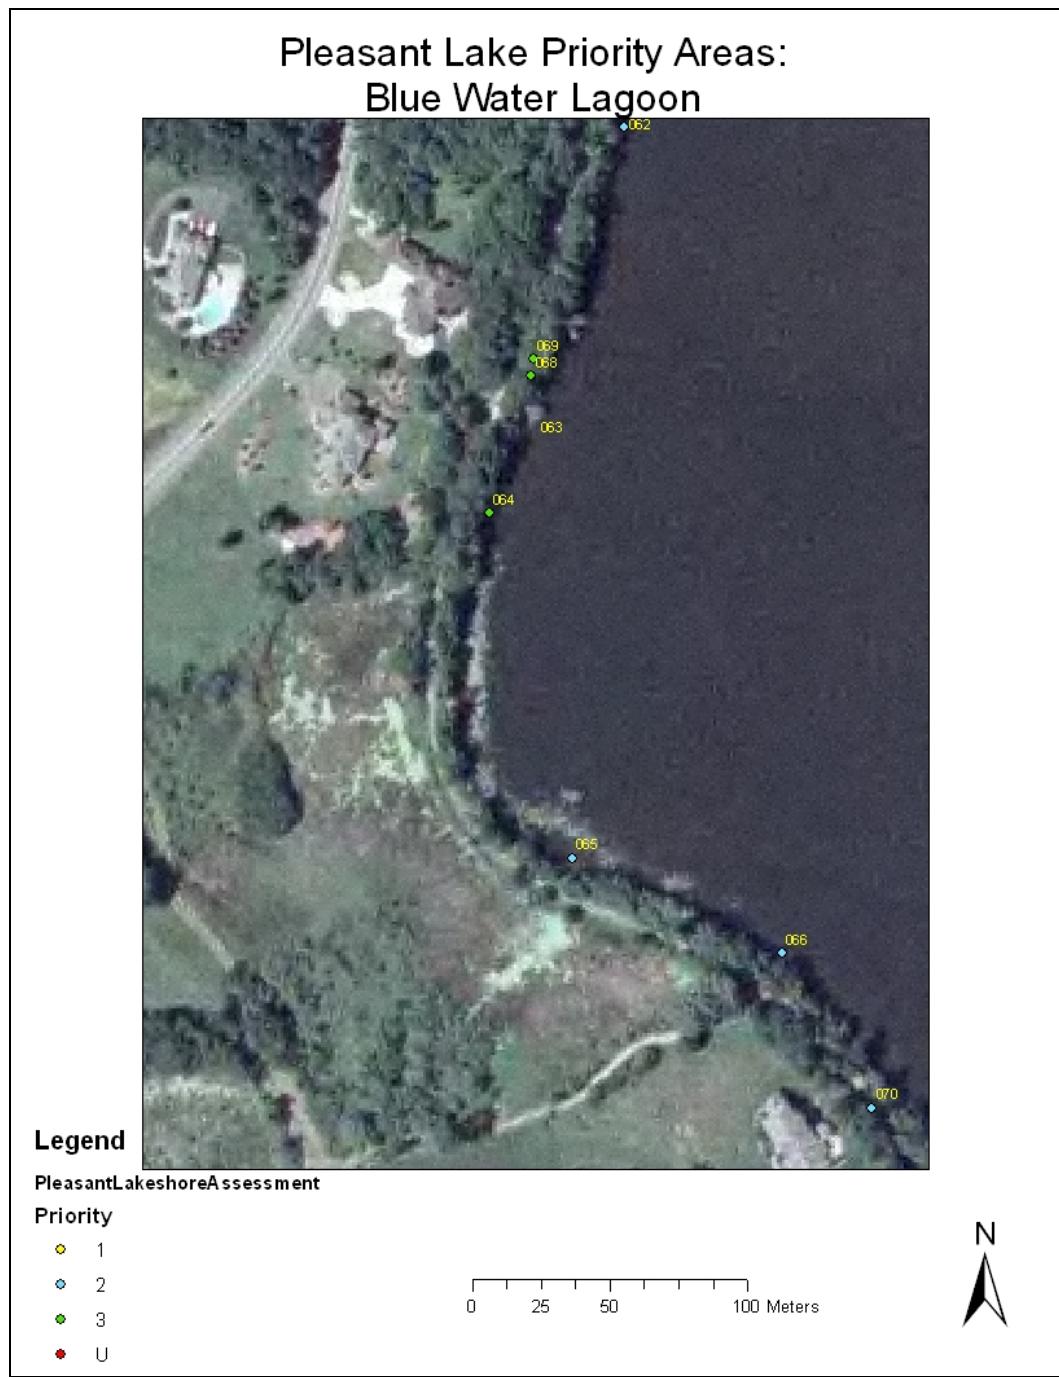
The shoreline located at “Blue Water Lagoon” and extending for about 2,000 feet to the southeast (until about the Hill Farm) is lower in height, and is connected to open wetlands, sedge meadows, and forested swamps to the west (see Figure 22). This shoreline was classified as *low bank, low energy*. The soil is a mosaic of organic soils and mineral soils. There are several priority areas here, but not urgent ones.

Figure 22. Map of Blue Water Lagoon of Pleasant Lake, showing priority areas.

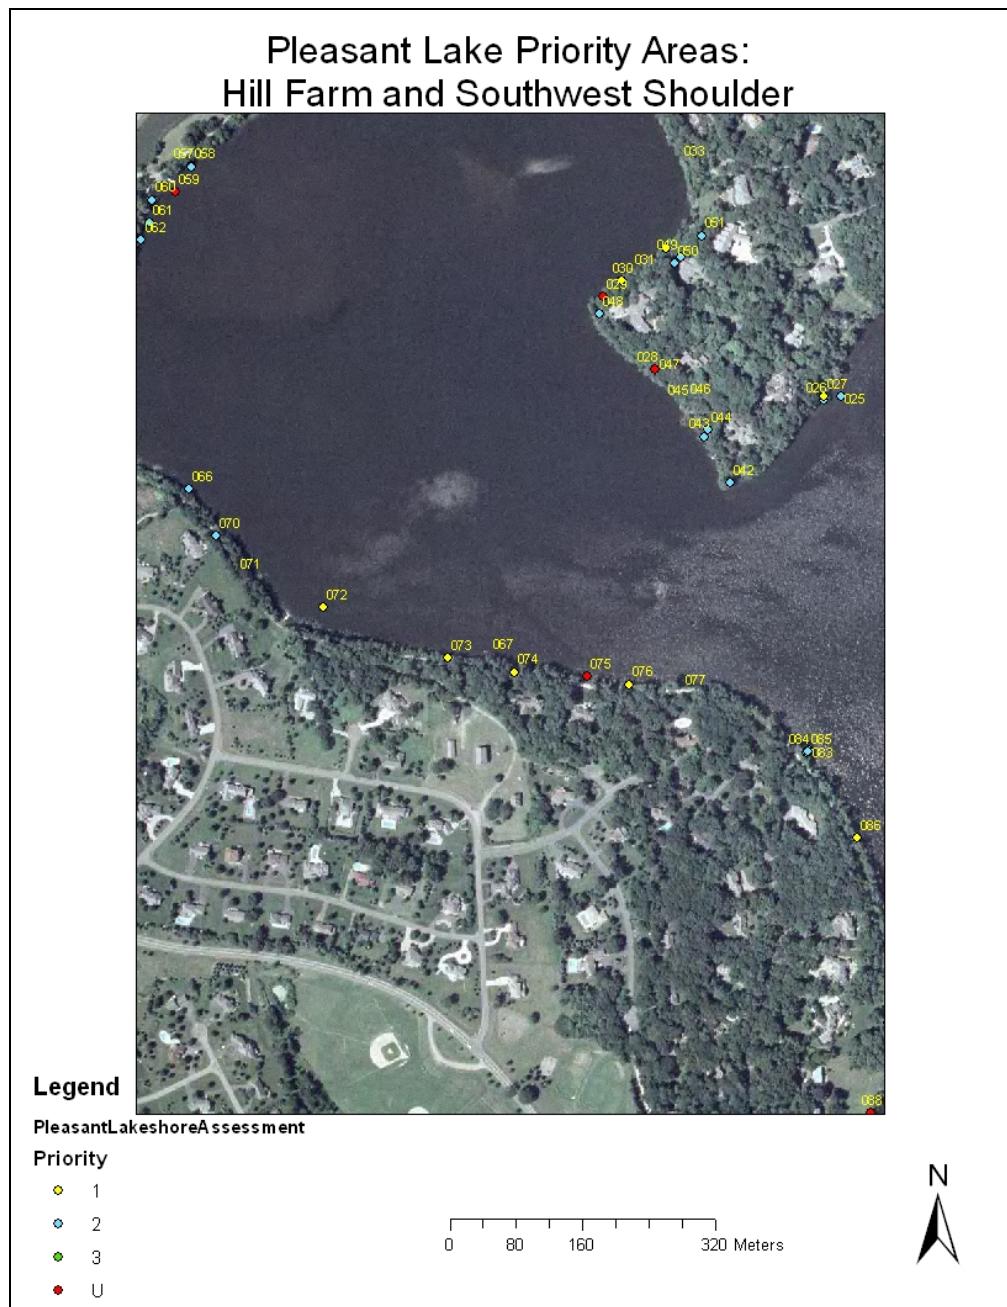
The stretch of approximately 2300 ft of shoreline rounding the bend approximately from Hill Farm to about 22 Evergreen Road has a very high bank and gets quite steep at times (see Figure 24). This shoreline was classified as *high bank, high energy* and *high bank, low energy*. This stretch has a couple of Urgent and High Priority areas where the bank is eroding very close to the trail.

Figure 24. Map of Hill Farm and Southwest Shoulder stretches of Pleasant Lake, showing priority areas.

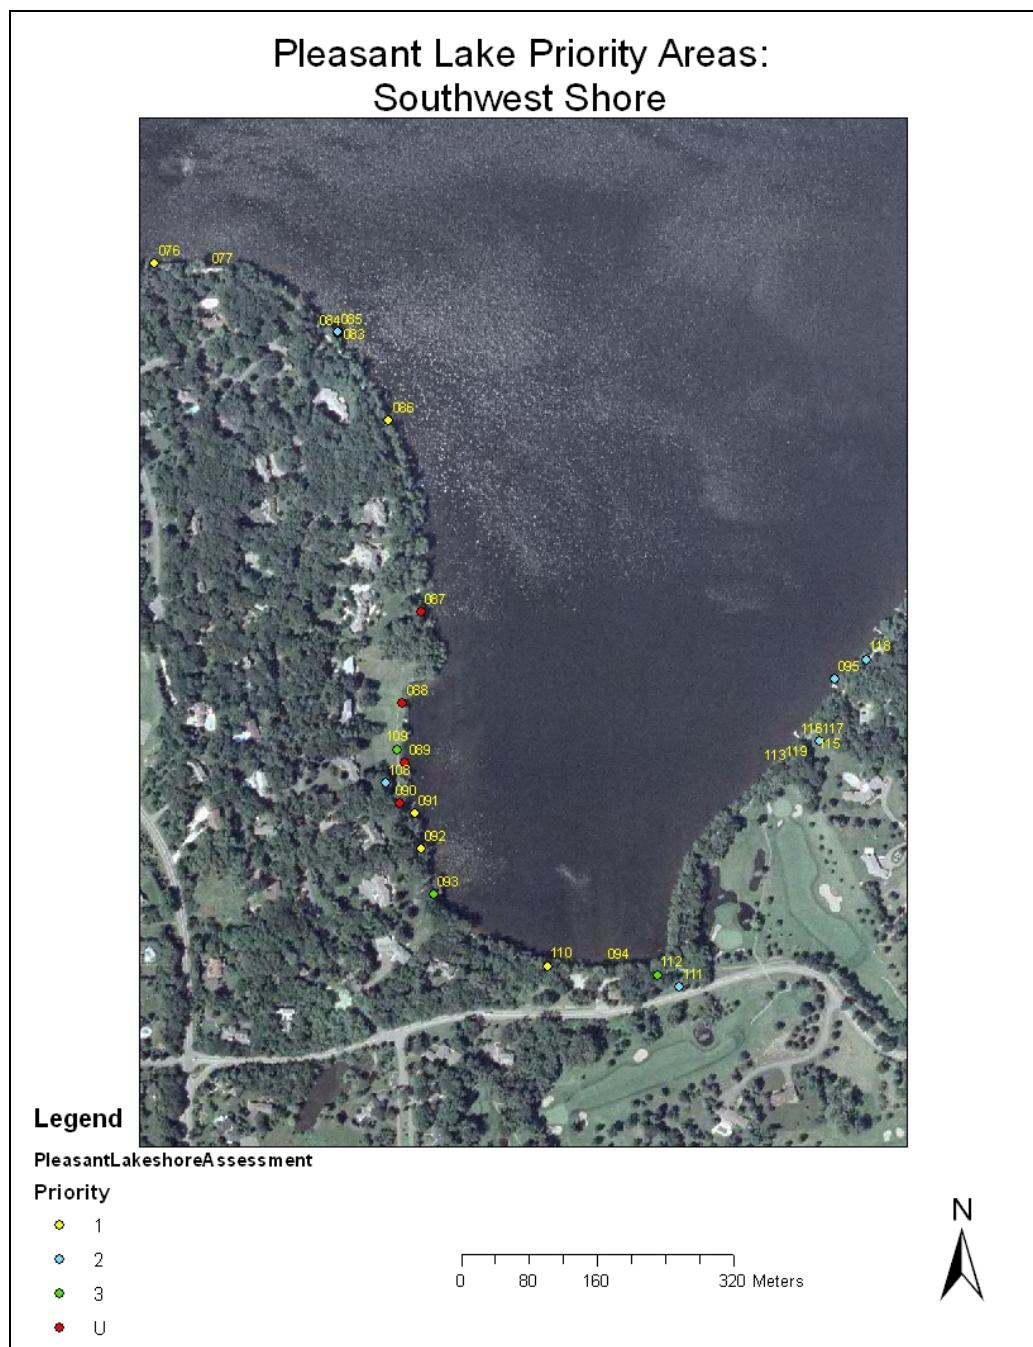
From about 22 Evergreen Road along the east-facing shoreline to the Gatehouse (see Figure 25). This approximately 2000 feet of shoreline is typified by low relief with gradual, shallow limnetic zones. This shoreline was classified as *low bank, high energy*. This stretch contains some Urgent High Priority areas where the bank is eroding very close to the trail. There are several properties that mow large areas of turf down to the water's edge.

Figure 25. Map of Southwest Shore of Pleasant Lake, showing priority areas.
Note that “urgent” priority areas are marked with a red dot.

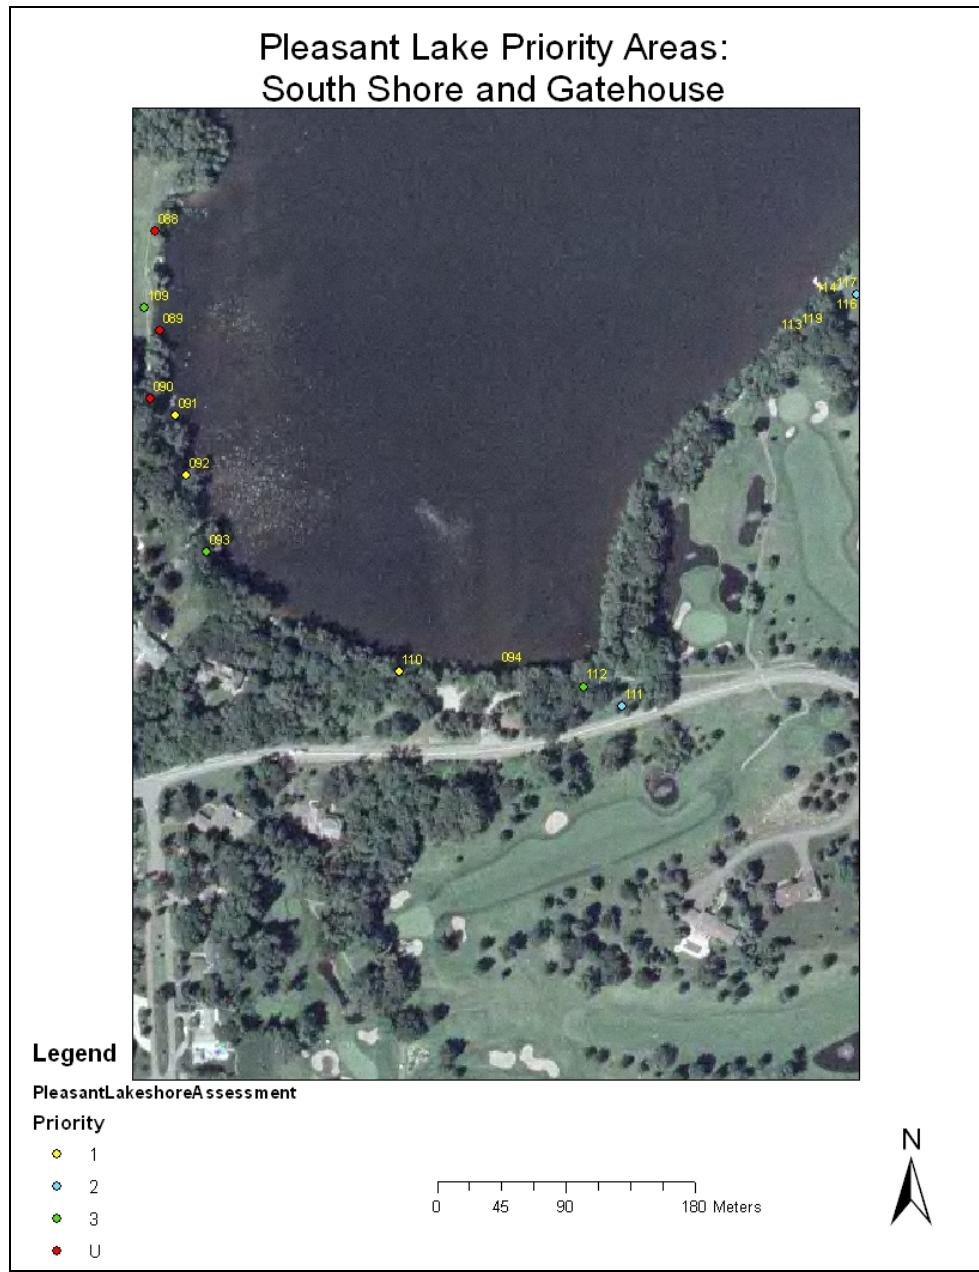
This is an approximately 1600 foot stretch of shoreline that encompasses the public trail from 2 Evergreen Road to the Golf Club, just north of East Pleasant Lake Road (see Figure 28). This shoreline was classified as *low bank, high energy*. Ice ridge formations are present, starting about 300 feet west of the Gatehouse. For the most part, the shoreline is in good shape here, probably owing to the fact that there is a nice, wide, continuous buffer throughout most of this stretch (punctuated by the boat launch). The Golf Course, by virtue of its presence, prevents homes from occupying this space, and thus prevents clearing vegetation in the buffer, which is a good thing for the shoreline.

Figure 28. Map of South Shore and Gatehouse of Pleasant Lake, showing priority areas.

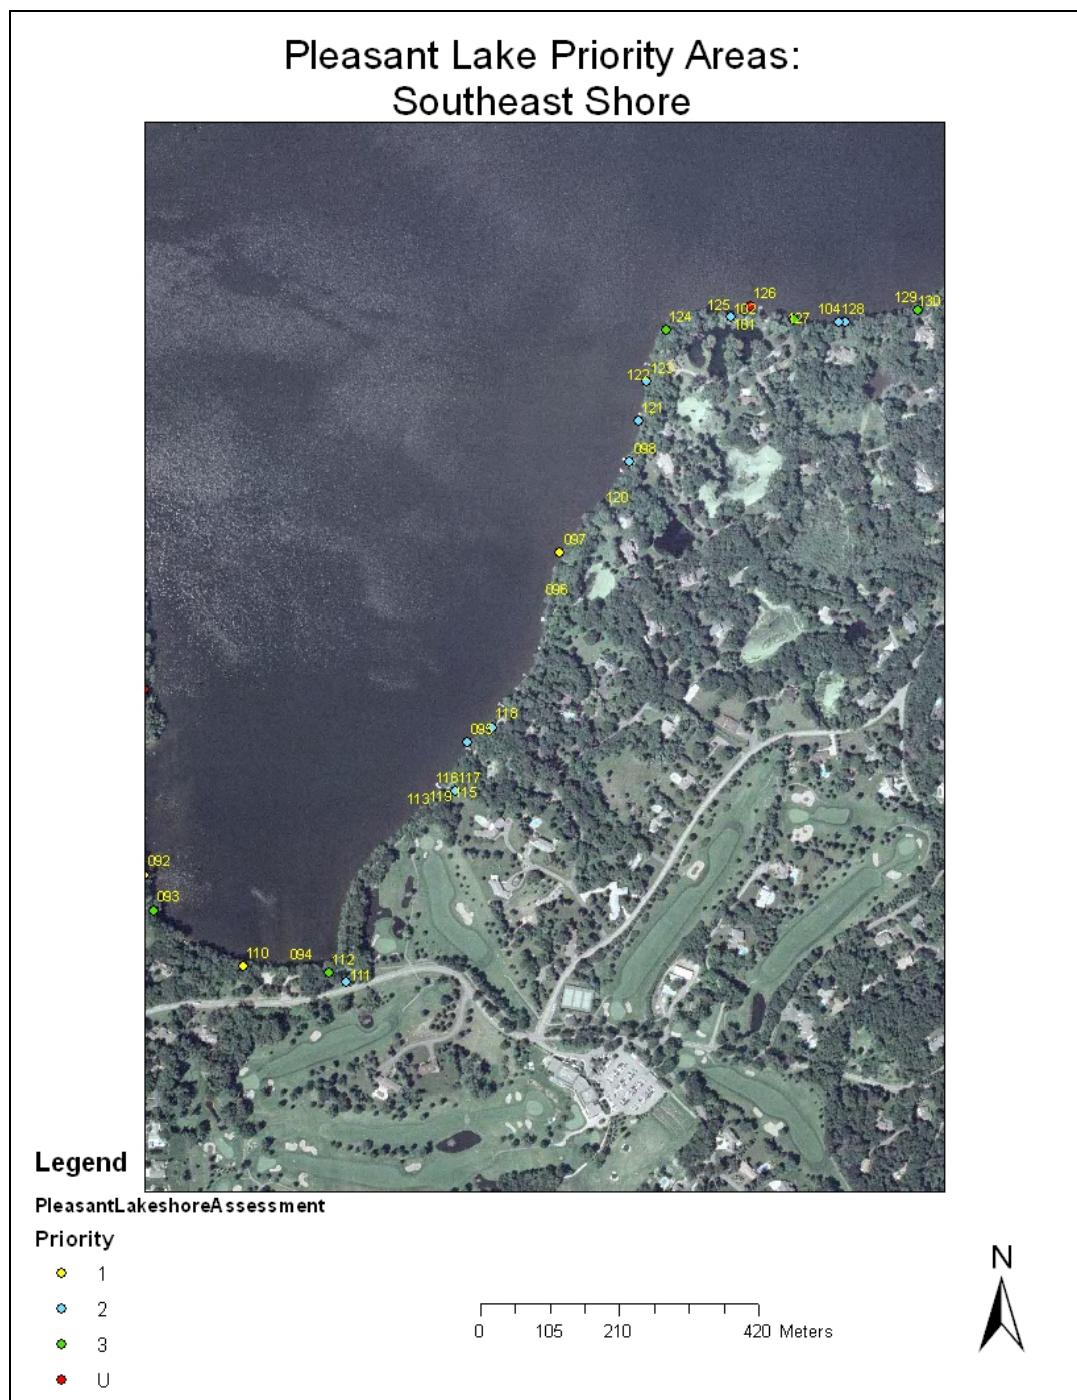
This reach includes area approximately 3800 feet long, stretching from the Golf Course (or at 5 Skillman Ln) to the point at 5 Raccoon Road (see Figure 29). This shoreline was classified as a combination of *low and high bank, high energy*. Generally this stretch is in relatively good condition. There are a few spots that warrant attention, however. Also, the entire stretch has evidence of ice ridge formation.

Figure 29. Map of Southeast Shore of Pleasant Lake, showing priority areas.
Note that one “urgent” priority area is marked with a red dot.

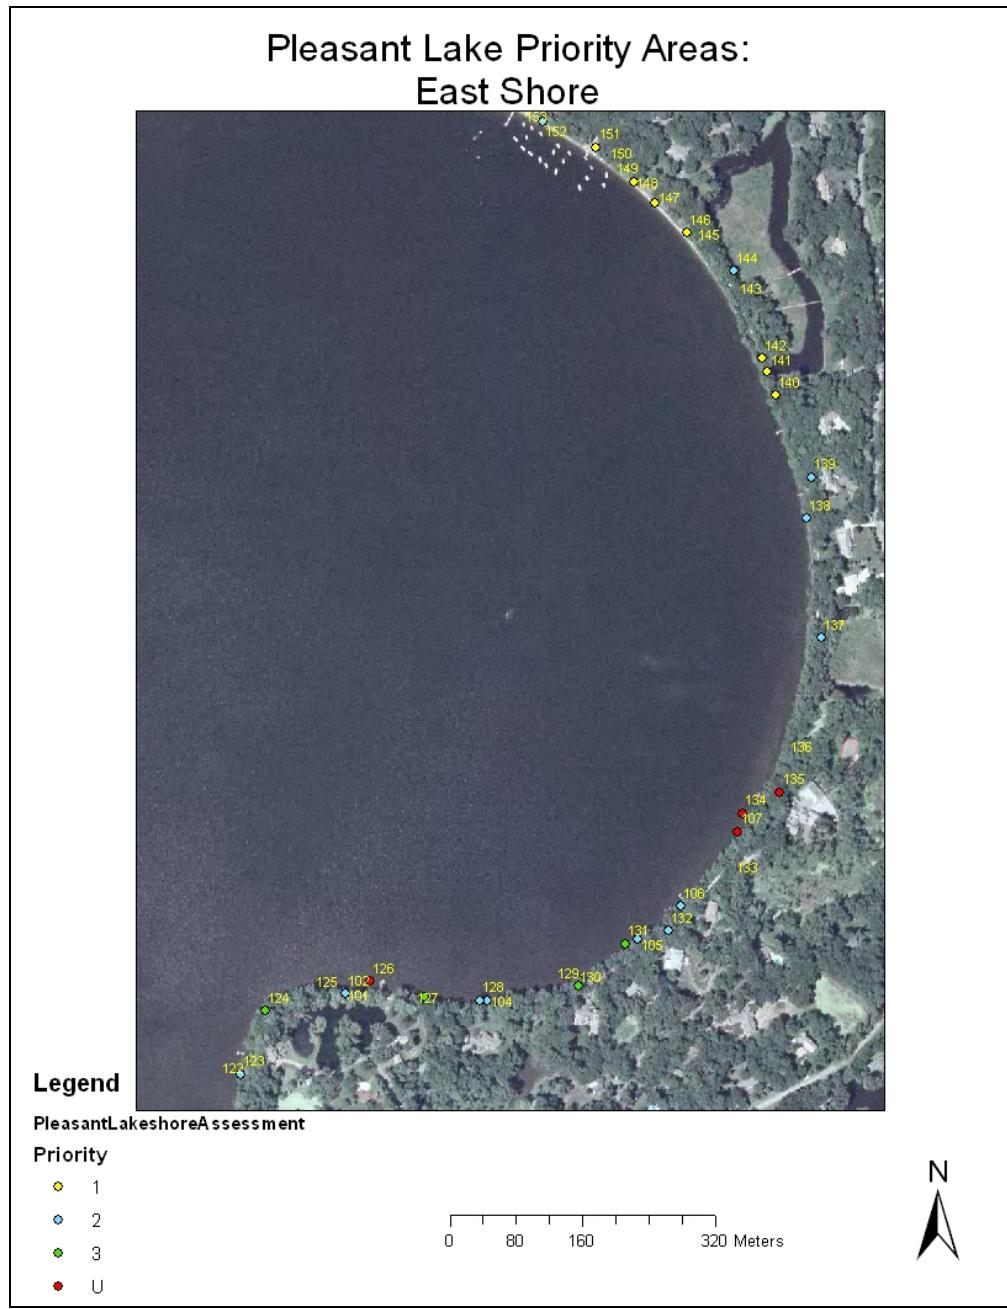
This section stretches from the point at 5 Raccoon Road all the way around in an arc to approximately 800 feet south of the Swimming Beach (at about 15 Oriole), for a total of approximately 4200 ft. This stretch is characterized by high relief and high, relatively steep banks for most of its distance. This shoreline was categorized as *high bank, high energy*, but punctuated with *low bank, high energy*. The buffer is fairly wide and forested throughout, but there are some significant “holes” in the vegetation at several spots (see map in Figure 31).

Figure 31. Map of East Shore of Pleasant Lake, showing priority areas.
Note that “urgent” priority areas are marked with a red dot.
