Pleasant Lake Shoreline Evaluation

North Oaks Homeowner Association

July 2009

The North Oaks Home Owners Association (NOHOA) owns the entire buffer area surrounding the lake, an approximately 50-feet strip up from the Ordinary High Water Line (OHWL). Funded by NOHOA, this report outlines the findings and recommendations stemming from the shoreline assessment that was performed by Great River Greening in June and July of 2009.

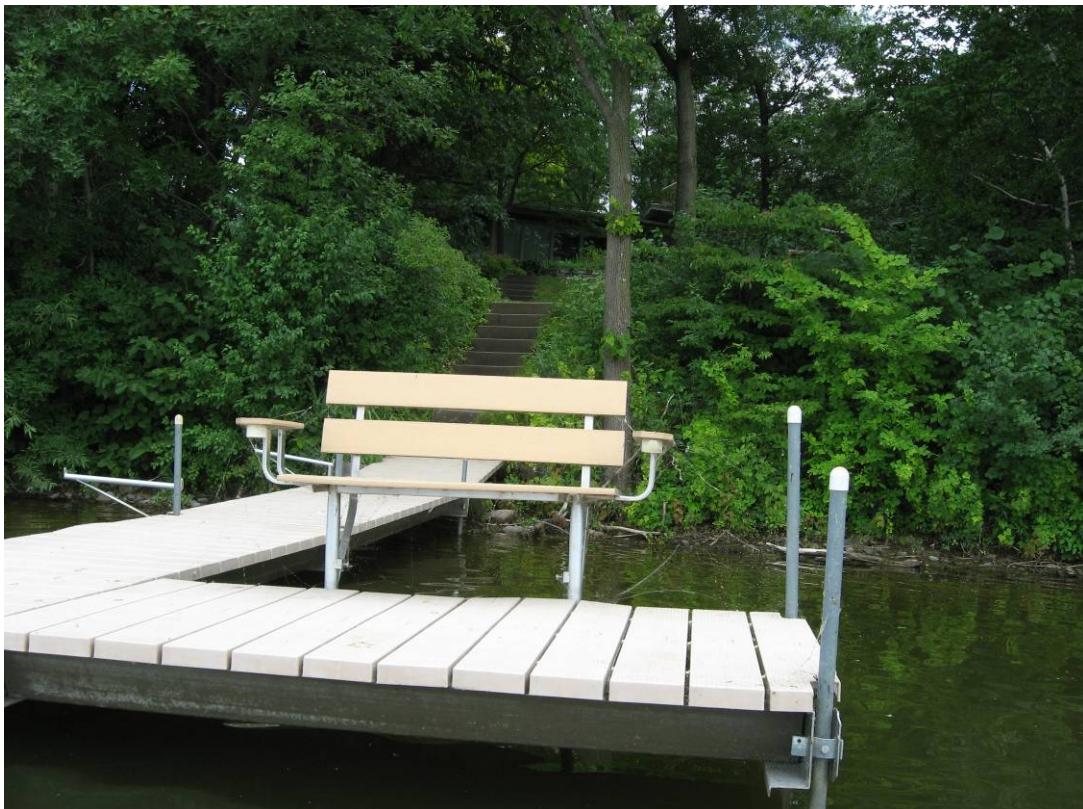
Figure 34. Model shoreline. Very vegetated. Cleared only a little around the deck. Trees left intact which gives structure. Shrubs are along the bank. Upland gardens, about 25' off the trail. Landscape trees and perennial beds on slope leading down to water (waypoint # 95).

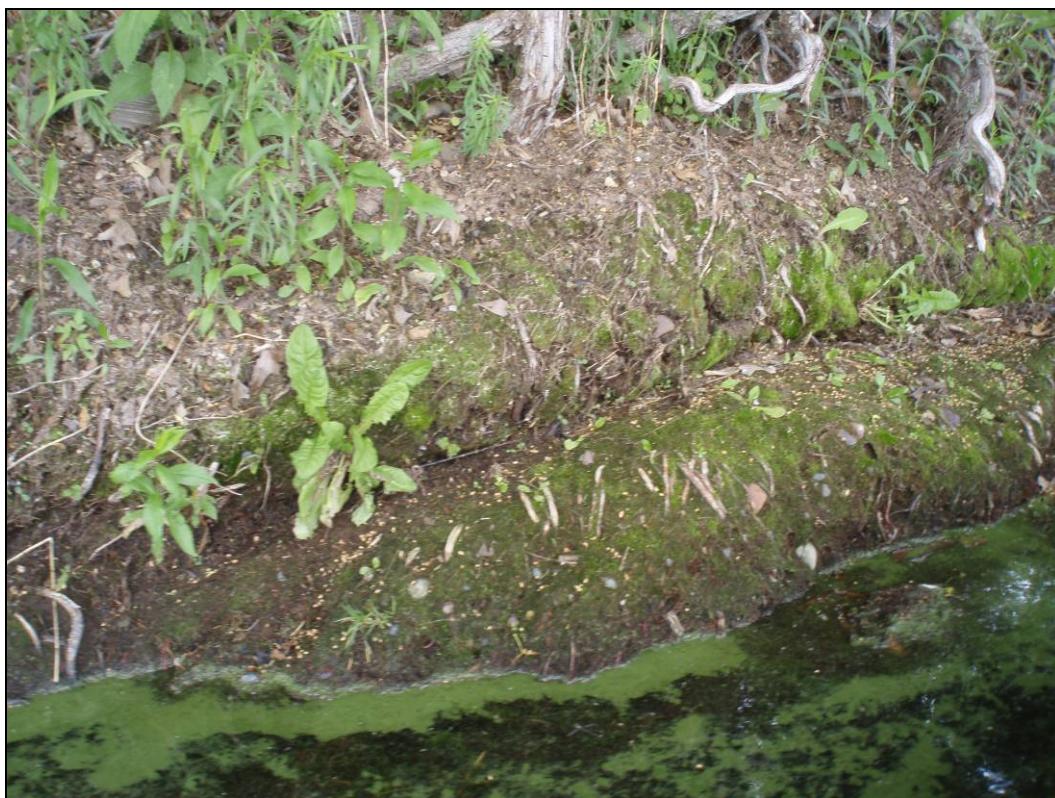
Many examples exist of black willow, *Salix nigra*, by virtue of its root system, protecting the toe of the shoreline of Pleasant Lake (see Figure 36 for a photo of tree’s root wad). This species of tree has a tendency to grow right along the water’s edge, and often leans out over the surface of the water. It has a peculiar characteristic of producing a long, root mass or “wad”, which runs parallel to the intersection of the lake water and the shore—right along the toe. This root wad is easily identified, upon close examination, by its red color that comes from the many little red root hairs that make up the component structure of the wad (see Figure 37). Many examples were observed where these root wads extended many feet (up to 50 feet) out from the base of the tree. This quality makes black willow an ideal shoreline protector, and it is highly recommended for use in the restoration of Pleasant Lake Shoreline.

Figure 36. Black willow root wad at toe of shoreline.

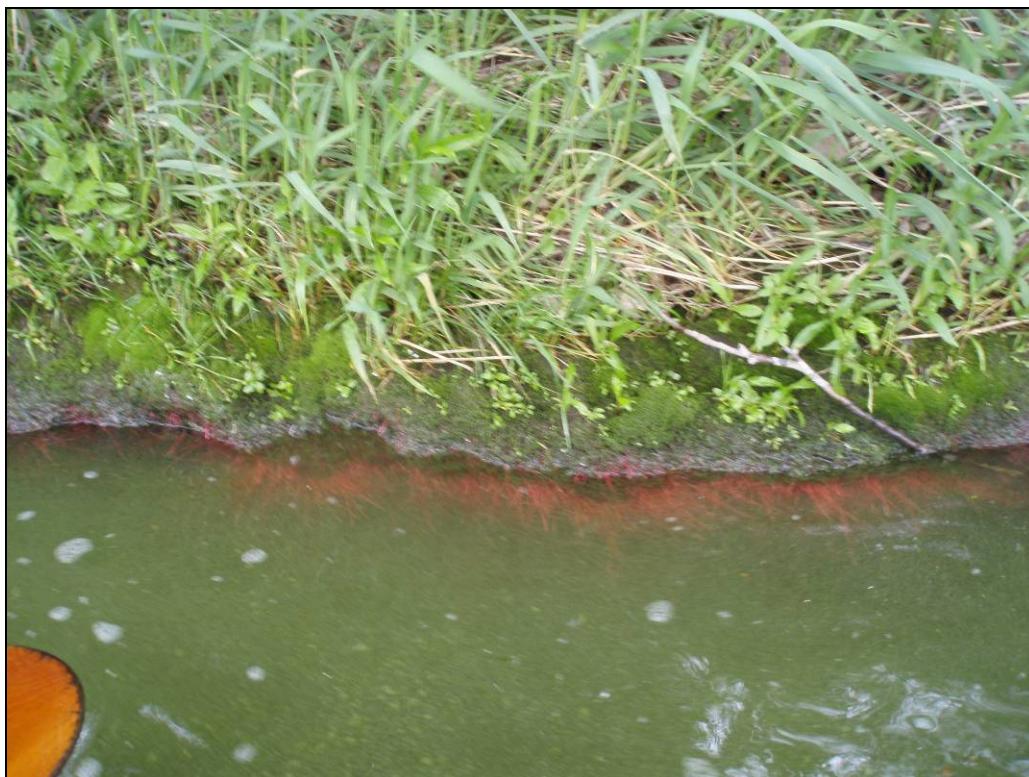
Figure 37. Red root hairs of Black Willow root wad.
