# Sustainable Lake Management Plan Gem Lake Ramsey County, MN

Prepared by: Kristine Jenson Vadnais Lake Area Water Management Organization 2014 This page was left blank intentionally.

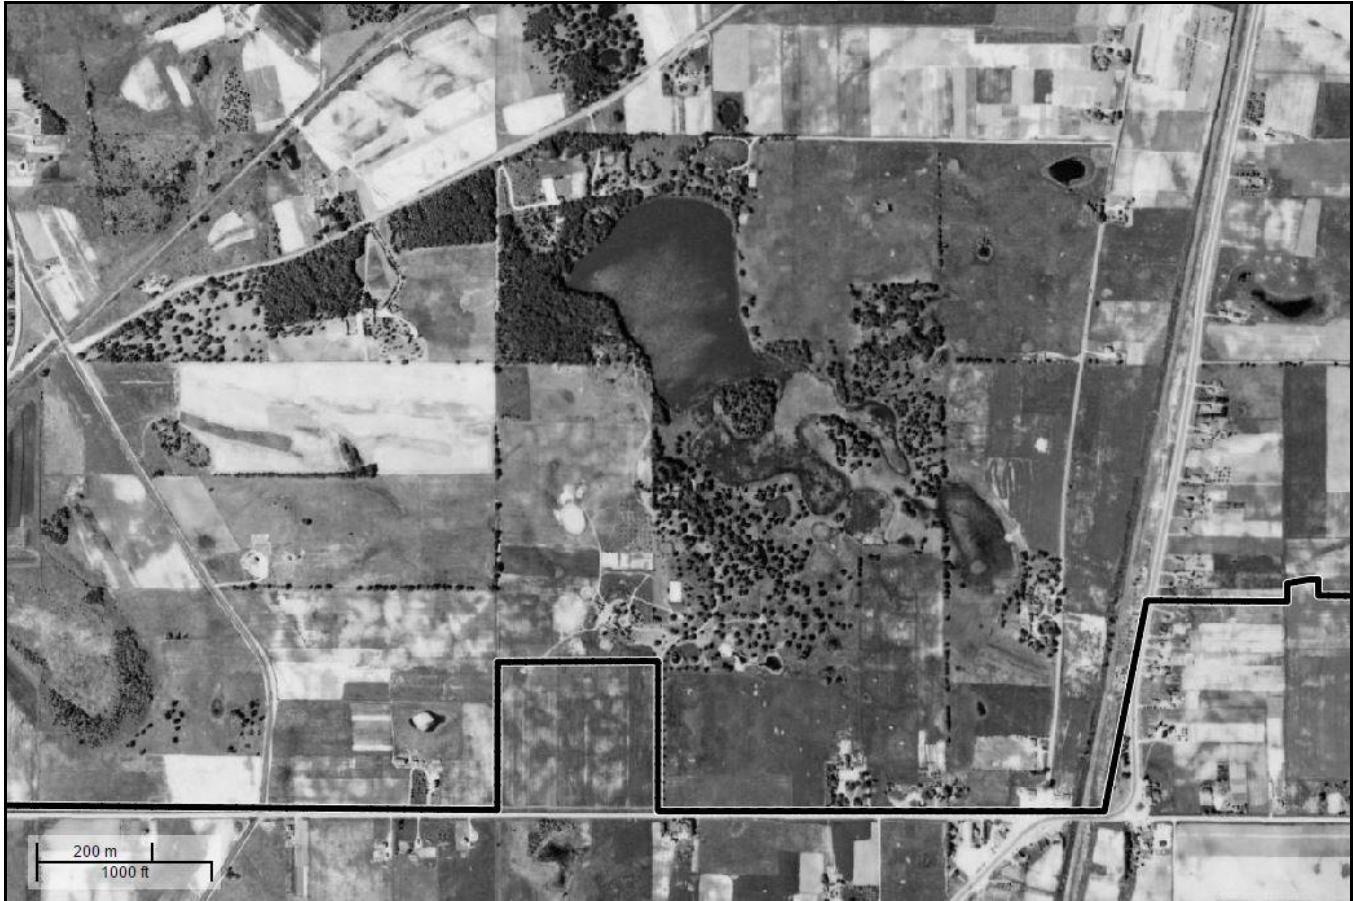
Figure 2: 1940 Aerial photo of Gem Lake

In 1940, the area has a few homes near the lake and what agriculture use within the subwatershed. What is now known as Hoffman Road is on the eastern side of the photo with homes built off the east side of the road. The railroad that runs parallel to Hoffman Road is also present.

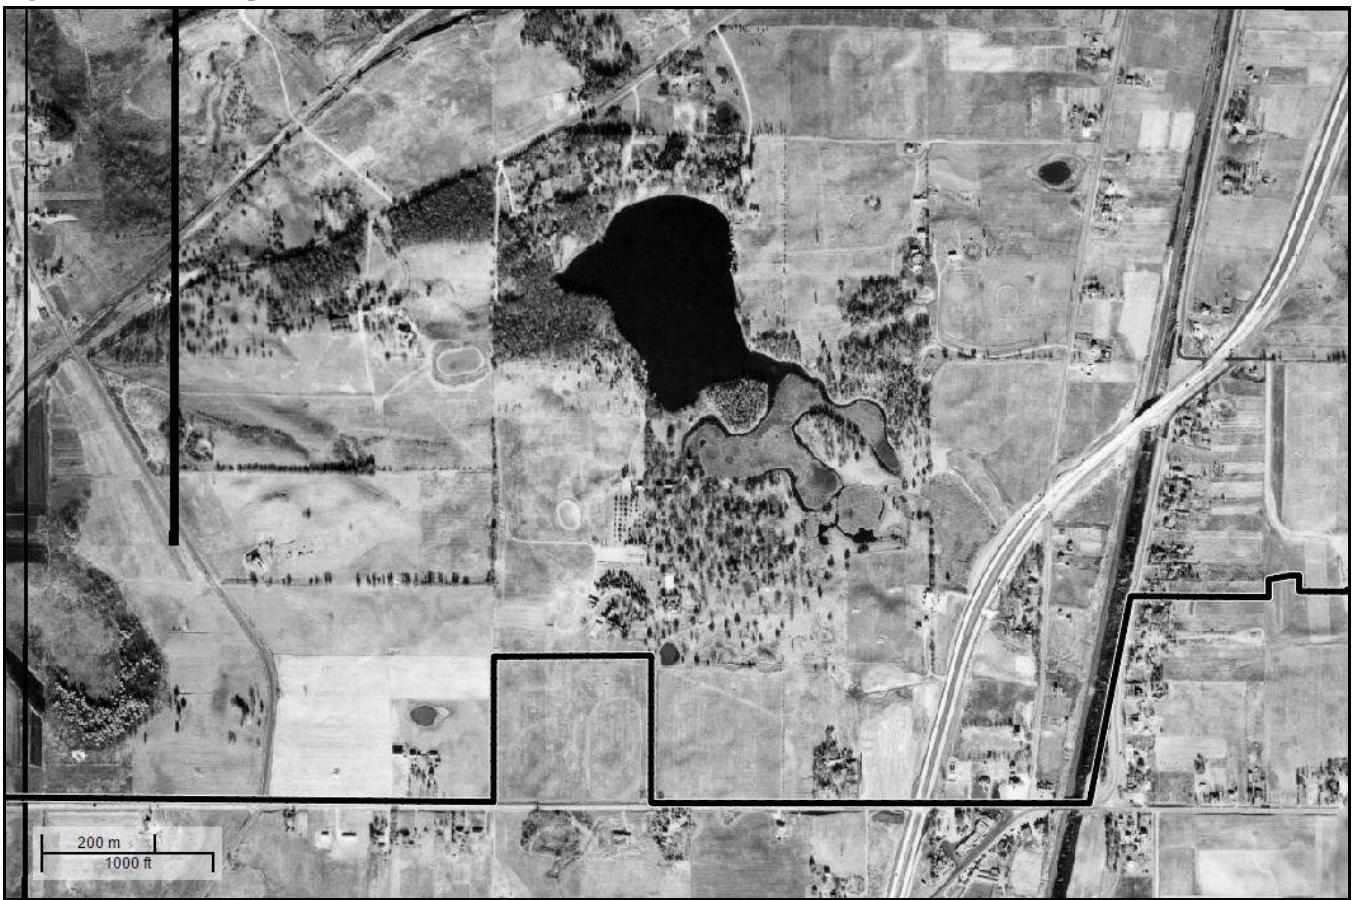
Figure 3: 1953 Aerial photo of Gem Lake

In 1953, a few more homes are cropping up in the subwatershed area. Highway 61 has been built and some development is occurring on the eastern side of the intersection of what is currently called County Road E and Highway 61.

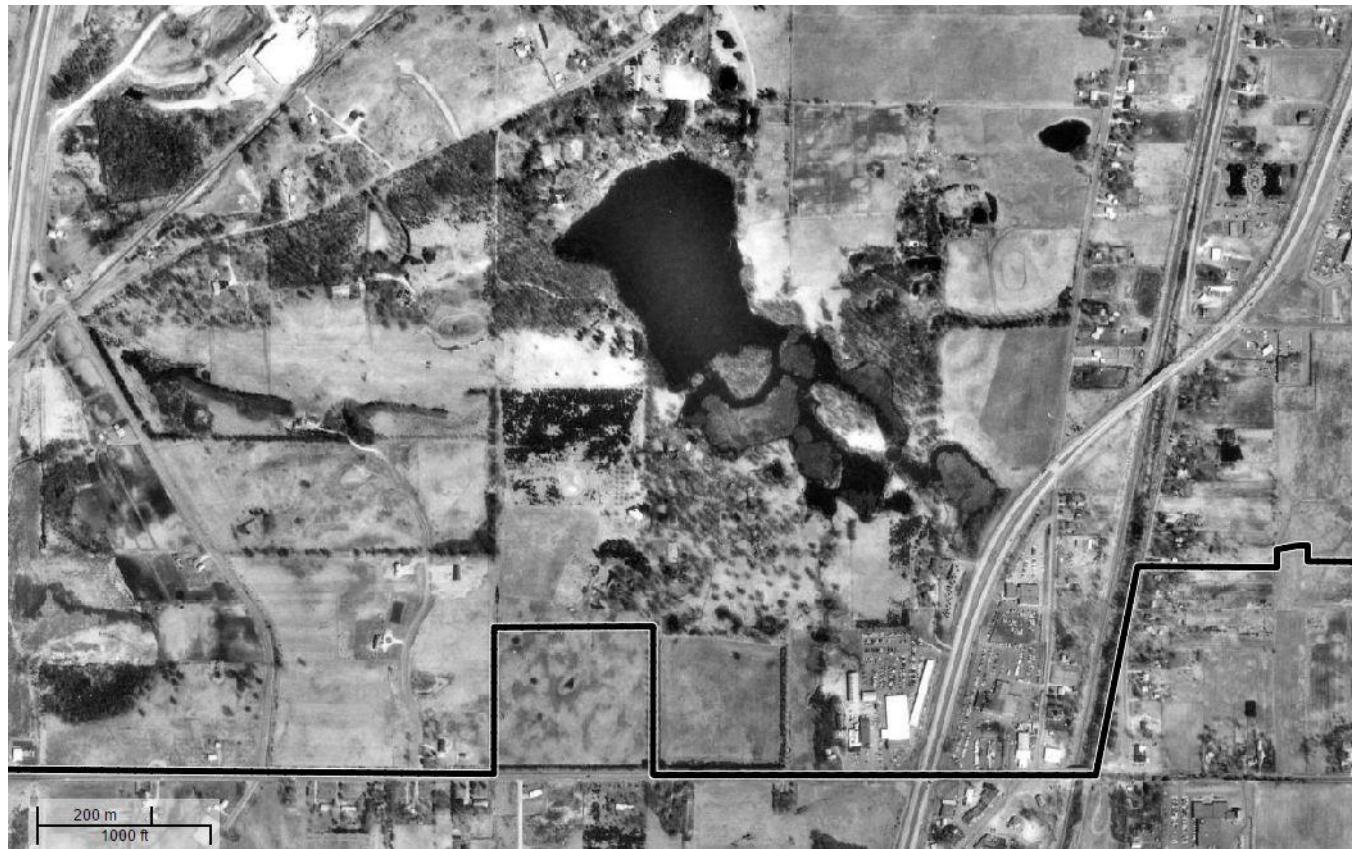
Figure 4: 1974 Aerial photo of Gem Lake

By 1974, commercial development is occurring at the intersection of Highway 61 and County Road E, along with more residential development along Scheuneman Road. Along the western edge of this photo, you can see that what is now known as Interstate 35E has been built.

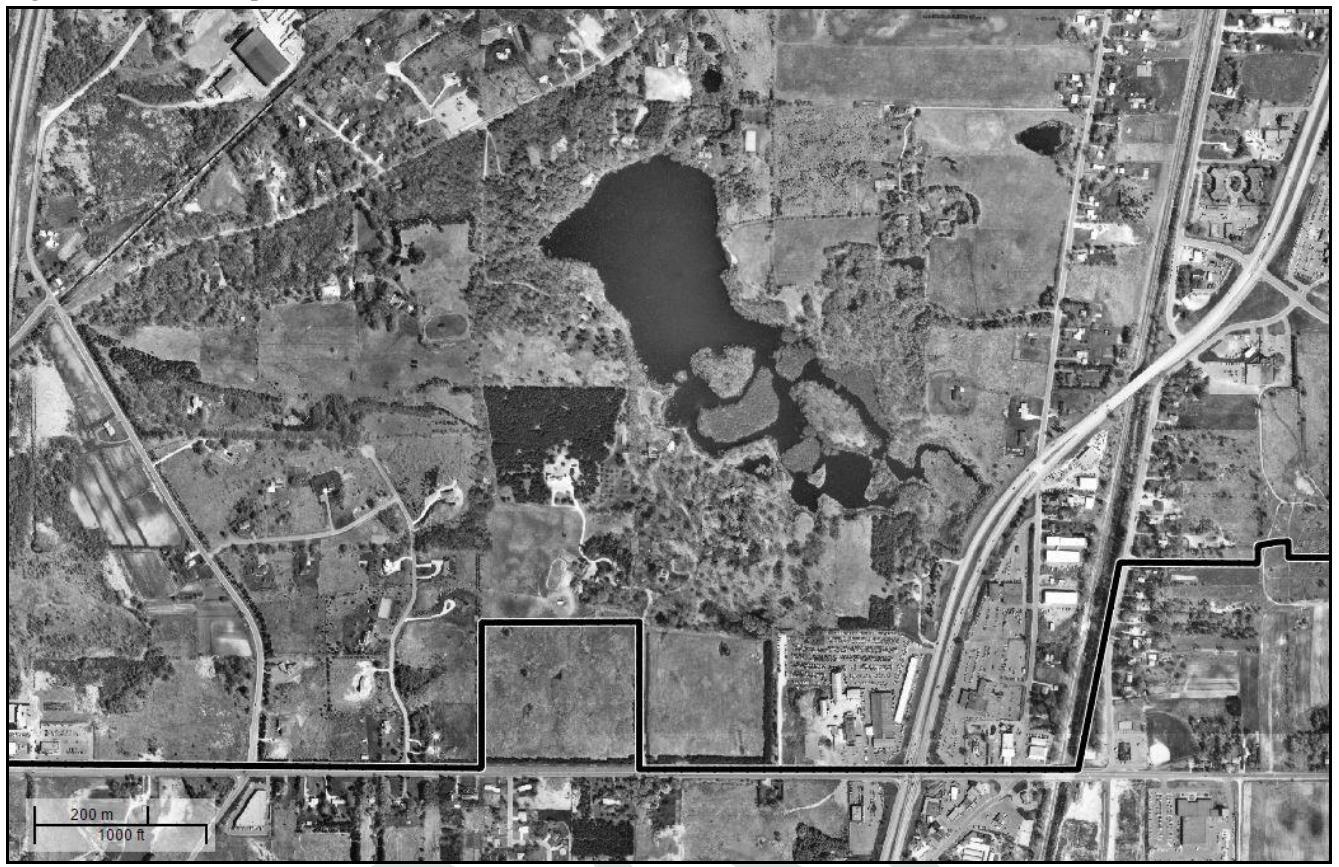
Figure 5: 1985 Aerial photo of Gem Lake

In 1985, more development has occurred in the area, especially between Scheuneman Road and the railroad tracks. Additionally, the residential developments around Daniels Farm Road and Big Fox Road are starting to show up.

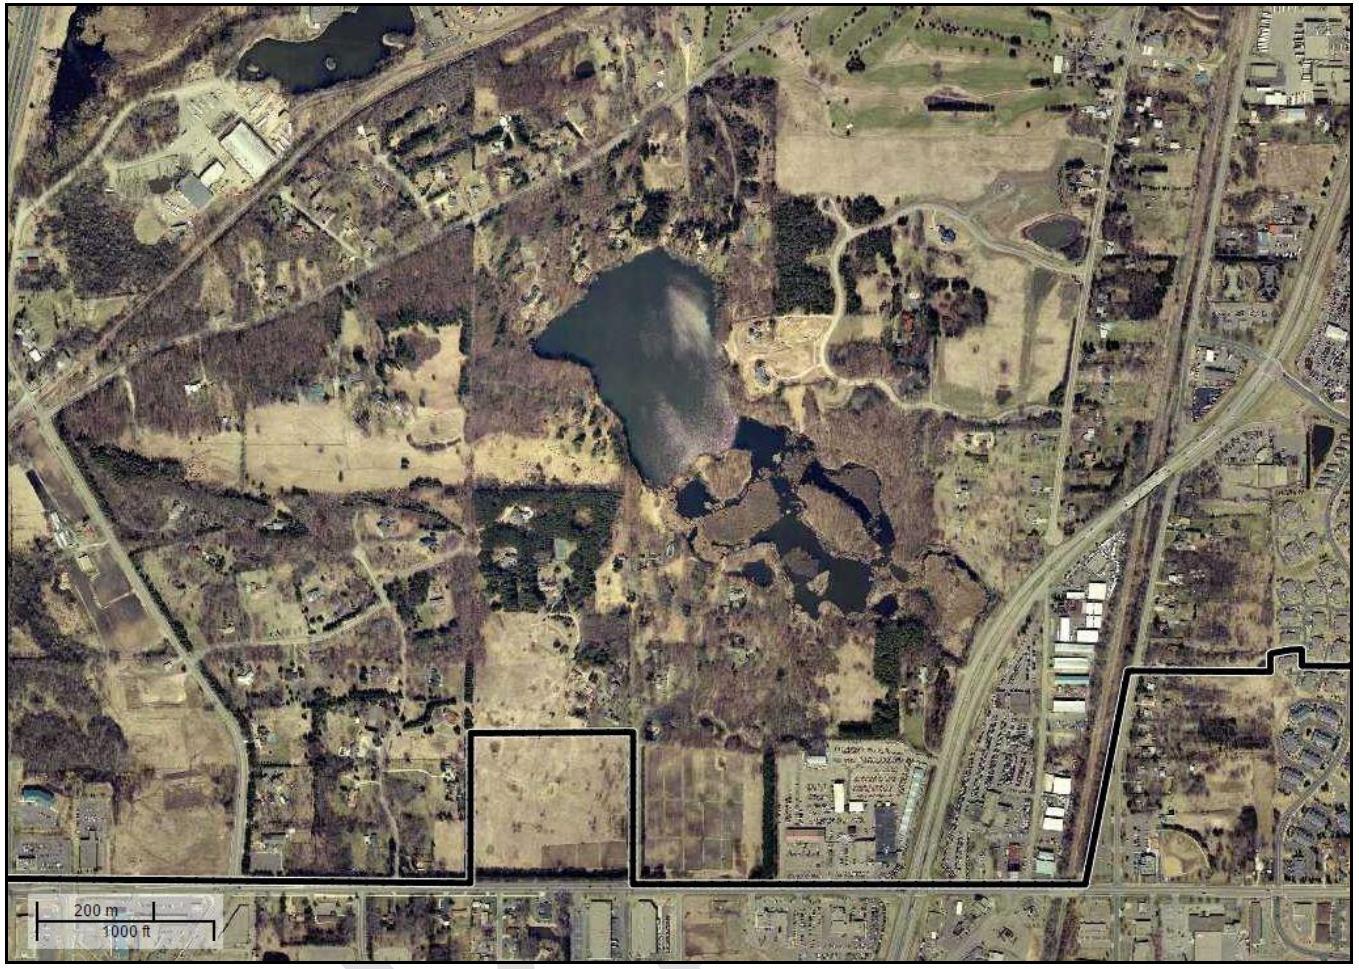
Figure 6: 2006 Aerial photo of Gem Lake

By 2006, the Hillary Farm residential area begun construction and the Gem Lake Golf Club has been developed.

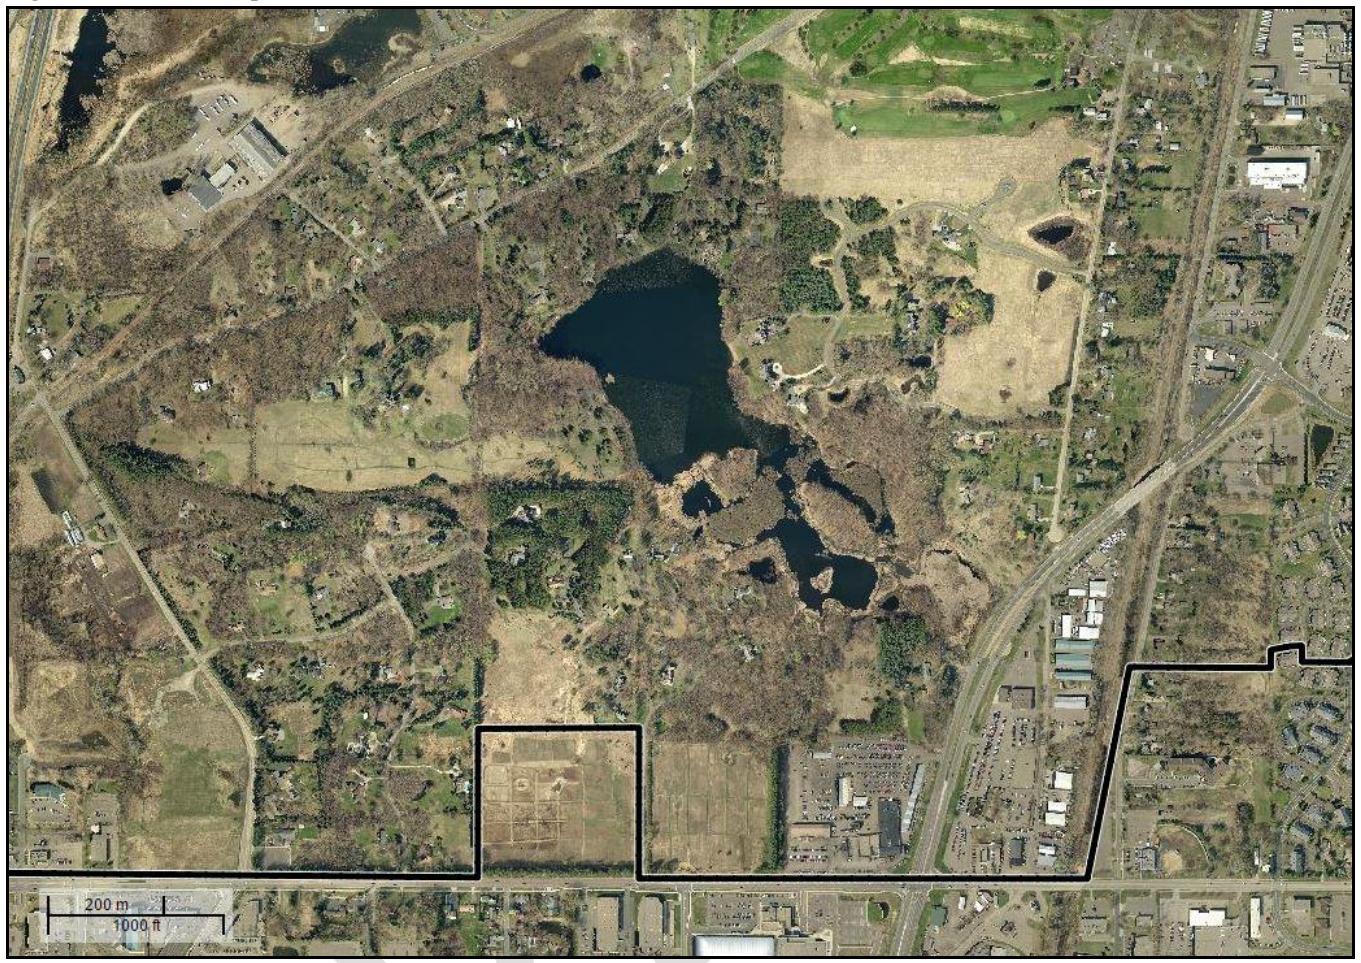
Figure 7: 2012 Aerial photo of Gem Lake

By 2012, there are more homes in the Hillary Farm area. More homes are planned for the Hillary Farm development.

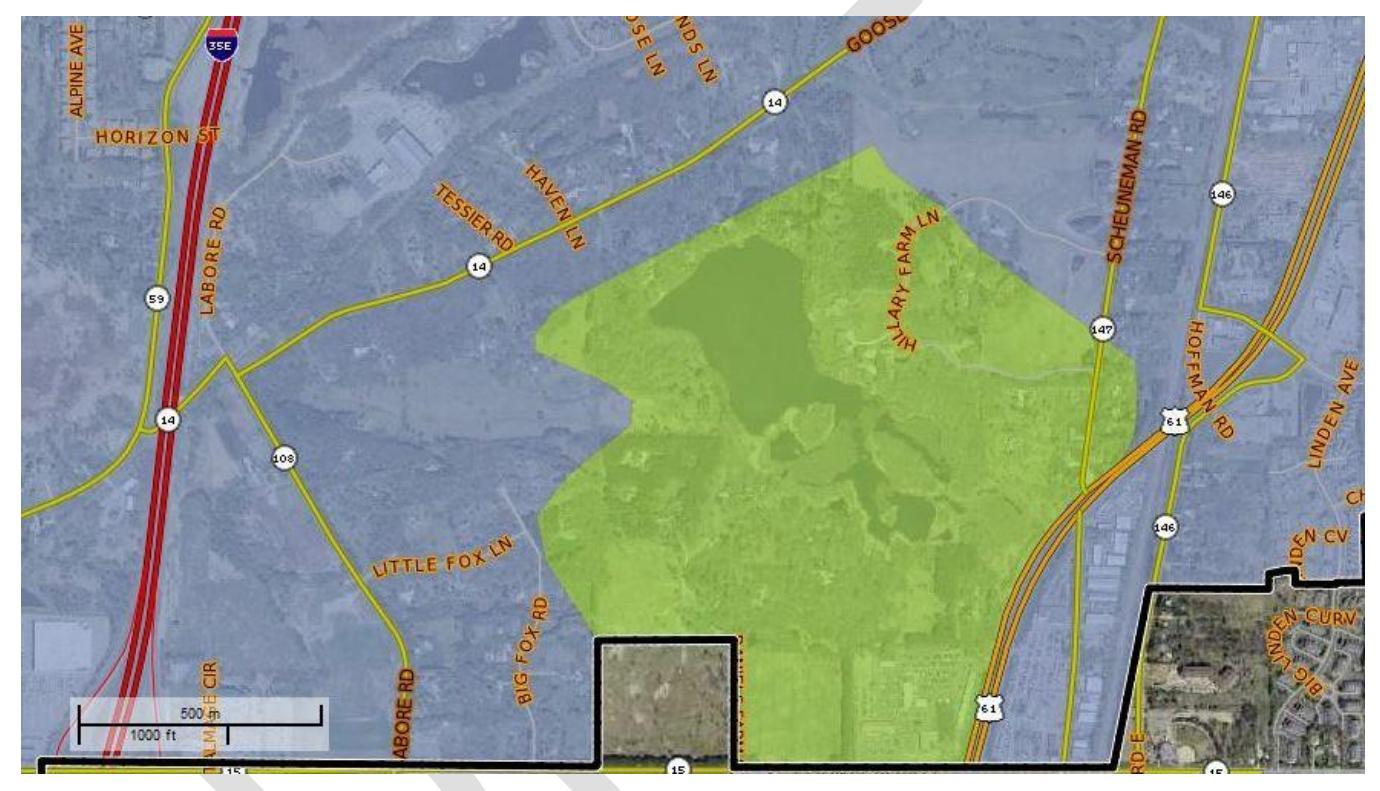
Figure 8: Gem Lake Subwatershed

Gem receives water from various sources. The subwatershed is shown in the green area of the map below and is 306 acres in size. The subwatershed area is about 15 times larger than the surface area of the lake. This is relatively small for a subwatershed. A positive aspect of a small subwatershed area is that there is not a lot of land contributing to stormwater runoff into the lake. The land use within the subwatershed is primarily undeveloped or residential. A large source of possible stormwater runoff comes from Highway 61. Gem Lake is slightly unusual in that water doesn't flow out of the subwatershed area. Gem Lake is the end point of stormwater runoff for this area and doesn't outflow into another part of the watershed. That means all stormwater runoff must be filtered and infiltrated within the subwatershed rather than moving on to another waterbody.

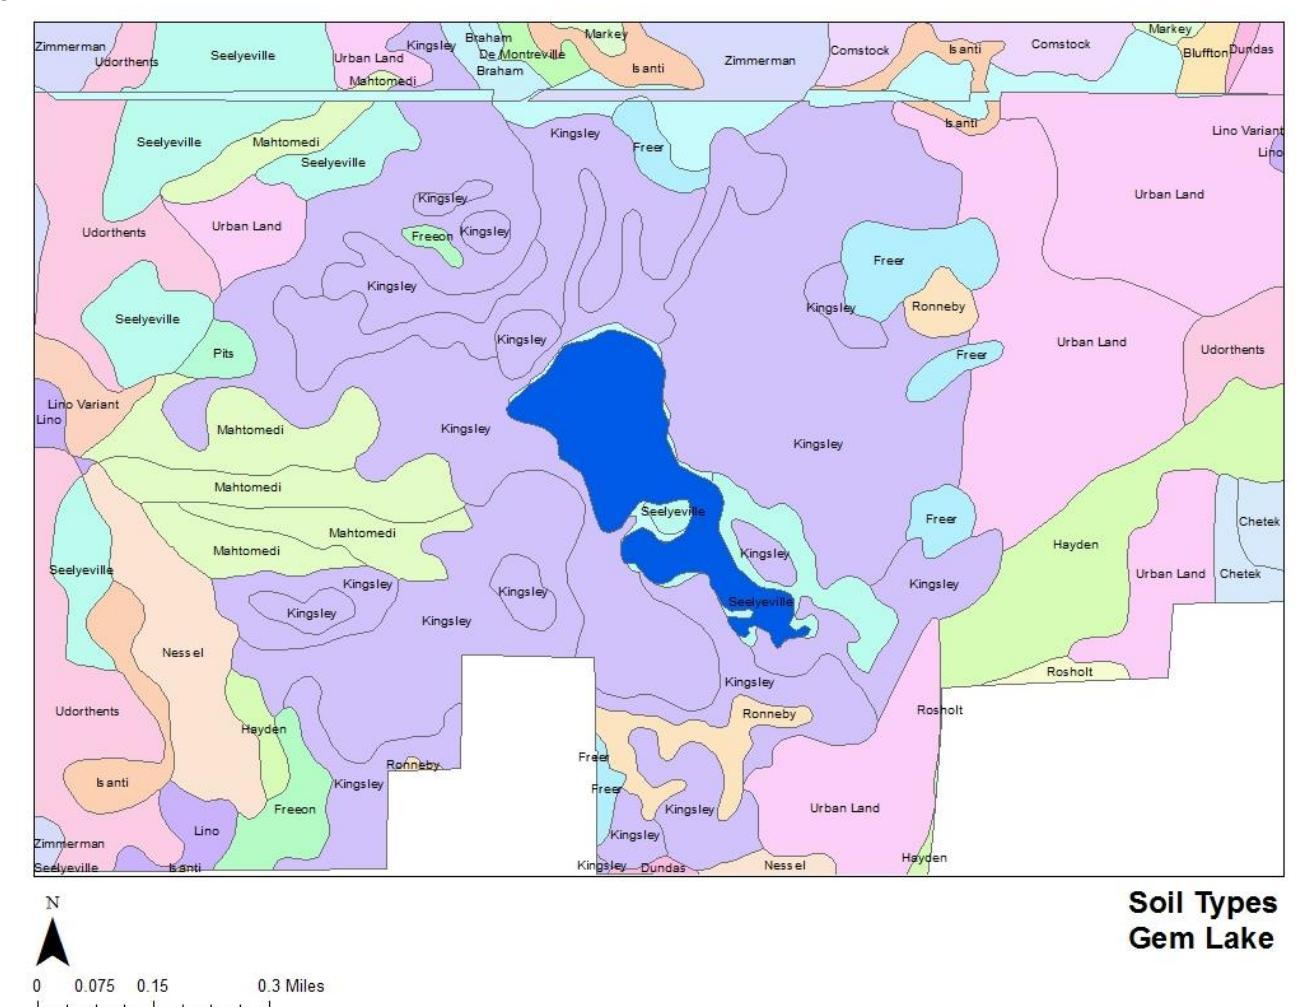
Figure 9: Soils around Gem Lake

The soil directly under and near Gem Lake is Seelyeville which is an organic muck. The soils near the lake are mainly Kingsley and Mahtomedi which tend to be soils that drain easily and are well suited for agriculture and homesites. Mahtomedi soils are found in forest areas as well.

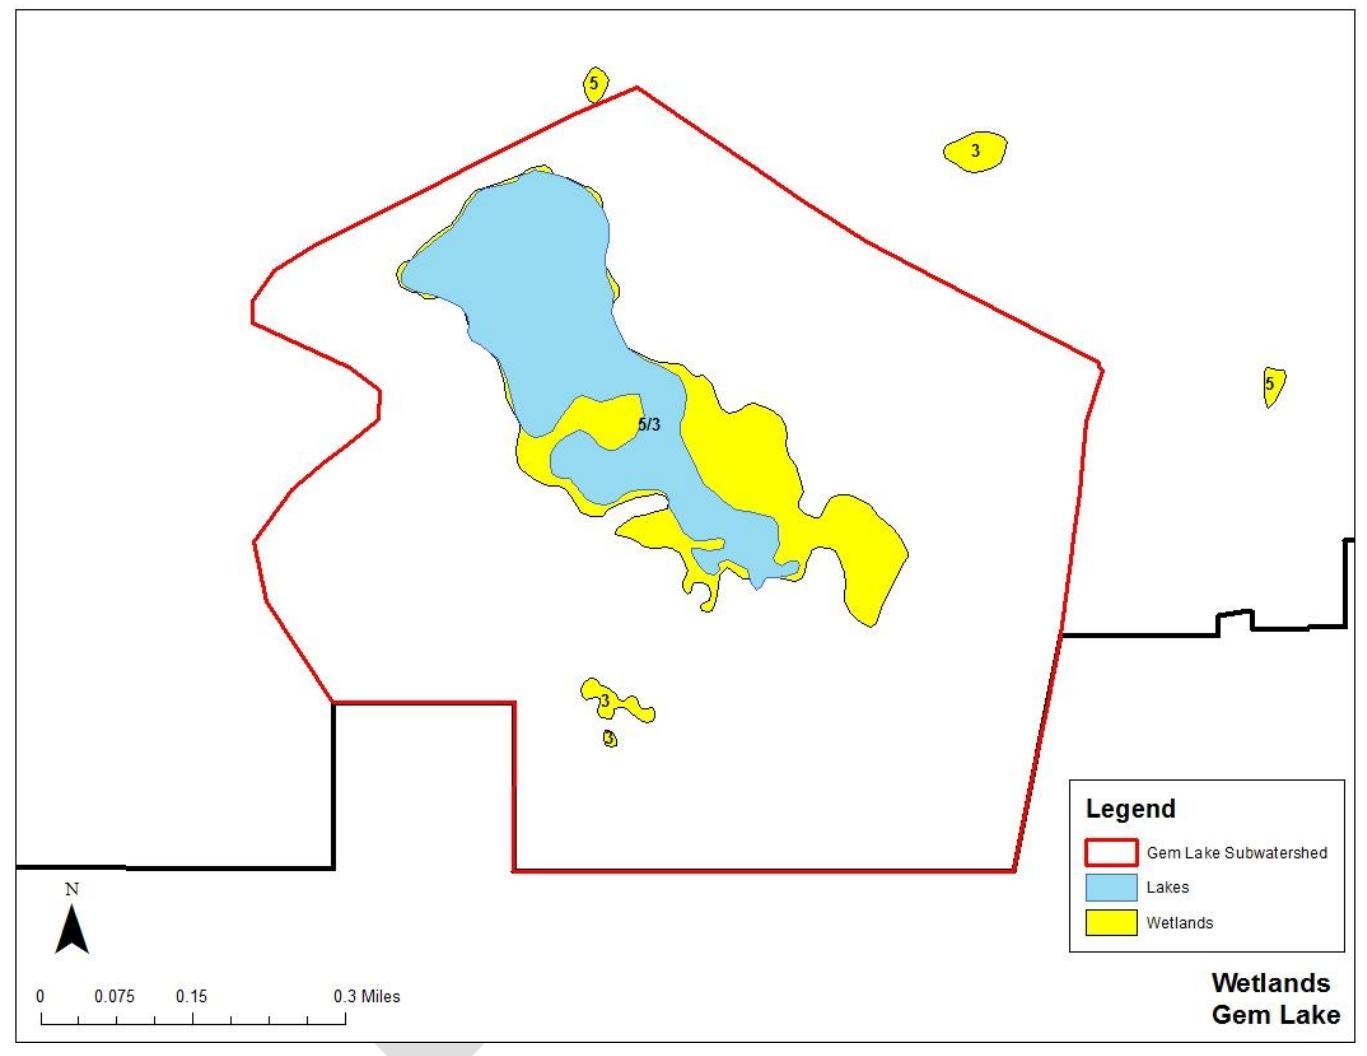
Gem Lake and the marsh surrounding it is classified as a Type 5/3 according to the Wetland US Fish & Wildlife Circular 39 classification system. Additionally, there are 2 small Type 3 wetlands south of Gem Lake. A Type 3 wetland is described as a shallow marsh. The soil is usually waterlogged in the spring and often covered with more than 6 inches of water. A Type 5 wetland is an open water wetland which included shallow ponds. Water is usually less than 6 feet deep and typically surrounded with vegetation. Both types of wetlands provide habitat for fish, birds, and other wildlife, retain floodwater, and protect water quality.

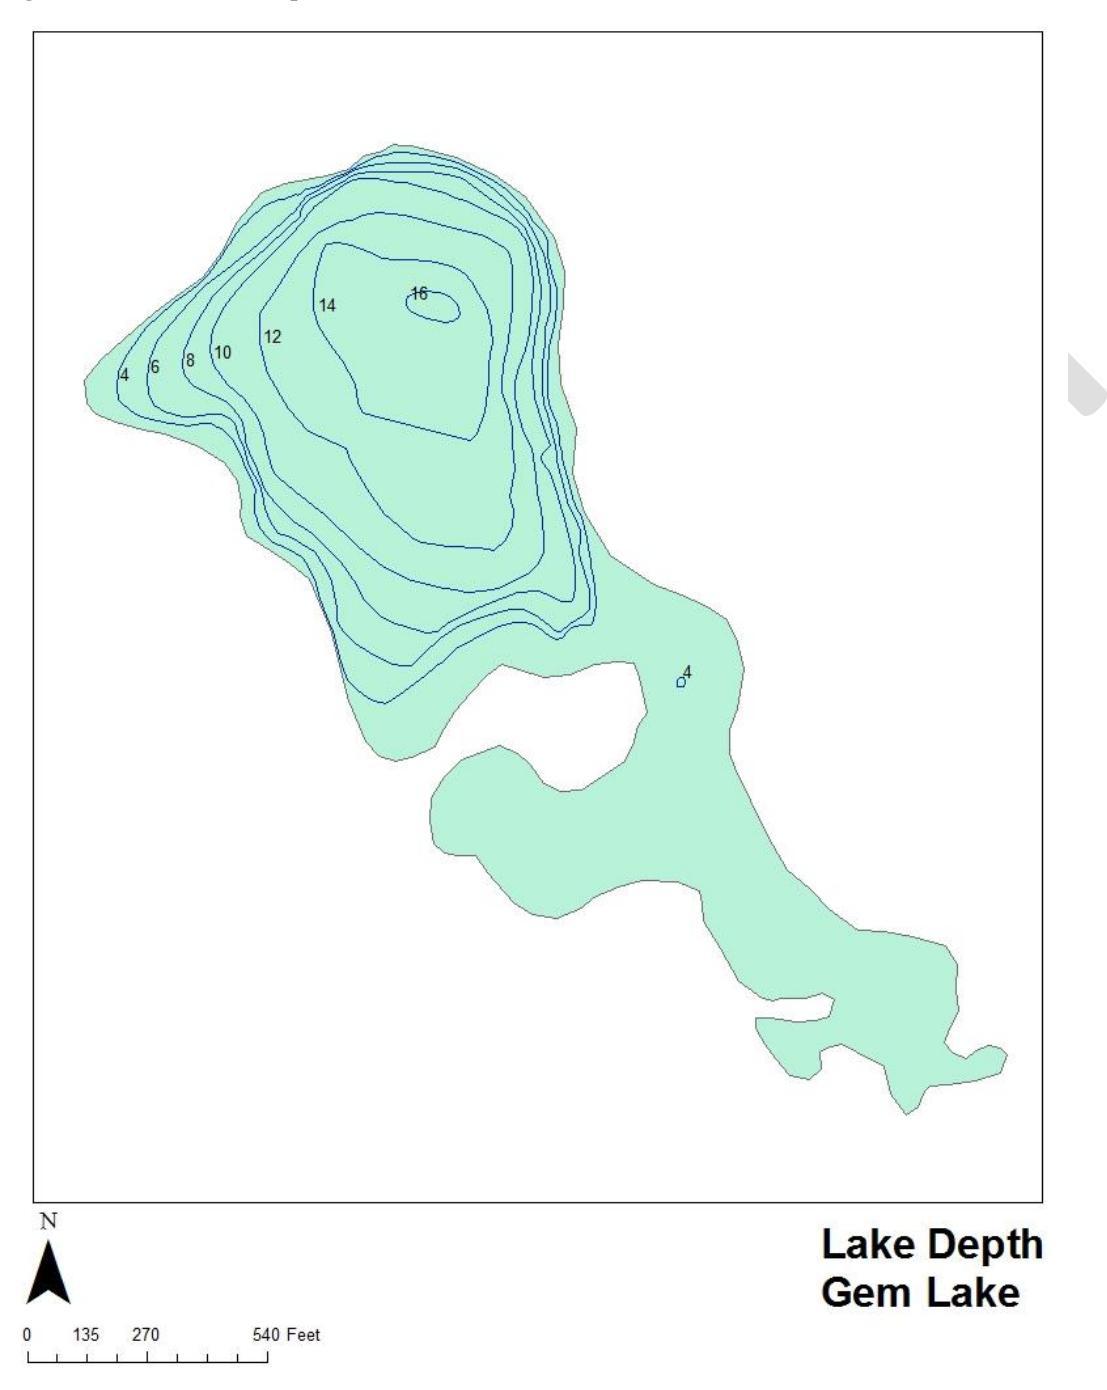
Figure 11: Gem Lake Depth

Gem Lake drops in depth rather quickly off the shoreline. VLAWMO's survey found the deepest point was 16 feet.

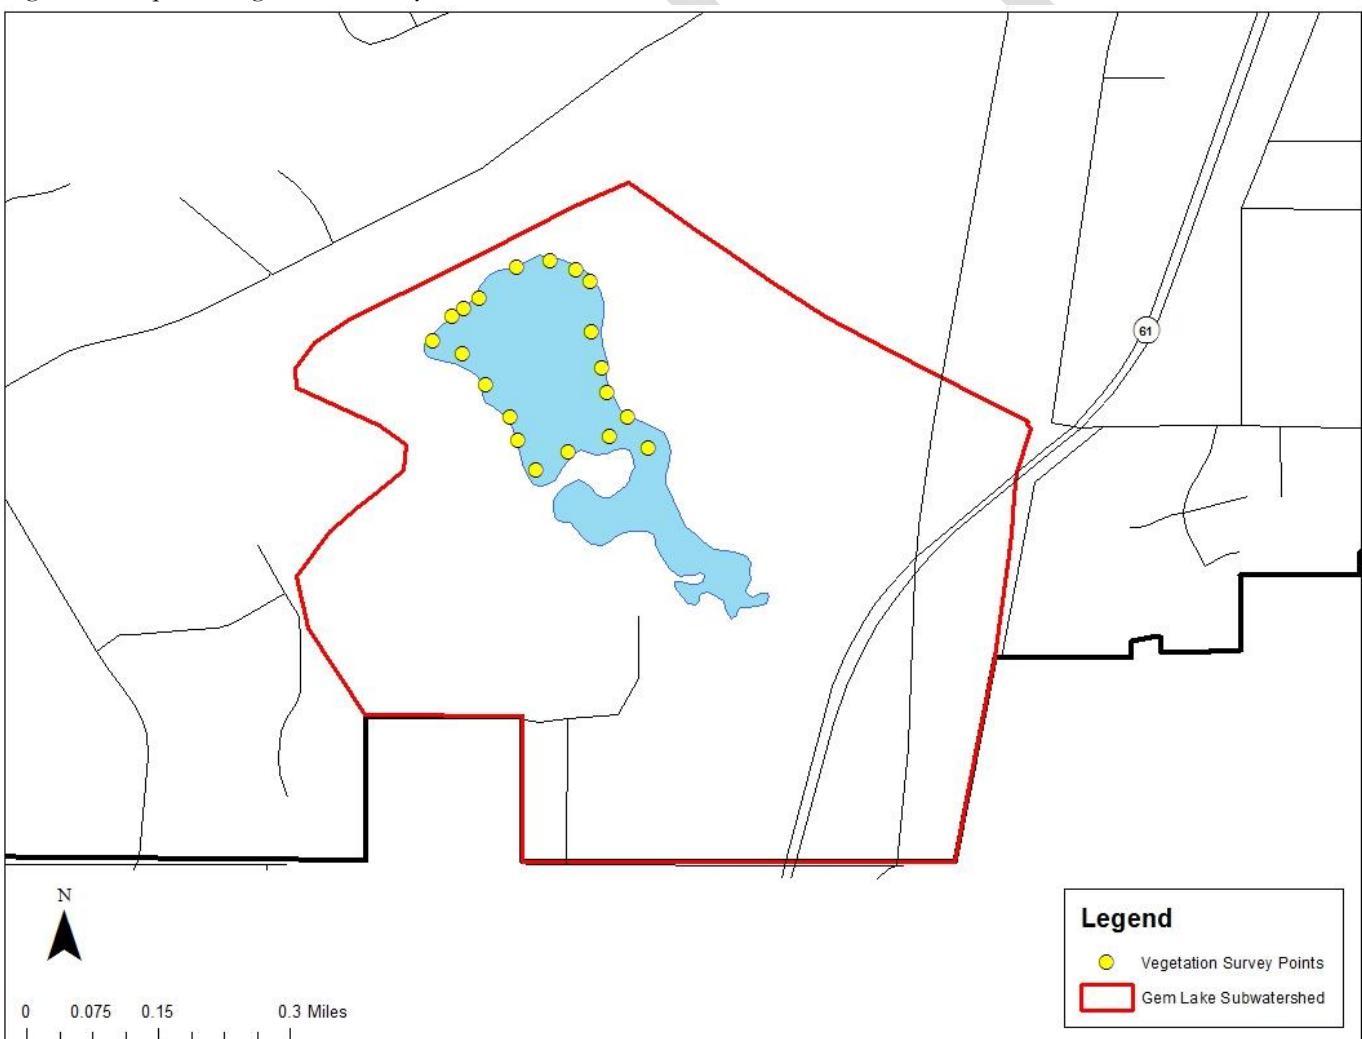
VLAWMO staff conducted an aquatic vegetation survey on June 30, 2010. Due to Gem's depth, plant life was only found around the perimeter of the lake. Once water depth goes past 4 feet, it gets harder for sunlight to reach down far enough to support plant life. Gem Lake does not have a diverse plant community within its waters. The 3 most abundant plant species found were Clasping-leaf Pondweed, Pickeral Weed, and White Water Lily. However, no invasive plant species were found in the lake which is a positive thing. Results of the survey are located in Table 1.
