## GOOSE LAKE & EAST & VLAWMO WEST

# **QUICK FACTS**

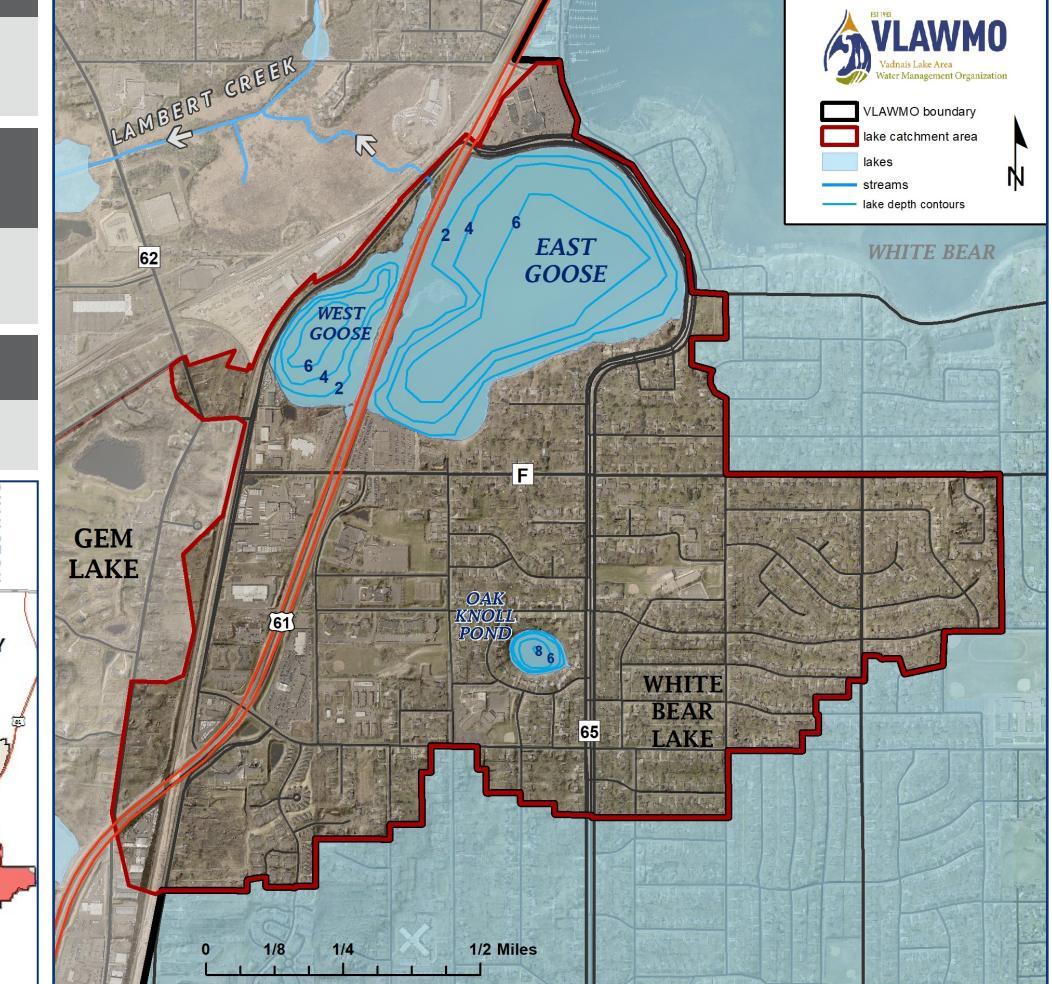
**OAK KNOLL POND,** also known as Wood Lake, which is located south of East Goose Lake near White Bear Avenue. It feeds into Goose Lake and is an important part of Goose Lake's improvement. Records and aerial imagery indicate that Oak Knoll is a natural pond that has transitioned from agriculture to suburban uses.
